Artikel: Repair of the Linfjord tunnel, Denmark

Repair of the Limfjord Tunnel, Denmark

Summary

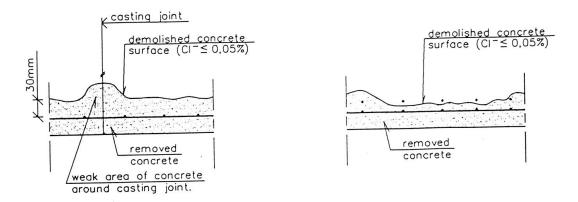
Two typical demolition profile is schematically shown below.

Generally concrete is removed until the amount of chlorides in the concrete is less than 0.05% by weight of concrete, however, never deeper than 30 mm behind the deepest layer of reinforcement unless weak areas of concrete facilitate deeper demolition.

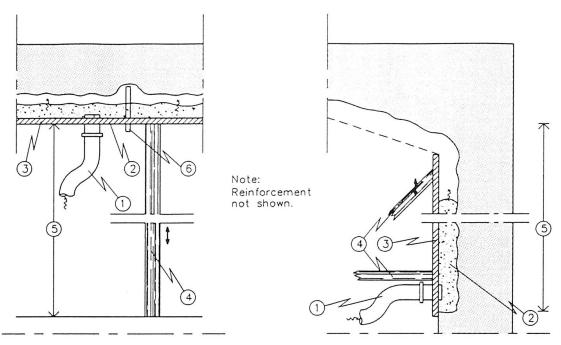
Principle - replacing concrete on tunnel ceiling

Principle - replacing concrete on tunnel wall

- ① Concrete supply, maximum pumping pressure: 1 atm
- ② High-slump concrete
- ③ Form, adjustable in height to comply with varying casting heights, see ⑤. The stiffness and capacity of the form is designed to meet specified requirements on straightness of wall/ceiling at maximum pumping pressure, see ①
- Scaffolding supporting the form, the scaffolding is accordingly designed to be adjustable in height, and to meet specified stiffness and capacity criteria at maximum pumping pressure. Furthermore, both form and scaffolding is designed to be easily relieved, moved, adjusted and re-established in another location
- © Casting height varying from approximately 4,5 meters to 5,5 meters
- © Ventilation tubes to avoid air being enclosed in voids during casting

The principle of pumping high-slump concrete is schematically shown on the illustrations below.
