Artikel: Repair of the Linfjord tunnel, Denmark
Autor: Vejlby Thomsen, J. / Hededal, Poul
DOI: <https://doi.org/10.5169/seals-59067>

Repair of the Limfjord Tunnel, Denmark

Summary

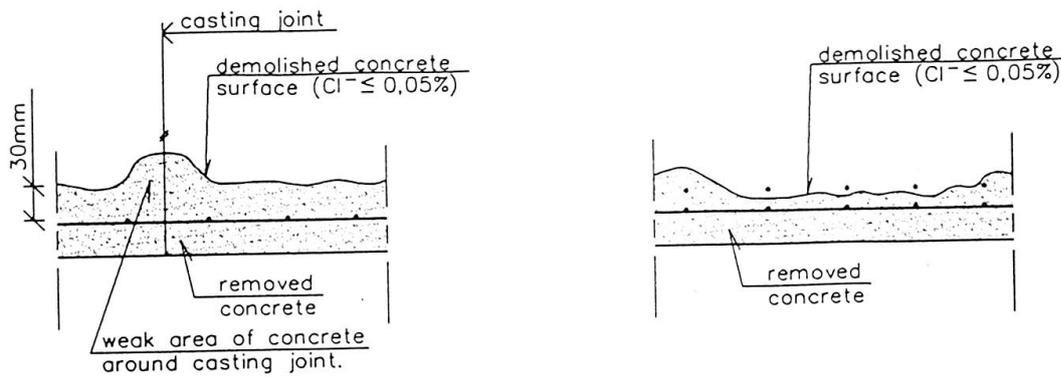
Generally concrete is removed until the amount of chlorides in the concrete is less than 0.05% by weight of concrete, however, never deeper than 30 mm behind the deepest layer of reinforcement unless weak areas of concrete facilitate deeper demolition.

Two typical demolition profile is schematically shown below.

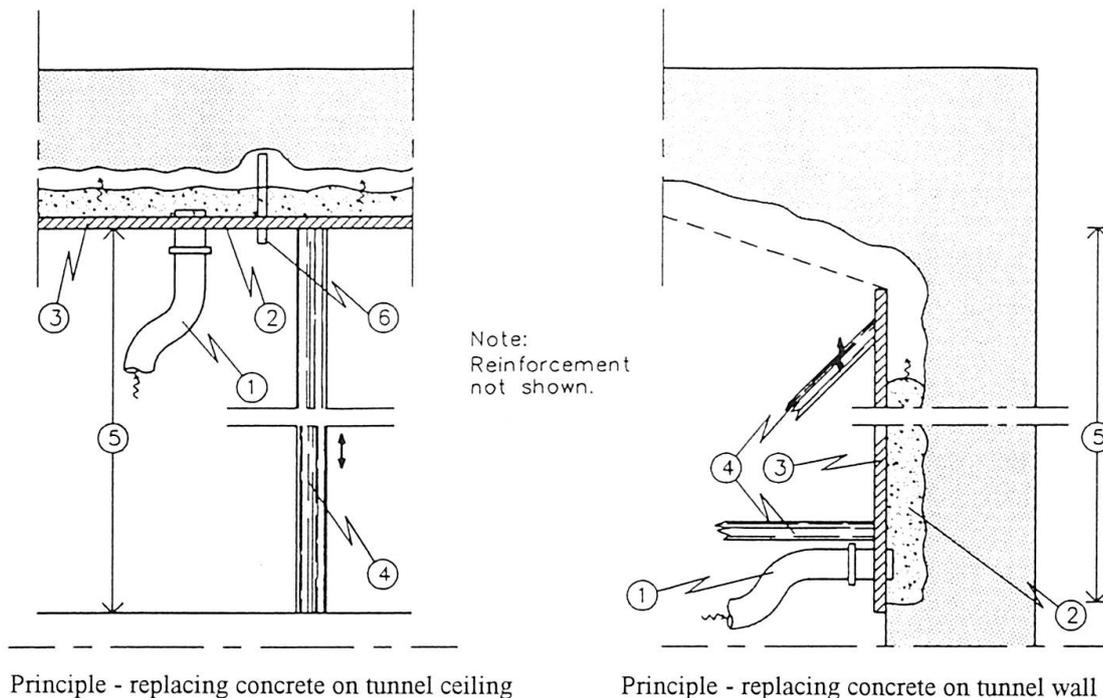
The principle of pumping high-slump concrete is schematically shown on the illustrations below.

- ① Concrete supply, maximum pumping pressure: 1 atm
- ② High-slump concrete
- ③ Form, adjustable in height to comply with varying casting heights, see ⑤. The stiffness and capacity of the form is designed to meet specified requirements on straightness of wall/ceiling at maximum pumping pressure, see ①
- ④ Scaffolding - supporting the form, the scaffolding is accordingly designed to be adjustable in height, and to meet specified stiffness and capacity criteria at maximum pumping pressure. Furthermore, both form and scaffolding is designed to be easily relieved, moved, adjusted and re-established in another location
- ⑤ Casting height varying from approximately 4,5 meters to 5,5 meters
- ⑥ Ventilation tubes to avoid air being enclosed in voids during casting
