Artikel: Repair of the Linfjord tunnel, Denmark
Autor: Vejlby Thomsen, J. / Hedeland, Poul
DOI: <https://doi.org/10.5169/seals-59067>

Repair of the Limfjord Tunnel, Denmark

J. Vejlby Thomsen
B.Sc., Civ. Eng.
Road Directorate,
Copenhagen,
Denmark

Poul Hededal
Head of Department
RAMBØLL
Aalborg, Denmark

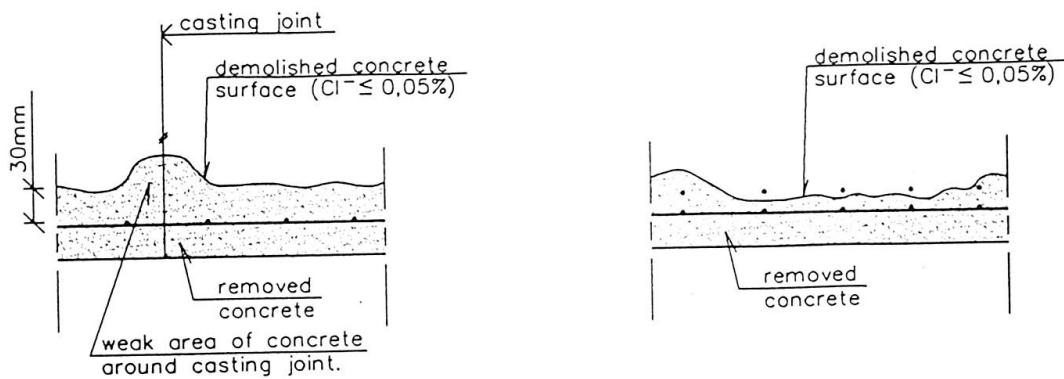
Generally concrete is removed until the amount of chlorides in the concrete is less than 0.05% by weight of concrete, however, never deeper than 30 mm behind the deepest layer of reinforcement unless weak areas of concrete facilitate deeper demolition.

Two typical demolition profile is schematically shown below.

Due to the large extend of concrete needing to be removed and the amount of reinforcement being exposed in this process, static considerations have necessitated guidelines on how the demolition work must be carried out, imposing the contractor to split up larger continuous demolition areas - especially on ceilings - into smaller sections, and replacing concrete in one section before removing damaged concrete from adjacent sections.
