**Artikel:** Rehabilitation of two existing tunnels in West Malaysia: a case study  
**Autor:** Singh, Parnam  
**DOI:** <https://doi.org/10.5169/seals-59073>

## Rehabilitation of Two Existing Tunnels In West Malaysia: A Case Study

Parnam Singh  
Manager  
L&M Structures Sdn  
Bhd, West Malaysia

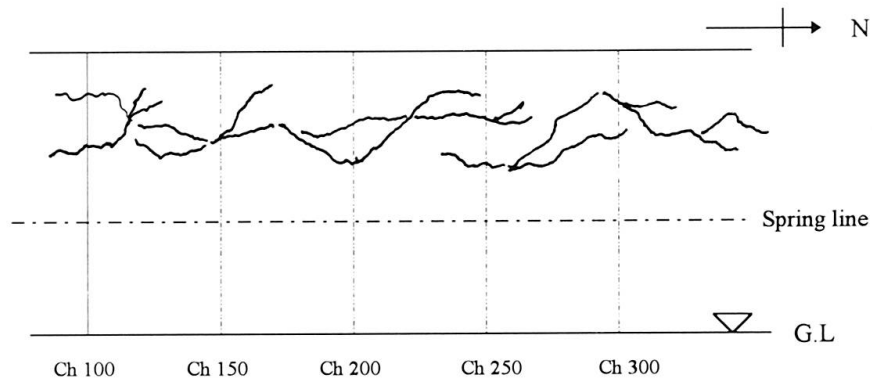
The appearance of cracks in the tunnel lining of both the tunnels was generally of concern to most motorists using the tunnels. However, from the detailed investigation carried out during the assessment programme it was noted that the pattern of cracks was typical of map cracks as shown in Fig. 3. The dry crack pattern was typical for both tunnels and core samples obtained from cracked concrete generally gave details of depth of cracks. Fig. 4 shows typical crack depths as seen in six 50mm core samples obtained from the tunnel linings. A detailed crack mapping exercise was carried out to locate the extent and severity of the cracks according to established chainages along the total length of the tunnels. The cracks were further divided into two main types; dry and wet cracks. Almost seventy percent of the 8500 metres length of cracks measured for both the tunnels fell under the dry crack category. Most of these cracks were contaminated with dirt particles. The remaining cracks were typically wet owing to their depth and location which was close to faults in rocks. The thickness of the tunnel lining varied between almost 850mm at the base

Fig.3 Typical map cracks observed in linings of north bound tunnel

of the tunnel to nearly 300mm at the crown. Most of these wet cracks were contaminated with lime salt deposits.

The dry cracks were first cleaned with a high pressure (1000 p.s.i) water jet using potable water. This was to ensure that the cracked surface was properly prepared prior to the crack repairs. A temporary seal was applied along the length of the cracks leaving masking seals along regular intervals. The temporary seal is an epoxy compound which serves as a barrier to prevent the flow of epoxy from the interior to the surface of the concrete during injection. As soon as the temporary seal was cured, the masking strips were removed exposing cracked concrete at regular intervals which served as entry ports for epoxy injection. The epoxy injection system used for sealing the dry cracks consisted of a low viscosity two component (resin & hardener) epoxy resin which is injected into the cracks using a high pressure, high speed, electromechanical handgun. The primary advantage of this electromechanical system is its ability to mix accurately the two components of the epoxy i.e resin and hardener in the desired ratio eliminating the possibility of inaccurate mix ratios. The epoxy resin is dispensed into the crack via a rubber nipple mounted onto the nozzle of the hand gun. The rubber nipple is pressed against the entry port to allow the entry of the epoxy into the crack. As soon as the epoxy is seen emerging from the adjacent entry port, the flow of the epoxy is temporarily halted by rubbing dry candle wax into the oozing port. Epoxy injection is continued until it appears in the successive entry port. The above steps are repeated until all the entry ports are injected with the epoxy.

The procedure for repairs to wet cracks differs a little from the dry cracks. For wet cracks, 8mm diameter holes are drilled along regular intervals of the crack length to serve as entry ports. Six mm diameter copper tubes approximately 75mm long are inserted into the holes. A temporary epoxy seal is applied to the surface of the cracks to seal off the crack surface between entry ports. The procedure for injection is repeated from the lower most entry port until all successive entry ports are completely injected using the hand gun. The sealing of the cracks using epoxy ensures that the cracks are structurally bonded and free from leaks.

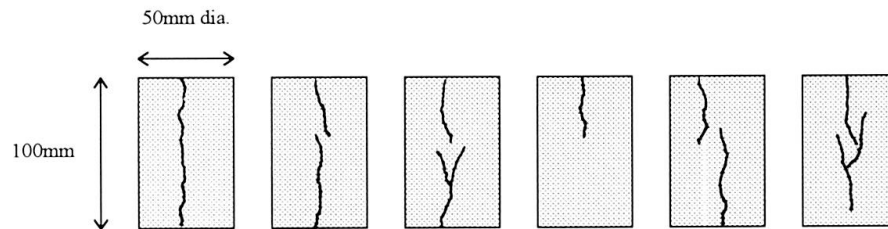
Based on the findings of the preliminary investigation a series of test were conducted to determine in-situ condition of concrete in the tunnel linings. As a means to determine surface hardness, Rebound Hammer test was carried out at selected locations after installing a mobile working platform. One lane of the dual carriageway was closed to traffic during the testing works. In order to determine the extent of cracks in the concrete a number of 50mm diameter core samples were extracted at cracked locations of the concrete. In most core samples the depth of cracks were observed to be in excess of 300mm. In some core samples the cracks were observed to have a series of smaller width cracks branching from the main crackline. Most of the cracks examined under a magnifying glass showed signs of contamination by dirt. An attempt was made to determine the depth of cracks using the indirect method for Ultrasonic Pulse Velocity test in areas where core sampling could not be conducted. This test served as a complementary test to compare sound concrete with cracked concrete by non-destructive methods. A hammer test was also conducted to check for weak spots in the concrete. This test was performed as a guide to differentiate between "ring" sound (often indicative of good concrete) and a "hollow" sound for loose or cracked concrete. Carbonation test was carried out on selected locations by spraying phenolphthalein indicator on freshly exposed concrete. At most test locations the depth of carbonation was noted to be close to 5mm.

Fig.4 Section through 50mm diameter core samples

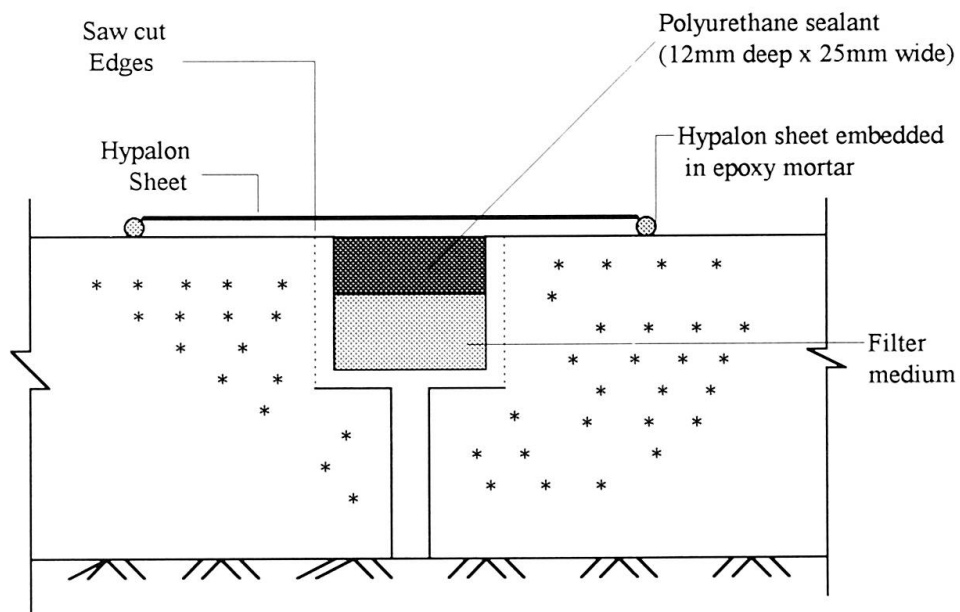
Fig.5 Section through expansion joint

The main defect observed in faulty expansion joints was loose and hardened sealant which had debonded from the existing groove. Some of the joints were affected by seepage of water from behind the tunnel lining. The defective sealant was completely removed to ensure the affected expansion joint was free from loose and debonded material. A chase measuring 25mm wide and 50mm deep was cut along the length of the faulty expansion joint using a diamond saw. The joint was cleaned with a high pressure water jet to prepare the surface for remedial treatment. A filter medium was then installed along the length of the expansion joint to convey trapped water into an adjoining uPVC pipe which was connected to the existing drain. The surface of the expansion joint was then sealed with a 12mm thick polyurethane sealant to prevent seepage of water from the filter membrane. As a protection to the exposed sealant, a hypalon sheet was installed along the length of the joint as shown in Fig. 5.

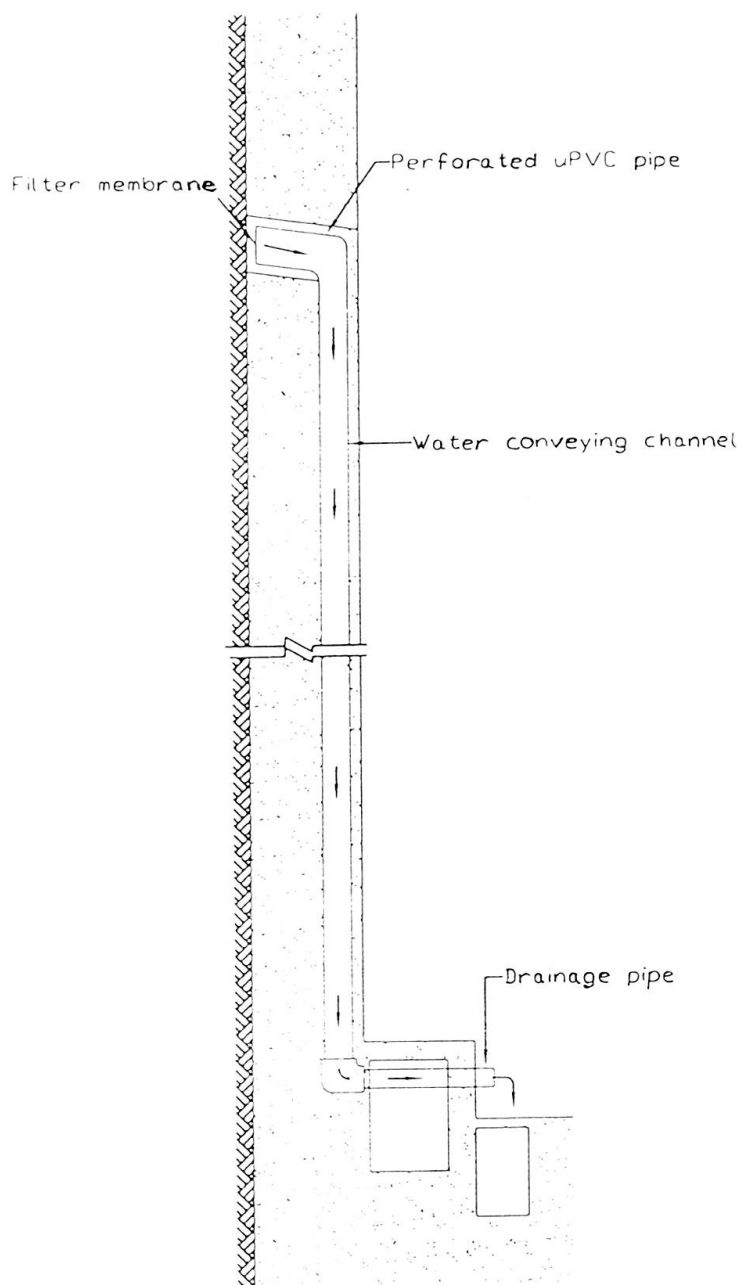
Fig. 6 Section through expansion joint showing drainage system

In expansion joints where excessive seepage of water occurred, additional water relief holes were drilled into the existing concrete lining. A 30mm diameter uPVC perforated pipe was inserted into the concrete lining after cutting a chase. The perforated section of the uPVC pipe was covered with a geotextile to prevent entry of contaminants into the perforations. Water collected in the uPVC pipe was then directed into the existing drains which were located on either sides of the tunnel. The side drains were thoroughly cleaned to ensure these were free from blockages. Fig. 6. shows a typical section of the modified drainage and water relief system.
