**Artikel:** Rehabilitation of two existing tunnels in West Malaysia: a case study  
**Autor:** Singh, Parnam  
**DOI:** <https://doi.org/10.5169/seals-59073>

## Rehabilitation of Two Existing Tunnels In West Malaysia: A Case Study

The Meru and Menora tunnels situated along West Malaysia's North-South Expressway were recently rehabilitated after more than 10 years in service. As part of the rehabilitation scheme an investigation programme was carried out to determine the nature and extent of defects in the ten year old concrete lined tunnels. Two main types of deterioration were investigated namely cracking and faulty expansion joints. The most widespread type of defects observed in the lining of the two tunnels was cracking. After having carried out the investigation programme a rehabilitation scheme was implemented to reinstate the existing defects. This paper highlights findings of the investigation programme including details of the overall rehabilitation scheme. It also makes recommendations for future maintenance and suggests long term monitoring of functionality and durability of the tunnel structure based on local Malaysian practice.

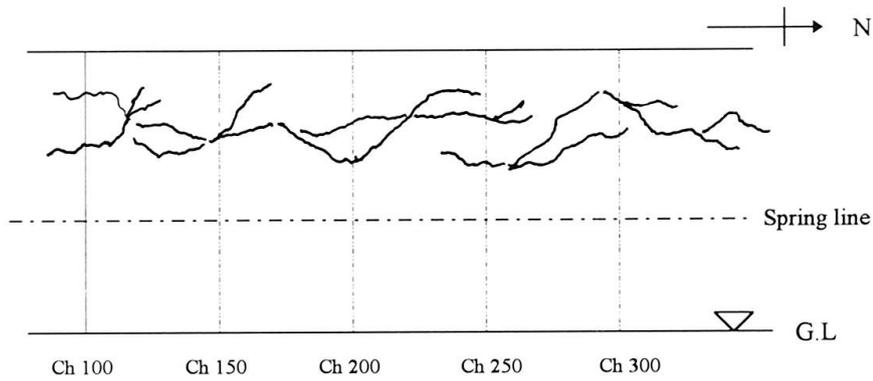
The appearance of cracks in the tunnel lining of both the tunnels was generally of concern to most motorists using the tunnels. However, from the detailed investigation carried out during the assessment programme it was noted that the pattern of cracks was typical of map cracks as shown in Fig. 3. The dry crack pattern was typical for both tunnels and core samples obtained from cracked concrete generally gave details of depth of cracks. Fig. 4 shows typical crack depths as seen in six 50mm core samples obtained from the tunnel linings. A detailed crack mapping exercise was carried out to locate the extent and severity of the cracks according to established chainages along the total length of the tunnels. The cracks were further divided into two main types; dry and wet cracks. Almost seventy percent of the 8500 metres length of cracks measured for both the tunnels fell under the dry crack category. Most of these cracks were contaminated with dirt particles. The remaining cracks were typically wet owing to their depth and location which was close to faults in rocks. The thickness of the tunnel lining varied between almost 850mm at the base

Fig.3 Typical map cracks observed in linings of north bound tunnel

of the tunnel to nearly 300mm at the crown. Most of these wet cracks were contaminated with lime salt deposits.

The dry cracks were first cleaned with a high pressure (1000 p.s.i) water jet using potable water. This was to ensure that the cracked surface was properly prepared prior to the crack repairs. A temporary seal was applied along the length of the cracks leaving masking seals along regular intervals. The temporary seal is an epoxy compound which serves as a barrier to prevent the flow of epoxy from the interior to the surface of the concrete during injection. As soon as the temporary seal was cured, the masking strips were removed exposing cracked concrete at regular intervals which served as entry ports for epoxy injection. The epoxy injection system used for sealing the dry cracks consisted of a low viscosity two component (resin & hardener) epoxy resin which is injected into the cracks using a high pressure, high speed, electromechanical handgun. The primary advantage of this electromechanical system is its ability to mix accurately the two components of the epoxy i.e resin and hardener in the desired ratio eliminating the possibility of inaccurate mix ratios. The epoxy resin is dispensed into the crack via a rubber nipple mounted onto the nozzle of the hand gun. The rubber nipple is pressed against the entry port to allow the entry of the epoxy into the crack. As soon as the epoxy is seen emerging from the adjacent entry port, the flow of the epoxy is temporarily halted by rubbing dry candle wax into the oozing port. Epoxy injection is continued until it appears in the successive entry port. The above steps are repeated until all the entry ports are injected with the epoxy.

The procedure for repairs to wet cracks differs a little from the dry cracks. For wet cracks, 8mm diameter holes are drilled along regular intervals of the crack length to serve as entry ports. Six mm diameter copper tubes approximately 75mm long are inserted into the holes. A temporary epoxy seal is applied to the surface of the cracks to seal off the crack surface between entry ports. The procedure for injection is repeated from the lower most entry port until all successive entry ports are completely injected using the hand gun. The sealing of the cracks using epoxy ensures that the cracks are structurally bonded and free from leaks.

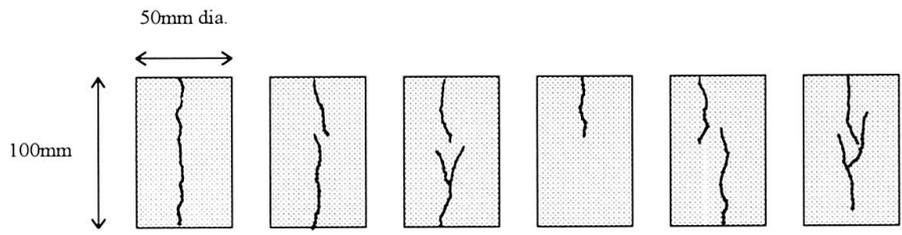
Fig.4 Section through 50mm diameter core samples

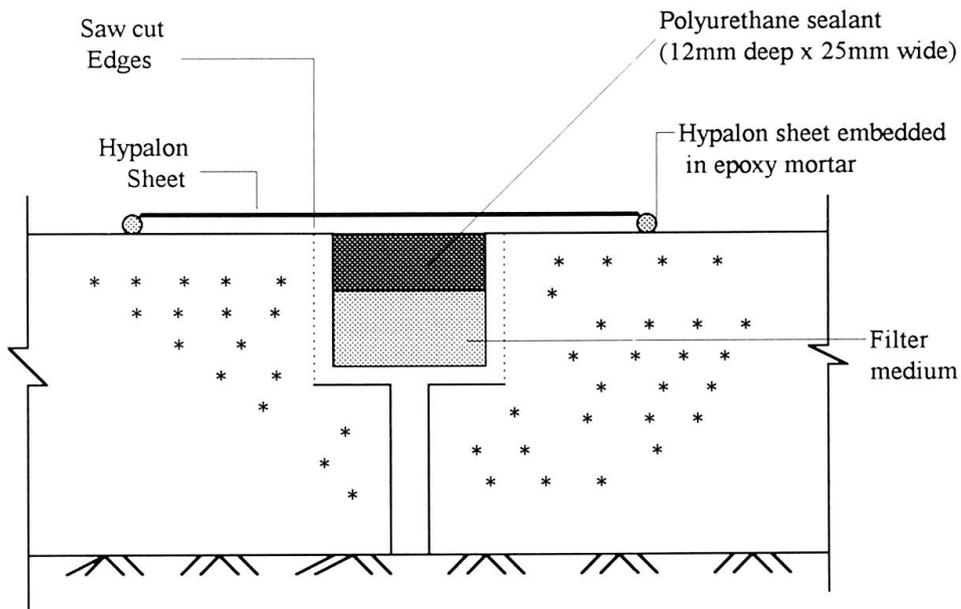
Fig.5 Section through expansion joint

A detailed inspection was also carried out to determine the extent of damage in the existing expansion joints. It was noted that most of the sealant in the expansion joint was loose and damaged. A separate inspection was carried out to check on the efficiency of the existing fire hydrant system. The inspection confirmed that a section of the existing fire hydrant system in the north bound tunnel was faulty. Further inspections were carried out on the existing drainage system along side the kerbs. This was to ensure that water collected behind the concrete lining could be effectively conveyed into the drainage system via the existing weep holes.

The main defect observed in faulty expansion joints was loose and hardened sealant which had debonded from the existing groove. Some of the joints were affected by seepage of water from behind the tunnel lining. The defective sealant was completely removed to ensure the affected expansion joint was free from loose and debonded material. A chase measuring 25mm wide and 50mm deep was cut along the length of the faulty expansion joint using a diamond saw. The joint was cleaned with a high pressure water jet to prepare the surface for remedial treatment. A filter medium was then installed along the length of the expansion joint to convey trapped water into an adjoining uPVC pipe which was connected to the existing drain. The surface of the expansion joint was then sealed with a 12mm thick polyurethane sealant to prevent seepage of water from the filter membrane. As a protection to the exposed sealant, a hypalon sheet was installed along the length of the joint as shown in Fig. 5.
