Artikel: Rehabilitation of two existing tunnels in West Malaysia: a case study

Rehabilitation of Two Existing Tunnels In West Malaysia: A Case Study

Parnam Singh Manager L&M Structures Sdn Bhd, West Malaysia

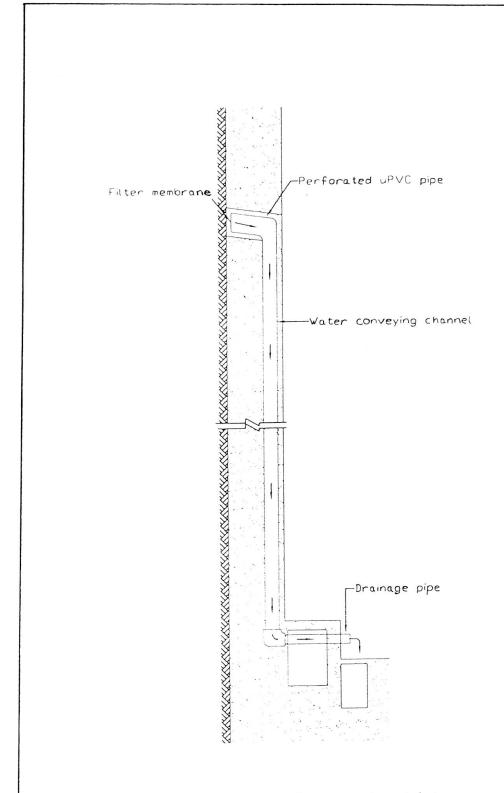
Fig. 6 Section through expansion joint showing drainage system

In expansion joints where excessive seepage of water occurred, additional water relief holes were drilled into the existing concrete lining. A 30mm diameter uPVC perforated pipe was inserted into the concrete lining after cutting a chase. The perforated section of the uPVC pipe was covered with a geotextile to prevent entry of contaminants into the perforations. Water collected in the uPVC pipe was then directed into the existing drains which were located on either sides of the tunnel. The side drains were thoroughly cleaned to ensure these were free form blockages. Fig. 6. shows a typical section of the modified drainage and water relief system.
