Rehabilitation of Two Existing Tunnels In West Malaysia: A Case Study

Parnam Singh
Manager
L&M Structures Sdn
Bhd, West Malaysia

The Meru and Menora tunnels situated along West Malaysia's North-South Expressway were recently rehabilitated after more than 10 years in service. As part of the rehabilitation scheme an investigation programme was carried out to determine the nature and extent of defects in the ten year old concrete lined tunnels. Two main types of deterioration were investigated namely cracking and faulty expansion joints. The most widespread type of defects observed in the lining of the two tunnels was cracking. After having carried out the investigation programme a rehabilitation scheme was implemented to reinstate the existing defects. This paper highlights findings of the investigation programme including details of the overall rehabilitation scheme. It also makes recommendations for future maintenance and suggests long term monitoring of functionality and durability of the tunnel structure based on local Malaysian practice.

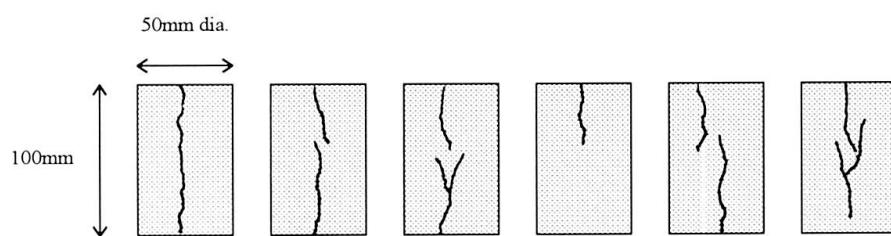
Fig.4 Section through 50mm diameter core samples

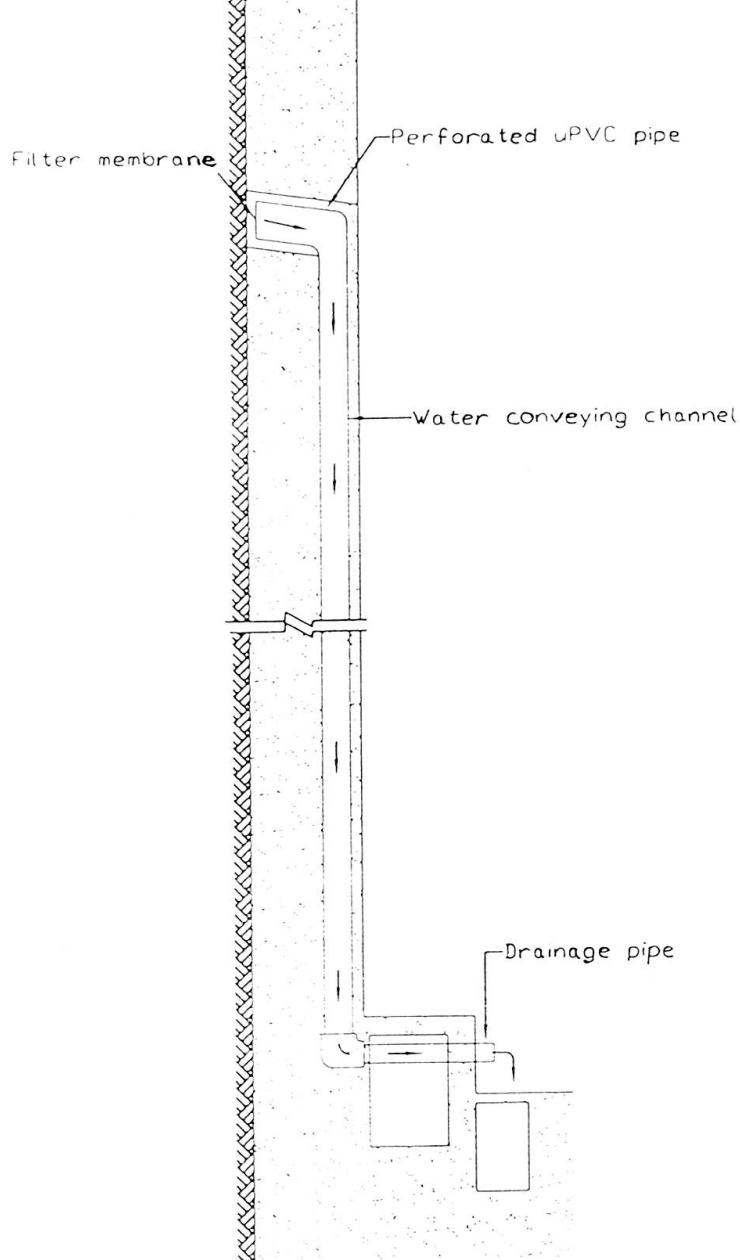
Fig. 6 Section through expansion joint showing drainage system

In expansion joints where excessive seepage of water occurred, additional water relief holes were drilled into the existing concrete lining. A 30mm diameter uPVC perforated pipe was inserted into the concrete lining after cutting a chase. The perforated section of the uPVC pipe was covered with a geotextile to prevent entry of contaminants into the perforations. Water collected in the uPVC pipe was then directed into the existing drains which were located on either sides of the tunnel. The side drains were thoroughly cleaned to ensure these were free from blockages. Fig. 6. shows a typical section of the modified drainage and water relief system.
