**Zeitschrift:** IABSE reports = Rapports AIPC = IVBH Berichte  
**Band:** 78 (1998)

**Artikel:** Rehabilitation work for the upheaval disaster at underground station caused by the groundwater rising  
**Autor:** Nozawa, Shinichiro / Kaneko, Shizuo / Matsuda, Takaji  
**DOI:** <https://doi.org/10.5169/seals-59074>

## Rehabilitation Work for the Upheaval Disaster at Underground Station Caused by the Groundwater Rising

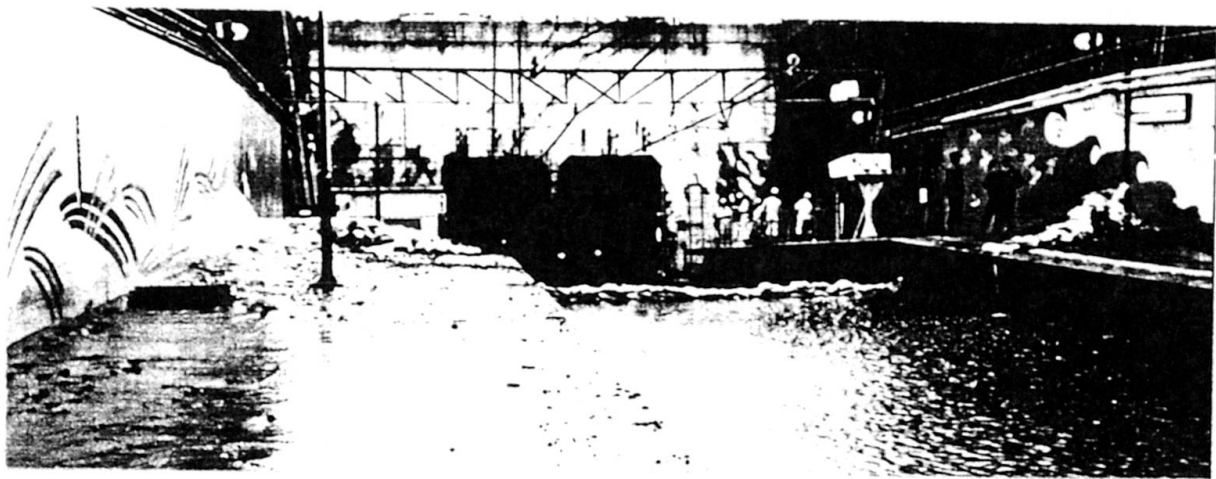
walls) with tunnels on either side. Rainfall had been almost continuous up to this point since 6th October, and the precipitation during this period was 227mm. Prior to this, a cumulative rainfall of 724mm had been observed between 1st August and 30th September, which was more than twice the average rainfall for these two months in the Musashino area. As a result of this rain, the groundwater level showed a sharp rise (to approx. 2.5m below the ground level), and the uplift (buoyancy) due to the groundwater caused upheaval (max. 1.34m) of the U-shaped retaining walls over a distance of 100m. The upheaval, in turn, resulted in a maximum opening of 70cm at the tops of the expansion joints in the retaining walls.

Large quantities of groundwater and earth flowed into the station through these openings, inundating the railway tracks. A major disruption of the passenger and freight traffic resulted during the subsequent two months until the restoration work was completed (Figure 1, Photos 1 and 2).

Photo 1 Conditions of Damage

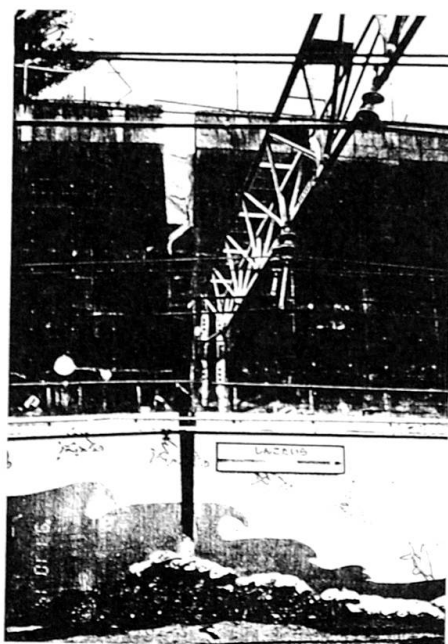
Photo 2 Conditions of Damage

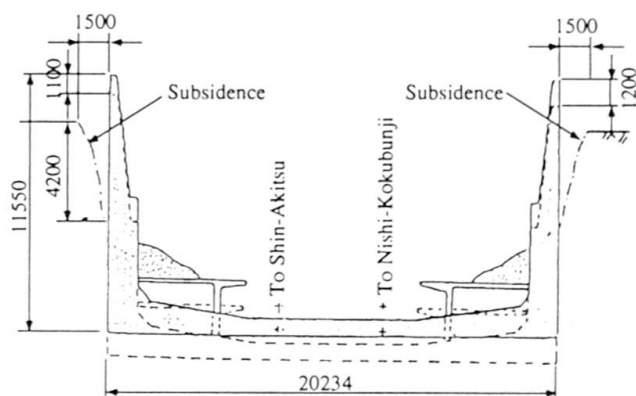
Fig. 1 Conditions of Damage

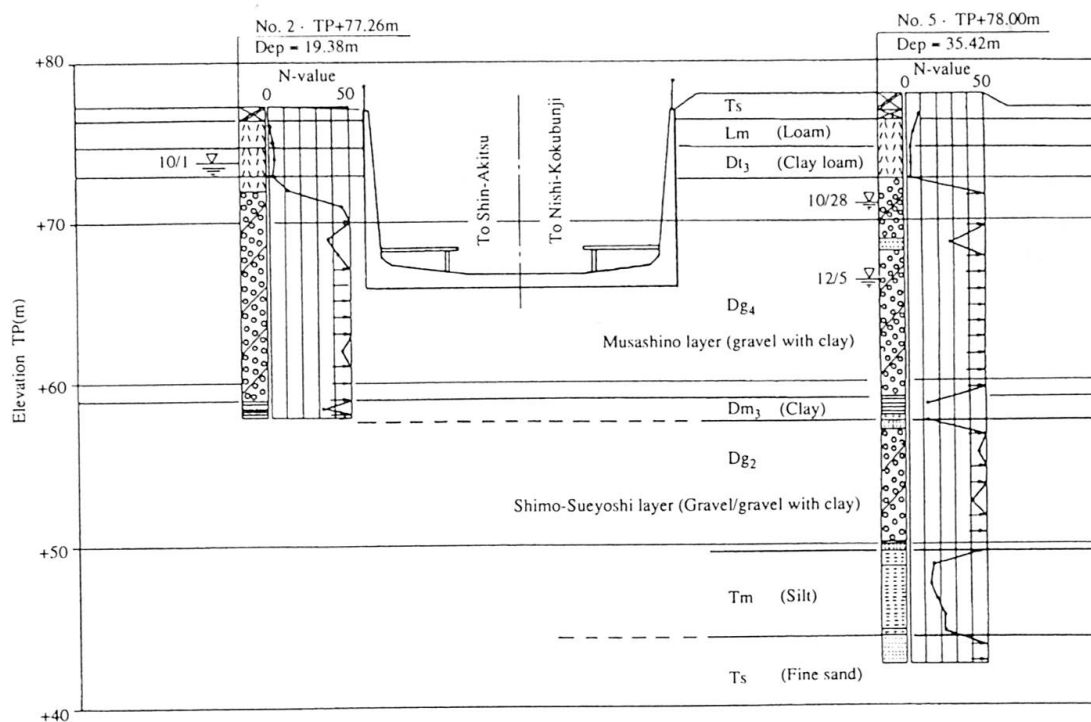
Fig. 2 Geological Profile

The Musashino Plateau, the diluvial plateau on which Shin-Kodaira station is located, is known as the largest plateau in Japan. Around Shin-Kodaira station, the Musashino gravel layer has a depth of 20m, below which are found alternating layers of clay containing shells and of sandy gravel. The Musashino gravel layer is covered with around 5m of Kanto loam soil. Groundwater is found under rather different conditions in the Musashino gravel layer and the sand layers further down. The Musashino gravel layer has a high void ratio and permeability and contains large quantities of groundwater. The groundwater in this area flows south-westwards towards the edge of the Musashino Plateau, crossing below the station (Figure 2).

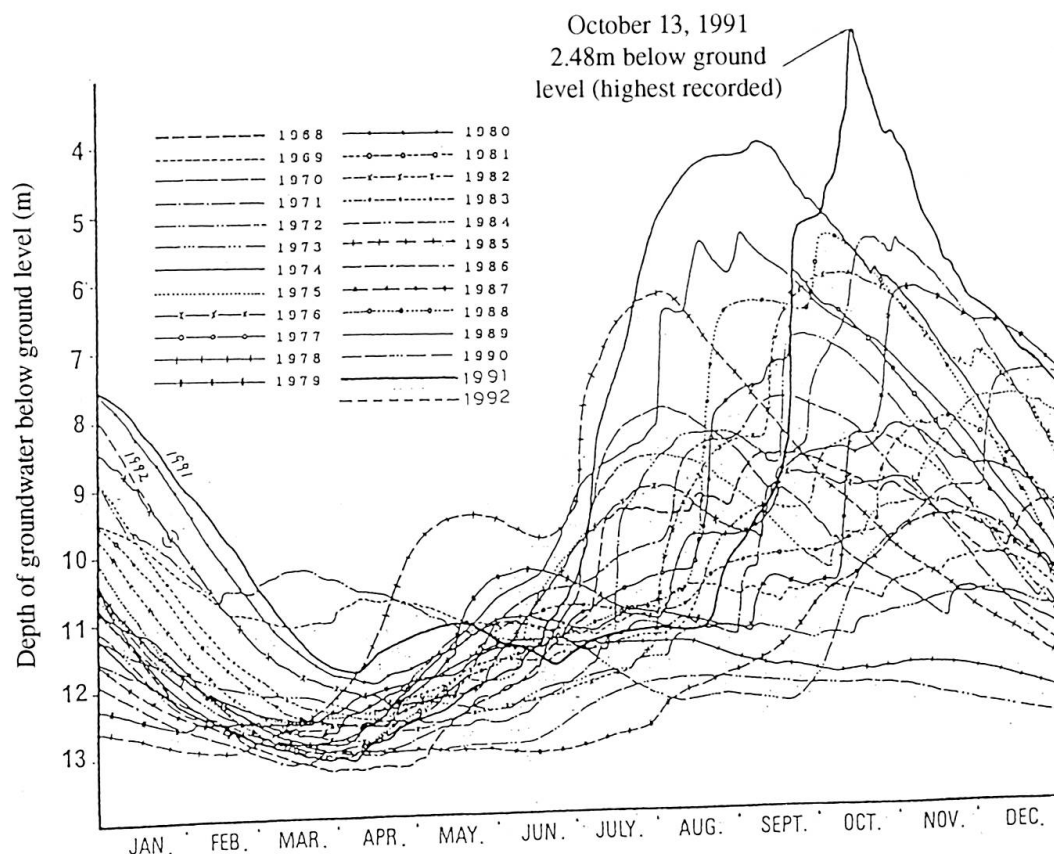
Fig. 3 Changes in Water Level Over Time in a Well at Kodaira-Nakamachi (produced by Hosono committee member)

Figure 3 illustrates data on groundwater levels gathered by Hosono of the General Center for Fire Prevention Science in Kodaira-Nakamachi, located approximately 1.1km east of Shin-Kodaira station. These observations continued for 24 years between 1968 and 1991. They show an annual cycle with the annual low water level around April rising through summer and autumn to reach the maximum. The highest groundwater level in the 23 years up to the preceding year was approximately 4m below ground level in 1974, but on 13th October 1991 the groundwater level exceeded this record by a further 1.5m, reaching 2.48m below ground level.

The balance point between the self-weight of the structure of Shin-Kodaira station and buoyancy due to groundwater (neglecting the effects of friction with the soil) is reached when the groundwater level rises to approximately 5m below ground level. Thus it can be inferred that the continuing rain from mid-August to early October raised the groundwater to a level unprecedented in the life of the station and caused buoyant upheaval of the U-shaped retaining walls.

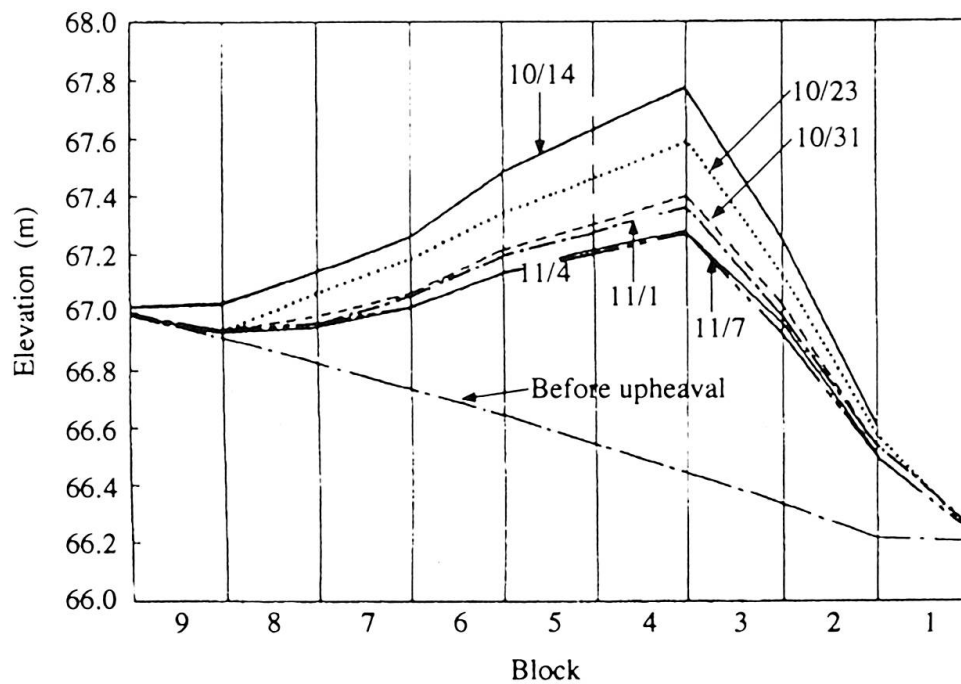
Fig. 4 Elevation of Lower Slabs (Slab Crests) : Measurement Results

Reduction of the buoyancy through lowering of the water level was chosen as the method for lowering the structural frame, as this was judged to be the quickest and most efficient method. Deep wells were arranged to lower the water level, seven inside the U-shaped retaining walls ( $\ell=7\text{m}$ ,  $\varnothing=650\text{mm}$ , lifting pipes: 100A, high lift underwater pumps: 15kw) and nineteen surrounding the outside of the retaining walls ( $\ell=20\text{m}$ ,  $\varnothing=700\text{mm}$ , lifting pipes: 100A, high lift underwater pumps: 15kw). Pumping began gradually on 22nd October and continued until 30th November, after the completion of the new slabs. There had been no past cases, however, where complete lowering of the structural frame was achieved after an upheaval as large as 1.3m and there were concerns as to whether adequate lowering of the water level could be achieved through use of deep wells. (Figure 4).
