Artikel: Rehabilitation work for the upheaval disaster at underground station caused by the groundwater rising
Autor: Nozawa, Shinichiro / Kaneko, Shizuo / Matsuda, Takaji
DOI: <https://doi.org/10.5169/seals-59074>

Rehabilitation Work for the Upheaval Disaster at Underground Station Caused by the Groundwater Rising

An abnormal rise in the groundwater level due to a spell of heavy rain resulted in ground upheaval of up to 1.34m over a 100m section at an underground station operated by the East Japan Railway Co. in the early morning of 12th October, 1991. The underground station is located in a cutting protected by U-shaped retaining walls, which are approximately 12m high and weigh approximately 120tf/m.

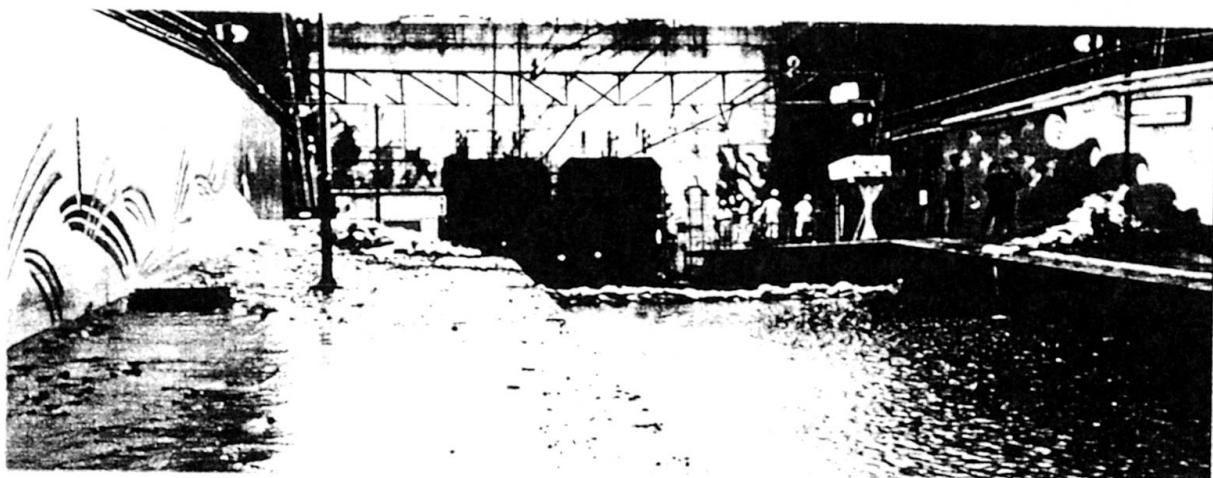
Photo 1 Conditions of Damage

walls) with tunnels on either side. Rainfall had been almost continuous up to this point since 6th October, and the precipitation during this period was 227mm. Prior to this, a cumulative rainfall of 724mm had been observed between 1st August and 30th September, which was more than twice the average rainfall for these two months in the Musashino area. As a result of this rain, the groundwater level showed a sharp rise (to approx. 2.5m below the ground level), and the uplift (buoyancy) due to the groundwater caused upheaval (max. 1.34m) of the U-shaped retaining walls over a distance of 100m. The upheaval, in turn, resulted in a maximum opening of 70cm at the tops of the expansion joints in the retaining walls.

Large quantities of groundwater and earth flowed into the station through these openings, inundating the railway tracks. A major disruption of the passenger and freight traffic resulted during the subsequent two months until the restoration work was completed (Figure 1, Photos 1 and 2).

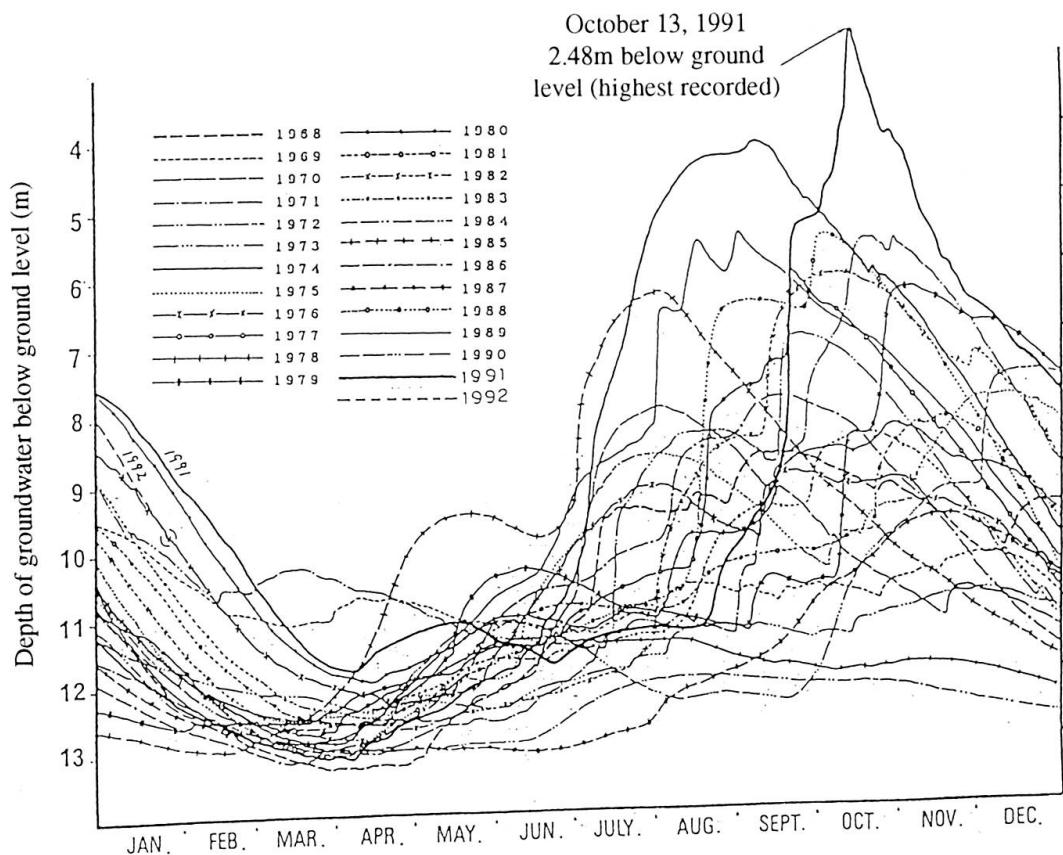
Fig. 3 Changes in Water Level Over Time in a Well at Kodaira-Nakamachi (produced by Hosono committee member)

Figure 3 illustrates data on groundwater levels gathered by Hosono of the General Center for Fire Prevention Science in Kodaira-Nakamachi, located approximately 1.1km east of Shin-Kodaira station. These observations continued for 24 years between 1968 and 1991. They show an annual cycle with the annual low water level around April rising through summer and autumn to reach the maximum. The highest groundwater level in the 23 years up to the preceding year was approximately 4m below ground level in 1974, but on 13th October 1991 the groundwater level exceeded this record by a further 1.5m, reaching 2.48m below ground level.

Investigation of the relation between the groundwater level and rainfall over these 23 years confirmed that the amount of rainfall over the preceding several months combined with the rainfall over the immediately preceding days produced a rapid rise in groundwater level. A relationship between cumulative rainfall over the preceding 60 and 90 days and the rise in groundwater level was also confirmed. Using 116 years of the precipitation data from the Central Weather Agency in Otemachi, Tokyo (27km away) the period of recurrence of the cumulative rainfall seen in the 60 days and 90 days surrounding the disaster was studied. In either case the recurrence period was 100 years (Tables 1 and 2). Calculations based on actual water level data put the recurrence period at 66 years.

The balance point between the self-weight of the structure of Shin-Kodaira station and buoyancy due to groundwater (neglecting the effects of friction with the soil) is reached when the groundwater level rises to approximately 5m below ground level. Thus it can be inferred that the continuing rain from mid-August to early October raised the groundwater to a level unprecedented in the life of the station and caused buoyant upheaval of the U-shaped retaining walls.

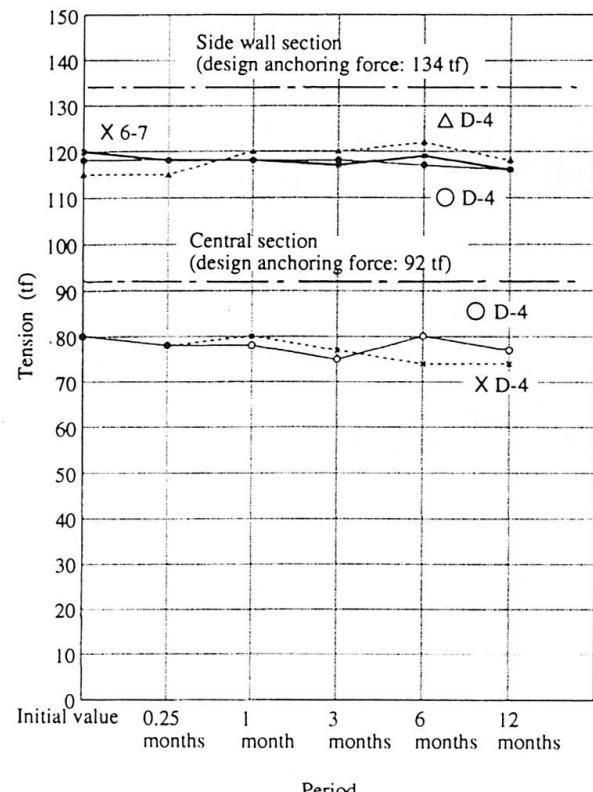
Fig. 14 Vertical Anchor Load: Measurement Results

Forces larger than the design anchoring force were applied as the tension in the vertical anchors to make allowances for such factors as creep. The tension applied initially varies according to positions of the anchors. It was 144tf per anchor in the ordinary side wall section and 106tf per anchor in the central section.

The initial values given above are those at the time of the completion of the restoration work. A slight lowering can be observed in the tension both in the side wall section and the central section after the passage of one year.

The design anchoring force was set at a value that would provide sufficient resistance when the groundwater level reached the ground surface level. The groundwater level being lower, the tension is smaller than the design anchoring data at present.
