Artikel: Rehabilitation work for the upheaval disaster at underground station

caused by the groundwater rising

Autor: Nozawa, Shinichiro / Kaneko, Shizuo / Matsuda, Takaji

Rehabilitation Work for the Upheaval Disaster at Underground Station Caused by the Groundwater Rising

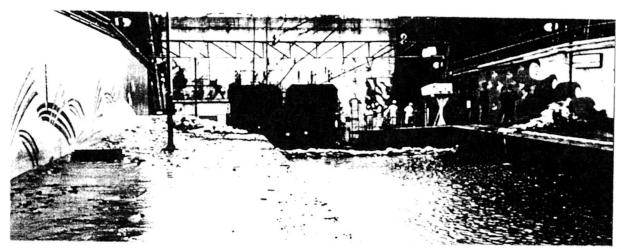
walls) with tunnels on either side. Rainfall had been almost continuous up to this point since 6th October, and the precipitation during this period was 227mm. Prior to this, a cumulative rainfall of 724mm had been observed between 1st August and 30th September, which was more than twice the average rainfall for these two months in the Musashino area. As a result of this rain, the groundwater level showed a sharp rise (to approx. 2.5m below the ground level), and the uplift (buoyancy) due to the groundwater caused upheaval (max. 1.34m) of the U-shaped retaining walls over a distance of 100m. The upheaval, in turn, resulted in a maximum opening of 70cm at the tops of the expansion joints in the retaining walls.

Large quantities of groundwater and earth flowed into the station through these openings, inundating the railway tracks. A major disruption of the passenger and freight traffic resulted during the subsequent two months until the restoration work was completed (Figure 1, Photos 1 and 2).

Photo 1 Conditions of Damage

Photo 2 Conditions of Damage

Fig. 1 Conditions of Damage

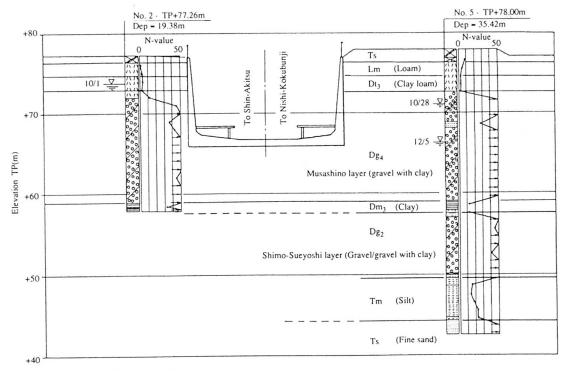
Fig. 2 Geological Profile

The Musashino Plateau, the diluvial plateau on which Shin-Kodaira station is located, is known as the largest plateau in Japan. Around Shin-Kodaira station, the Musashino gravel layer has a depth of 20m, below which are found alternating layers of clay containing shells and of sandy gravel. The Musashino gravel layer is covered with around 5m of Kanto loam soil. Groundwater is found under rather different conditions in the Musashino gravel layer and the sand layers further down. The Musashino gravel layer has a high void ratio and permeability and contains large quantities of groundwater. The groundwater in this area flows south-westwards towards the edge of the Musashino Plateau, crossing below the station (Figure 2).

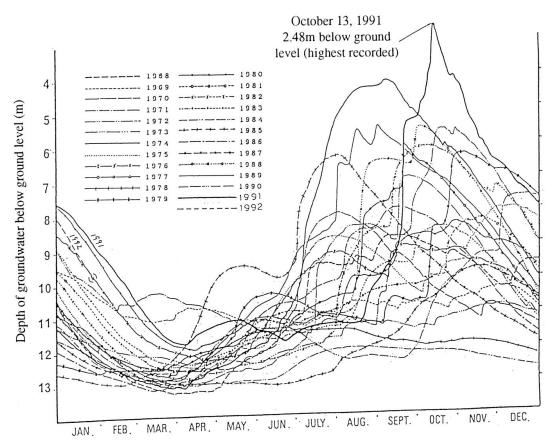
Fig. 3 Changes in Water Level Over Time in a Well at Kodaira-Nakamachi (produced by Hosono committee member)

Figure 3 illustrates data on groundwater levels gathered by Hosono of the General Center for Fire Prevention Science in Kodaira-Nakamachi, located approximately 1.1km east of Shin-Kodaira station. These observations continued for 24 years between 1968 and 1991. They show an annual cycle with the annual low water level around April rising through summer and autumn to reach the maximum. The highest groundwater level in the 23 years up to the preceding year was approximately 4m below ground level in 1974, but on 13th October 1991 the groundwater level exceeded this record by a further 1.5m, reaching 2.48m below ground level.

The balance point between the self-weight of the structure of Shin-Kodaira station and buoyancy due to groundwater (neglecting the effects of friction with the soil) is reached when the groundwater level rises to approximately 5m below ground level. Thus it can be inferred that the continuing rain from mid-August to early October raised the groundwater to a level unprecedented in the life of the station and caused buoyant upheaval of the U-shaped retaining walls.

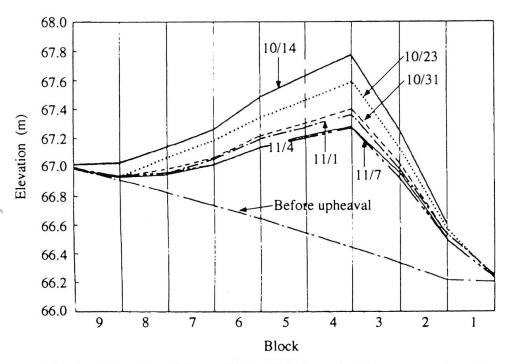
Fig. 4 Elevation of Lower Slabs (Slab Crests): Measurement Results

Reduction of the buoyancy through lowering of the water level was chosen as the method for lowering the structural frame, as this was judged to be the quickest and most efficient method. Deep wells were arranged to lower the water level, seven inside the U-shaped retaining walls (ℓ =7m, Ø=650mm, lifting pipes: 100A, high lift underwater pumps: 15kw) and nineteen surrounding the outside of the retaining walls (ℓ =20m, Ø=700mm, lifting pipes: 100A, high lift underwater pumps: 15kw). Pumping began gradually on 22nd October and continued until 30th November, after the completion of the new slabs. There had been no past cases, however, where complete lowering of the structural frame was achieved after an upheaval as large as 1.3m and there were concerns as to whether adequate lowering of the water level could be achieved through use of deep wells. (Figure 4).

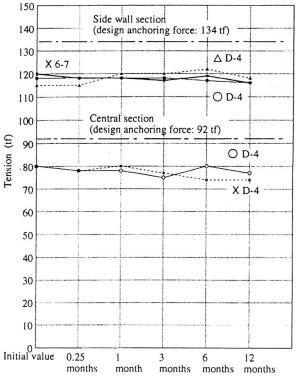
Fig. 14 Vertical Anchor Load: Measurement Results

Forces larger than the design anchoring force were applied as the tension in the vertical anchors to make allowances for such factors as creep. The tension applied initially varies according to positions of the anchors. It was 144tf per anchor in the ordinary side wall section and 106tf per anchor in the central section.

The initial values given above are those at the time of the completion of the restoration work. A slight lowering can be observed in the tension both in the side wall section and the central section after the passage of one year.

The design anchoring force was set at a value that would provide sufficient resistance when the groundwater level reached the ground surface level. The groundwater level being lower, the tension is smaller than the design anchoring data at present.
