**Artikel:** Ten years' maintenance of Seto Ohashi Bridges  
**Autor:** Yashuda, Masahiko / Okuda, Motoi / Matsumoto, Tsuyoshi  
**DOI:** <https://doi.org/10.5169/seals-59924>

## Ten Years' Maintenance of Seto Ohashi Bridges

### Summary

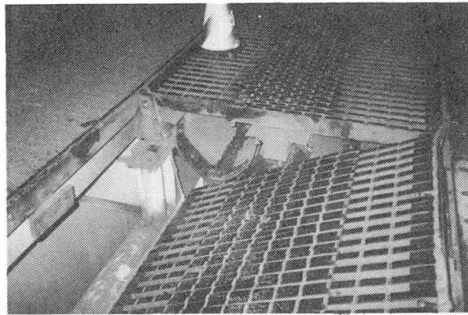
Fig. 1 Accident of Link Expansion Joint

On May 3<sup>rd</sup> 1994, there was an accident that one of the link expansion joints of the Iwaguro-jima Bridge inclined and one car was damaged. This accident was due to the fact that the nuts of bolts of the universal joint which connected the expansion joint and the bridge deck loosened and fell. Consequently one end of the joint fell and the whole joint inclined. To prevent same accidents, expansion joint stoppers are installed and cotter pins are applied on all bolts which connect expansion joints and bridge decks. This improvement was finished in March 1995.

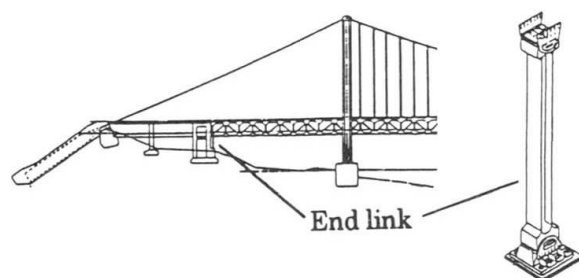
The ends of stiffening truss girders of the three suspension bridges of the Seto Ohashi Bridge are supported upward by end links vertically from beneath the girder. The maximum reaction force of the end link of the Shimotsui-Seto Bridge is 2558 ton, which is about twice larger than other two suspension bridges because this bridge has extended side spans which are not suspended from the main cables. From June 1993, these end links began to make large noises when heavier freight trains passed through the bridge. In January to February 1994, the noise source was closely investigated using the acoustic emission method. It was found that the noise source was the center of the semispherical boss of the lower pivot structure of the end links. The pivot structure consists of a semispherical boss which is embedded on a concrete abutment and a concave semispherical cover which is placed at the end of the link beam and over the boss. It was inferred that the movement of a pivot was not large enough to diffuse solid lubricant embedded in the concave cover, consequently a stick slip phenomenon of metal surfaces occurred and noises were emitted. To prevent this stick slip phenomenon, a hole was bored on a concave cover to reach the center of a boss and liquid lubricant was pressured into the surfaces. This countermeasure worked well and the noise problem was solved. All of the end links of the Shimotsui-Seto Bridge was repaired by this method until 1997.

Fig. 2 End link of the Shimotsui-Seto Bridge

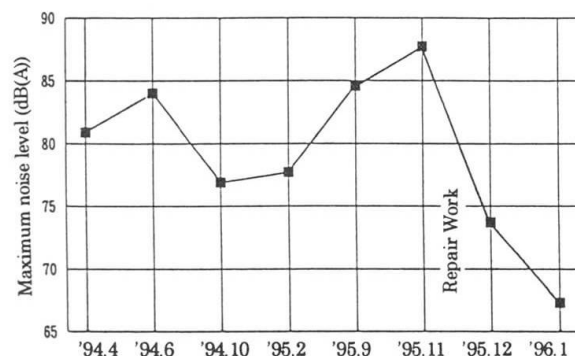
Fig. 3 Noise reduction of end link
