**Artikel:** Ten years' maintenance of Seto Ohashi Bridges

## Ten Years' Maintenance of Seto Ohashi Bridges

### **Summary**

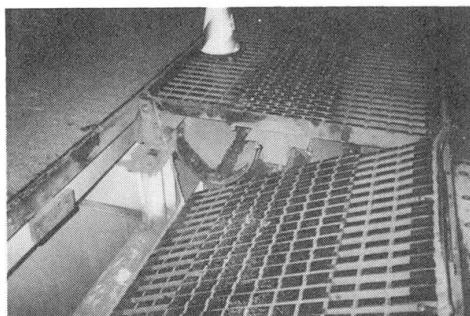
Fig.1 Accident of Link Expansion Joint

On May 3<sup>rd</sup> 1994, there was an accident that one of the link expansion joints of the Iwaguro-jima Bridge inclined and one car was damaged. This accident was due to the fact that the nuts of bolts of the universal joint which connected the expansion joint and the bridge deck loosened and fell. Consequently one end of the joint fell and the whole joint inclined. To prevent same accidents, expansion joint stoppers are installed and cotter pins are applied on all bolts which connect expansion joints and bridge decks. This improvement was finished in March 1995.

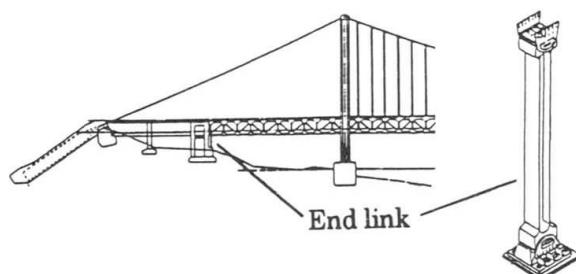
The ends of stiffening truss girders of the three suspension bridges of the Seto Ohashi Bridge are supported upward by end links vertically from beneath the girder. The maximum reaction force of the end link of the Shimotsui-Seto Bridge is 2558 ton, which is about twice larger than other two suspension bridges because this bridge has extended side spans which are not suspended from the main cables.

From June 1993, these end links began to make large noises when heavier freight trains passed through the bridge. In January to February 1994, the noise source was closely investigated using the acoustic emission method. It was found that the noise source was the center of the semispherical boss of the lower pivot structure of the end links. The pivot structure consists of a semispherical boss which is embedded on a concrete abutment and a concave semispherical cover which is placed at the end of the link beam and over the boss. It was inferred that the movement of a pivot was not large enough to diffuse solid lubricant embedded in the concave cover, consequently a stick slip phenomenon of metal surfaces occurred and noises were emitted. To prevent this stick slip phenomenon, a hole was bored on a concave cover to reach the center of a boss and liquid lubricant was pressured into the surfaces. This countermeasure worked well and the noise problem was solved. All of the end links of the Shimotsui-Seto Bridge was repaired by this method until 1997.

Fig.2 End link of the Shimotsui-Seto Bridge

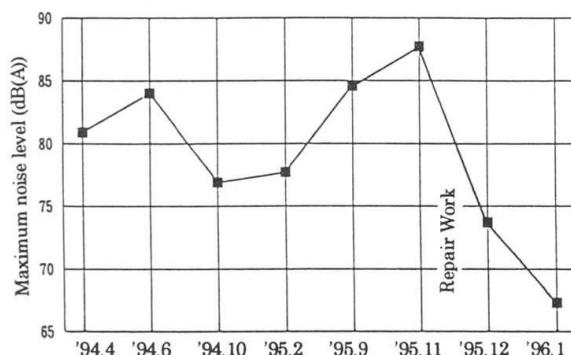
Fig.3 Noise reduction of end link
