Artikel: Ten years' maintenance of Seto Ohashi Bridges
Autor: Yashuda, Masahiko / Okuda, Motoi / Matsumoto, Tsuyoshi
DOI: <https://doi.org/10.5169/seals-59924>

Ten Years' Maintenance of Seto Ohashi Bridges

Summary

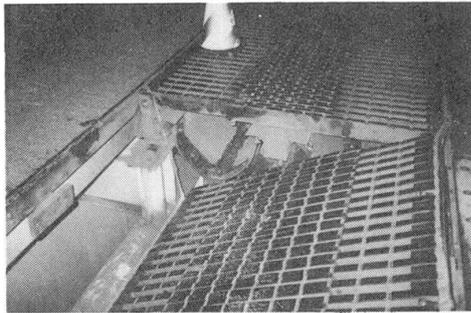
Fig.1 Accident of Link Expansion Joint

On May 3rd 1994, there was an accident that one of the link expansion joints of the Iwaguro-jima Bridge inclined and one car was damaged. This accident was due to the fact that the nuts of bolts of the universal joint which connected the expansion joint and the bridge deck loosened and fell. Consequently one end of the joint fell and the whole joint inclined. To prevent same accidents, expansion joint stoppers are installed and cotter pins are applied on all bolts which connect expansion joints and bridge decks. This improvement was finished in March 1995.

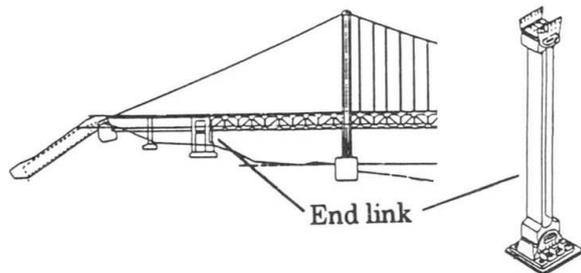
The ends of stiffening truss girders of the three suspension bridges of the Seto Ohashi Bridge are supported upward by end links vertically from beneath the girder. The maximum reaction force of the end link of the Shimotsui-Seto Bridge is 2558 ton, which is about twice larger than other two suspension bridges because this bridge has extended side spans which are not suspended from the main cables. From June 1993, these end links began to make large noises when heavier freight trains passed through the bridge. In January to February 1994, the noise source was closely investigated using the acoustic emission method. It was found that the noise source was the center of the semispherical boss of the lower pivot structure of the end links. The pivot structure consists of a semispherical boss which is embedded on a concrete abutment and a concave semispherical cover which is placed at the end of the link beam and over the boss. It was inferred that the movement of a pivot was not large enough to diffuse solid lubricant embedded in the concave cover, consequently a stick slip phenomenon of metal surfaces occurred and noises were emitted. To prevent this stick slip phenomenon, a hole was bored on a concave cover to reach the center of a boss and liquid lubricant was pressured into the surfaces. This countermeasure worked well and the noise problem was solved. All of the end links of the Shimotsui-Seto Bridge was repaired by this method until 1997.

Fig.2 End link of the Shimotsui-Seto Bridge

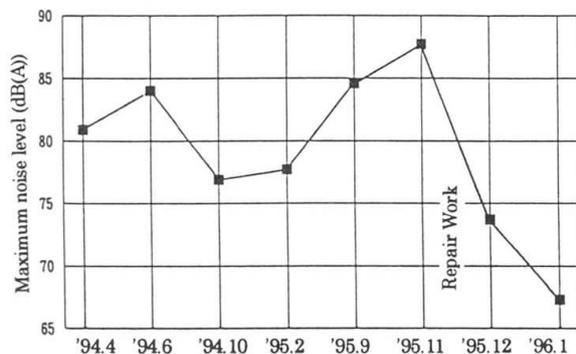
Fig.3 Noise reduction of end link
