New Zealand case studies of scour at bridge foundations

New Zealand Case Studies of Scour at Bridge Foundations

Three cases of bridge scour damage that have occurred within New Zealand are presented herein. In each case, the bridge and the site are described, the damage process is outlined, and any adopted remedial measures are discussed. The cases presented have been selected to highlight both the various vertical scour components occurring for bridge sites, and also a range of appropriate remedial measures for endangered bridge structures.

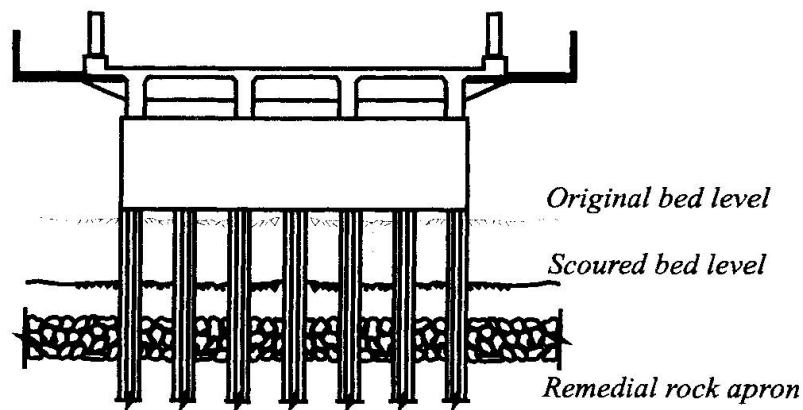
This road bridge over the Ashburton River is a 340 m long, two lane, reinforced concrete structure that was built in 1931. The bridge comprises 31 slab-type piers (Figure 1), about 25 of which lie within the active river channel. Each pier is founded on seven 400 mm reinforced concrete octagonal piles, these piles having been driven to a relatively uniform depth of between 6.5 m and 6.7 m below the underside of the pile caps. The original average bed level was measured at 0.2 m below the underside of the pile caps.

General scour exacerbated by gravel extraction from the river upstream and downstream of the bridge has resulted in a gradual lowering of the bed level at the bridge site (Figure 1). The average bed level lowered approximately 0.9 m from 1937 to 1994, each of the piers within the river channel having exposed piles. In 1978, the average bed level was measured at a level of 1.7 m below the underside of the pile cap. The bridge at this time was concluded to be extremely vulnerable to scour damage by pier undermining arising from the progressive degradation of the bed. Concern for the stability of the bridge was accentuated by the shallowness of the foundation piles and also debris rafts forming at the site increasing the potential for local scour pier undermining and bridge damage or failure in significant floods.

Rock aprons were constructed in 1979 around each of the piers within the active channel (Figure 1). Each apron measures 5 m wide, 15 m long and 1.6 m thick. Rock riprap of a median size d_{50} of 0.5 m was used to construct the aprons, with the upper surface of each apron located beneath the riverbed surface and

approximately 2 m below the base of the pile cap. Aprons act to reduce the scour potential at piers both by armouring the bed against local scour due to local hydraulic vortices, and also by protecting against general scour by dropping at the apron extremities as this scour develops. Aprons nevertheless cannot provide total assurance against scouring, particularly for ongoing general degradation. Inspection in 1994 indicated the rock apron to be exposed at one pier only. Bed levels in the river channel continue to be regularly monitored.

Figure 1 Typical Side Elevation of a Foundation and Remedial Works for the Ashburton River Road Bridge

The bridge has to date performed satisfactorily in the large floods over its life, even with the bed lower than its present level. Possible additional future scour damage mitigation options which have been identified include underpinning of the piers and the construction of a weir immediately downstream of the bridge, with the weir crest level no lower than the underside of the pier caps. The usual form of weir adopted is a rock riprap structure comprising a crest and downstream apron. Such weirs have been used very successfully in the West Coast and Canterbury areas of New Zealand to control degrading river channels. At the Ashburton River Road Bridge site, the weir would significantly affect fish migration, riverbed levels, and stopbank effectiveness upstream of the bridge, and also bed levels immediately downstream of the weir, which would degrade.

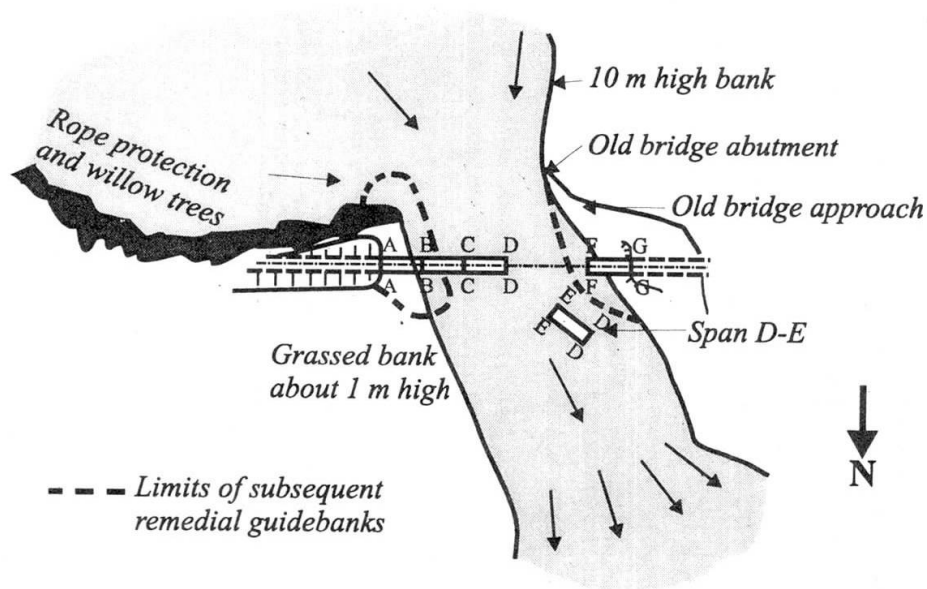
The bridge, which spans a channel forming a sudden contraction for flood flows, is located at the exit from a wide channel containing a braided river at low flows (Figure 4). A shift and shortening in the river course downstream of the bridge resulted in rapid bed degradation at the bridge site during construction of the bridge in 1967. This degradation and later flooding resulted in piles extending to only 6.8 m below the minimum bed level. The angle of flow attack on the slab piers also increased at this time. The channel, which was relatively flat between the five central piers, was subsequently essentially stable in alignment and cross-section.

On 12 March, 1982, a flood occurred for which the peak flow was estimated to be 700 m³/s (approximately 82% of the design flood flow of 850 m³/s). The bridge had previously withstood a flood flow in June 1967 estimated at 700 m³/s. Debris, including trees up to 20 m long and 1.2 m in diameter, were noted in the flow and adjacent to the piers as the flood receded, the skewed approach flows holding the debris against the sides of the exposed piles of the piers during the flood event.

For the 1982 flood, it appears that the two approach embankments concentrated flow between Piers D and F at an angle of about 30° to the face of Pier E (Figure 4). The flood flows at a skewed angle to the pier, exacerbated by debris accumulation effects, resulted in increased lateral loading and increased scour depths for Pier E. Pier E was consequently scoured out, with the associated loss of the two adjoining deck spans (Figure 4). The remaining sections of the bridge were undamaged. Scour holes at the piers were noted to be infilled as the flood receded.

Figure 4 Schematic Site Plan of the Waitangitaona River Road Bridge Failure

New guidebanks extending into the channel were subsequently established through the bridge site (Figure 4). A 1.5 m thick riprap layer at a slope of 2:1 (H:V), extended by a horizontal riprap toe apron 2 m thick with its upper surface at the existing bed level, was used to protect existing piers located within the new guidebanks. For these piers, the existing piles were also supplemented with three steel H-piles at each end

of the pile cap, these additional piles extending to 13 m below the design bed level. The riprap utilised consisted of rocks of $d_{50} = 750$ mm. Each pier remaining in the revised stream channel was underpinned with two cylinders of 1.5 m diameter at 11 m centres, each cylinder connected to the existing pier via a 1.0 m octagonal column above the design bed level. The cylinder foundations were driven to 13 m below the bed. The existing piled foundations and mass concrete skirt for each of these piers in the revised stream channel were removed along with the base of the slab pier to 2 m above the design flood levels, this level allowing some clearance to minimise any debris accumulations at the piers.
