Artikel: New Zealand case studies of scour at bridge foundations
Autor: Coleman, Stephen / Melville, Bruce
DOI: <https://doi.org/10.5169/seals-60778>

New Zealand Case Studies of Scour at Bridge Foundations

Three case studies of scour at New Zealand bridges are presented to illustrate examples of components of scour which need to be considered in bridge foundation design. The Ashburton River Road Bridge was threatened by scour arising from a combination of progressive degradation, local scour, and debris accumulation effects. The Bulls Road Bridge failed principally as the result of a combination of progressive degradation, scour at a bend, local scour for oblique flows, debris accumulation effects, and lateral loading for the failed pier. The Waitangitona River Road Bridge failed as the result of the combination of scour at the convergence of flow paths (scour at a confluence), contraction scour, local scour for oblique flows, and debris accumulation effects. Various forms of measures proposed and adopted for remediation and prevention of scour in these cases are presented, where these measures include modified pier designs, riprap aprons, riprap weirs, and riprap-lined guidebank

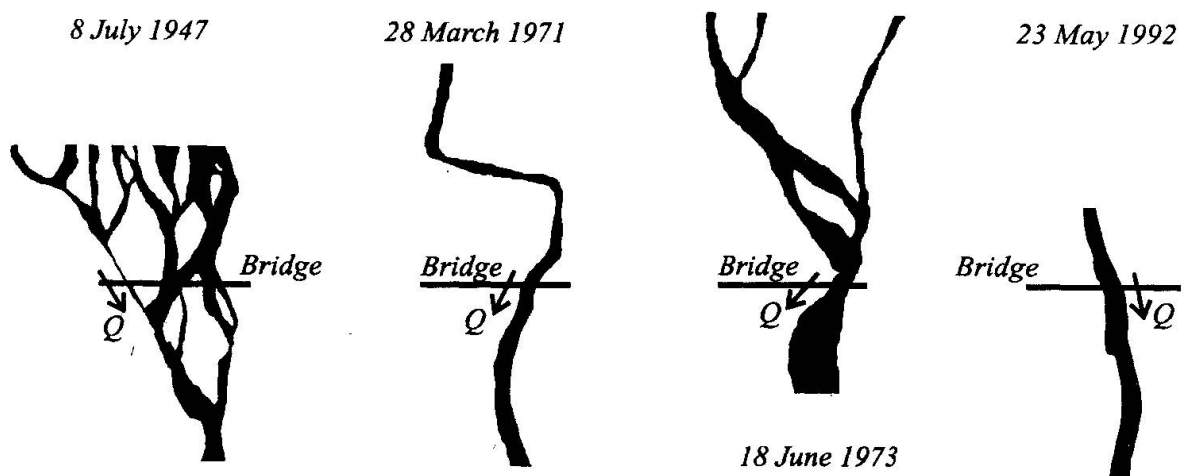
Figure 2 Development of the Principal Flow Channels of the Rangitikei River at the Bulls Road Bridge

In 1947, the river was significantly braided (Figure 2), with numerous channels upstream of the bridge site. Bed levels were relatively uniform over the width of the cross-section. With gravel extraction occurring from 1949 upstream and downstream of the bridge site, the number of braided channel branches reduced to 1-2 main channels meandering within the wider channel (Figure 2). The new flow channels were deeper and narrower than the previous channels. Such developments arising from gravel extraction from a river can be forecasted based on qualitative methodologies describing channel development. River control works were developed over the period from 1949 to 1973 to protect the outsides of the meander bends upstream of the bridge. A high terrace that is relatively erosion-resistant defines the true-left bank of the wider channel. The river meanders reinforced by the bend protection works immediately upstream of the bridge resulted in the main flow channel deflecting off the true-left terrace just upstream of the bridge and passing underneath the end of the bridge at an angle of about 55° to the bridge centreline in the early 1970s (Figure 2).

Each of Piers P and Q was replaced by a single column of 1.83 m diameter supported by a cylinder of 2.13 m diameter. The respective cylinders for Piers P and Q extend to 17.1 m and 18.9 m below the level of the base of the old pile cap. Piers R, S and H to O were also underpinned by 2 cylinders of 1.7 m diameter spaced at 12.95 m centres, the cylinders extending down to 17.1 m below the level of the underside of the original pile cap. To control bed levels, strict control has also been introduced on gravel extraction. It is of interest to note that from 1992 to 1997, the main river channel passed principally between Piers J-M (Figure 2).

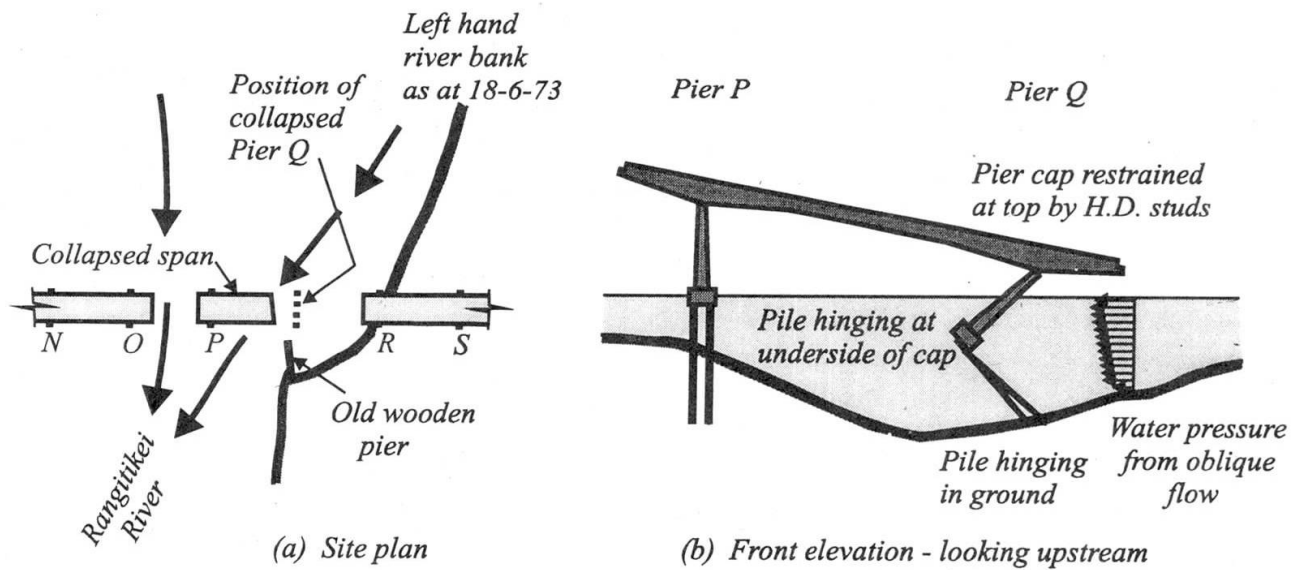
Figure 3 The Bulls Road Bridge Failure

In conjunction with the gravel extraction, mean and minimum bed levels at the bridge site fell relatively steadily over the period from 1945 to 1972. Anecdotal evidence based on cross-section measurements indicates the existence of about 6 m depth of scour at Pier Q about one month prior to failure. With the deepening of the main flow channel under the bridge, an old timber pier was exposed immediately downstream of Pier Q in 1971-1972 (Figure 3).

On June 15, 1973, failure of the bridge occurred on the falling limb of a flood hydrograph estimated as approximating an annual flood event. The flood flows oblique to Pier Q (Figure 3) are estimated to have eroded through the thin papa layer and exposed the underlying fine river sand to the flow. The oblique angle of the flows to the slab-type pier and the increase in material erodibility would then have increased the depth and rate of development of the local scour at this pier. Flow between Pier Q and the exposed

debris-enlarged old timber pier immediately downstream (Figure 3) would also have induced increased local flow velocities around Pier Q, further increasing local scour rates and depths. The reduced fixity at the base of the piles as the scour developed, combined with the flows oblique to the pier exerting lateral pressures on the exposed piles, resulted in hinging occurring both at the base of the piles and also at the underside of the pile cap for Pier Q (Figure 3). The collapse of Pier Q together with the end of the bridge deck connecting Piers P and Q also caused rotation of Pier P, with the suspended spans adjacent to Piers P and Q falling into the river (Figure 3).

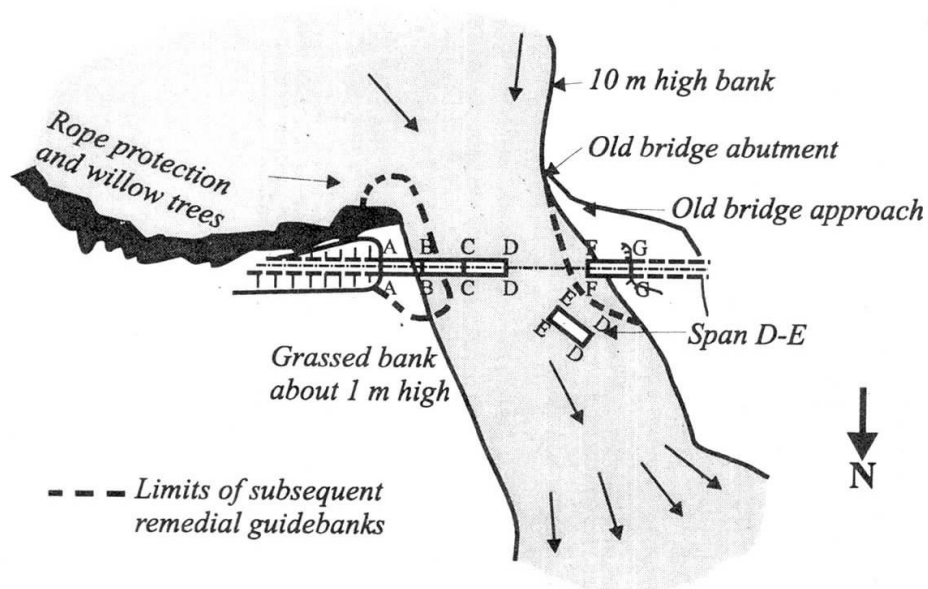
Figure 4 Schematic Site Plan of the Waitangitaona River Road Bridge Failure

The bridge, which spans a channel forming a sudden contraction for flood flows, is located at the exit from a wide channel containing a braided river at low flows (Figure 4). A shift and shortening in the river course downstream of the bridge resulted in rapid bed degradation at the bridge site during construction of the bridge in 1967. This degradation and later flooding resulted in piles extending to only 6.8 m below the minimum bed level. The angle of flow attack on the slab piers also increased at this time. The channel, which was relatively flat between the five central piers, was subsequently essentially stable in alignment and cross-section.

For the 1982 flood, it appears that the two approach embankments concentrated flow between Piers D and F at an angle of about 30° to the face of Pier E (Figure 4). The flood flows at a skewed angle to the pier, exacerbated by debris accumulation effects, resulted in increased lateral loading and increased scour depths for Pier E. Pier E was consequently scoured out, with the associated loss of the two adjoining deck spans (Figure 4). The remaining sections of the bridge were undamaged. Scour holes at the piers were noted to be infilled as the flood receded.

New guidebanks extending into the channel were subsequently established through the bridge site (Figure 4). A 1.5 m thick riprap layer at a slope of 2:1 (H:V), extended by a horizontal riprap toe apron 2 m thick with its upper surface at the existing bed level, was used to protect existing piers located within the new guidebanks. For these piers, the existing piles were also supplemented with three steel H-piles at each end

of the pile cap, these additional piles extending to 13 m below the design bed level. The riprap utilised consisted of rocks of $d_{50} = 750$ mm. Each pier remaining in the revised stream channel was underpinned with two cylinders of 1.5 m diameter at 11 m centres, each cylinder connected to the existing pier via a 1.0 m octagonal column above the design bed level. The cylinder foundations were driven to 13 m below the bed. The existing piled foundations and mass concrete skirt for each of these piers in the revised stream channel were removed along with the base of the slab pier to 2 m above the design flood levels, this level allowing some clearance to minimise any debris accumulations at the piers.
