Artikel: New Zealand case studies of scour at bridge foundations

Autor: Coleman, Stephen / Melville, Bruce

New Zealand Case Studies of Scour at Bridge Foundations

SUMMARY

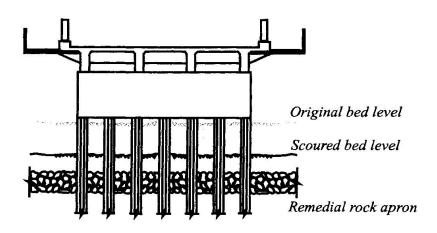
This road bridge over the Ashburton River is a 340 m long, two lane, reinforced concrete structure that was built in 1931. The bridge comprises 31 slab-type piers (Figure 1), about 25 of which lie within the active river channel. Each pier is founded on seven 400 mm reinforced concrete octagonal piles, these piles having been driven to a relatively uniform depth of between 6.5 m and 6.7 m below the underside of the pile caps. The original average bed level was measured at 0.2 m below the underside of the pile caps.

General scour exacerbated by gravel extraction from the river upstream and downstream of the bridge has resulted in a gradual lowering of the bed level at the bridge site (Figure 1). The average bed level lowered approximately 0.9 m from 1937 to 1994, each of the piers within the river channel having exposed piles. In 1978, the average bed level was measured at a level of 1.7 m below the underside of the pile cap. The bridge at this time was concluded to be extremely vulnerable to scour damage by pier undermining arising from the progressive degradation of the bed. Concern for the stability of the bridge was accentuated by the shallowness of the foundation piles and also debris rafts forming at the site increasing the potential for local scour pier undermining and bridge damage or failure in significant floods.

Figure 1 Typical Side Elevation of a Foundation and Remedial Works for the Ashburton River Road Bridge

Rock aprons were constructed in 1979 around each of the piers within the active channel (Figure 1). Each apron measures 5 m wide, 15 m long and 1.6 m thick. Rock riprap of a median size d₅₀ of 0.5 m was used to construct the aprons, with the upper surface of each apron located beneath the riverbed surface and

approximately 2 m below the base of the pile cap. Aprons act to reduce the scour potential at piers both by armouring the bed against local scour due to local hydraulic vortices, and also by protecting against general scour by dropping at the apron extremities as this scour develops. Aprons nevertheless cannot provide total assurance against scouring, particularly for ongoing general degradation. Inspection in 1994 indicated the rock apron to be exposed at one pier only. Bed levels in the river channel continue to be regularly monitored.

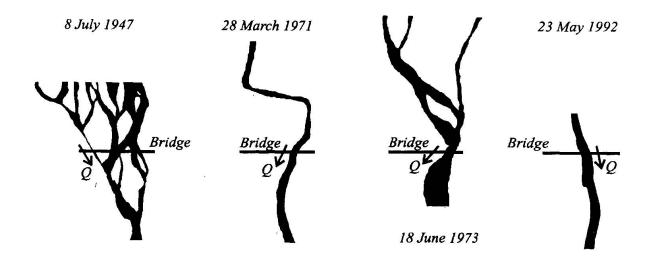
In 1947, the river was significantly braided (Figure 2), with numerous channels upstream of the bridge site. Bed levels were relatively uniform over the width of the cross-section. With gravel extraction occurring from 1949 upstream and downstream of the bridge site, the number of braided channel branches reduced to 1-2 main channels meandering within the wider channel (Figure 2). The new flow channels were deeper and narrower than the previous channels. Such developments arising from gravel extraction from a river can be forecasted based on qualitative methodologies describing channel development. River control works were developed over the period from 1949 to 1973 to protect the outsides of the meander bends upstream of the bridge. A high terrace that is relatively erosion-resistant defines the true-left bank of the wider channel. The river meanders reinforced by the bend protection works immediately upstream of the bridge resulted in the main flow channel deflecting off the true-left terrace just upstream of the bridge and passing underneath the end of the bridge at an angle of about 55° to the bridge centreline in the early 1970s (Figure 2).

Figure 2 Development of the Principal Flow Channels of the Rangitikei River at the Bulls Road Bridge

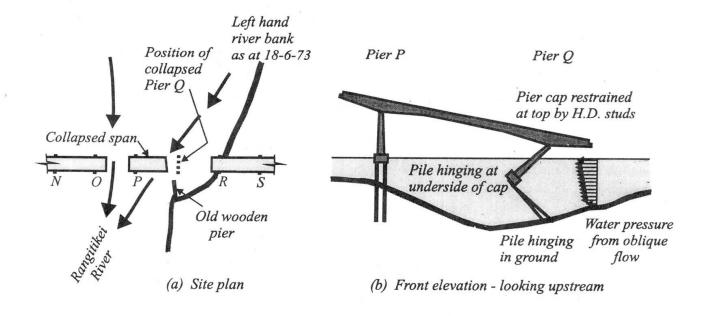
In conjunction with the gravel extraction, mean and minimum bed levels at the bridge site fell relatively steadily over the period from 1945 to 1972. Anecdotal evidence based on cross-section measurements indicates the existence of about 6 m depth of scour at Pier Q about one month prior to failure. With the deepening of the main flow channel under the bridge, an old timber pier was exposed immediately downstream of Pier Q in 1971-1972 (Figure 3).

On June 15, 1973, failure of the bridge occurred on the falling limb of a flood hydrograph estimated as approximating an annual flood event. The flood flows oblique to Pier Q (Figure 3) are estimated to have eroded through the thin papa layer and exposed the underlying fine river sand to the flow. The oblique angle of the flows to the slab-type pier and the increase in material erodibility would then have increased the depth and rate of development of the local scour at this pier. Flow between Pier Q and the exposed

debris-enlarged old timber pier immediately downstream (Figure 3) would also have induced increased local flow velocities around Pier Q, further increasing local scour rates and depths. The reduced fixity at the base of the piles as the scour developed, combined with the flows oblique to the pier exerting lateral pressures on the exposed piles, resulted in hinging occurring both at the base of the piles and also at the underside of the pile cap for Pier Q (Figure 3). The collapse of Pier Q together with the end of the bridge deck connecting Piers P and Q also caused rotation of Pier P, with the suspended spans adjacent to Piers P and Q falling into the river (Figure 3).

Figure 3 The Bulls Road Bridge Failure

Each of Piers P and Q was replaced by a single column of 1.83 m diameter supported by a cylinder of 2.13 m diameter. The respective cylinders for Piers P and Q extend to 17.1 m and 18.9 m below the level of the base of the old pile cap. Piers R, S and H to O were also underpinned by 2 cylinders of 1.7 m diameter spaced at 12.95 m centres, the cylinders extending down to 17.1 m below the level of the underside of the original pile cap. To control bed levels, strict control has also been introduced on gravel extraction. It is of interest to note that from 1992 to 1997, the main river channel passed principally between Piers J-M (Figure 2).

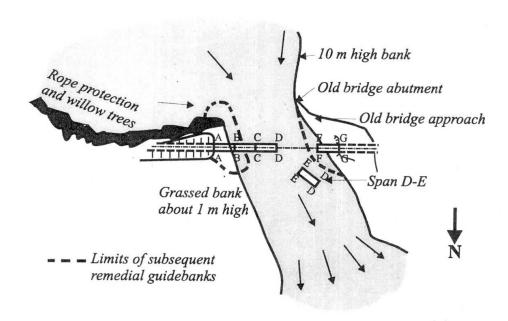
The bridge, which spans a channel forming a sudden contraction for flood flows, is located at the exit from a wide channel containing a braided river at low flows (Figure 4). A shift and shortening in the river course downstream of the bridge resulted in rapid bed degradation at the bridge site during construction of the bridge in 1967. This degradation and later flooding resulted in piles extending to only 6.8 m below the minimum bed level. The angle of flow attack on the slab piers also increased at this time. The channel, which was relatively flat between the five central piers, was subsequently essentially stable in alignment and cross-section.

For the 1982 flood, it appears that the two approach embankments concentrated flow between Piers D and F at an angle of about 30° to the face of Pier E (Figure 4). The flood flows at a skewed angle to the pier, exacerbated by debris accumulation effects, resulted in increased lateral loading and increased scour depths for Pier E. Pier E was consequently scoured out, with the associated loss of the two adjoining deck spans (Figure 4). The remaining sections of the bridge were undamaged. Scour holes at the piers were noted to be infilled as the flood receded.

Figure 4 Schematic Site Plan of the Waitangitaona River Road Bridge Failure

New guidebanks extending into the channel were subsequently established through the bridge site (Figure 4). A 1.5 m thick riprap layer at a slope of 2:1 (H:V), extended by a horizontal riprap toe apron 2 m thick with its upper surface at the existing bed level, was used to protect existing piers located within the new guidebanks. For these piers, the existing piles were also supplemented with three steel H-piles at each end

of the pile cap, these additional piles extending to 13 m below the design bed level. The riprap utilised consisted of rocks of $d_{50} = 750$ mm. Each pier remaining in the revised stream channel was underpinned with two cylinders of 1.5 m diameter at 11 m centres, each cylinder connected to the existing pier via a 1.0 m octagonal column above the design bed level. The cylinder foundations were driven to 13 m below the bed. The existing piled foundations and mass concrete skirt for each of these piers in the revised stream channel were removed along with the base of the slab pier to 2m above the design flood levels, this level allowing some clearance to minimise any debris accumulations at the piers.
