**Zeitschrift:** IABSE reports = Rapports AIPC = IVBH Berichte  
**Band:** 80 (1999)

**Artikel:** New Zealand case studies of scour at bridge foundations  
**Autor:** Coleman, Stephen / Melville, Bruce  
**DOI:** <https://doi.org/10.5169/seals-60778>

## New Zealand Case Studies of Scour at Bridge Foundations

Three case studies of scour at New Zealand bridges are presented to illustrate examples of components of scour which need to be considered in bridge foundation design. The Ashburton River Road Bridge was threatened by scour arising from a combination of progressive degradation, local scour, and debris accumulation effects. The Bulls Road Bridge failed principally as the result of a combination of progressive degradation, scour at a bend, local scour for oblique flows, debris accumulation effects, and lateral loading for the failed pier. The Waitangitona River Road Bridge failed as the result of the combination of scour at the convergence of flow paths (scour at a confluence), contraction scour, local scour for oblique flows, and debris accumulation effects. Various forms of measures proposed and adopted for remediation and prevention of scour in these cases are presented, wh

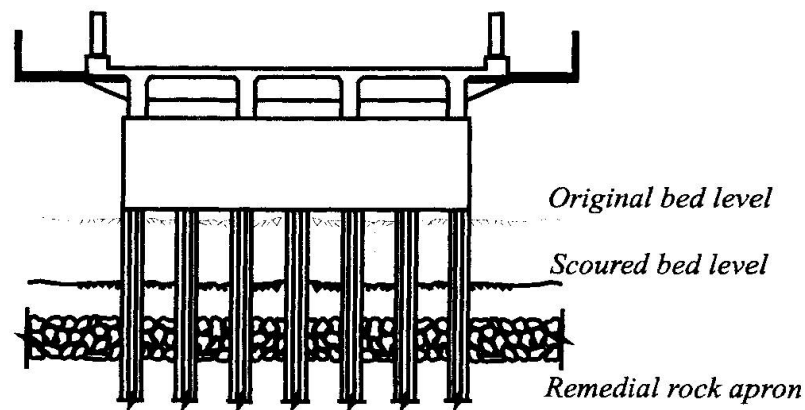
Figure 1 Typical Side Elevation of a Foundation and Remedial Works for the Ashburton River Road Bridge

This road bridge over the Ashburton River is a 340 m long, two lane, reinforced concrete structure that was built in 1931. The bridge comprises 31 slab-type piers (Figure 1), about 25 of which lie within the active river channel. Each pier is founded on seven 400 mm reinforced concrete octagonal piles, these piles having been driven to a relatively uniform depth of between 6.5 m and 6.7 m below the underside of the pile caps. The original average bed level was measured at 0.2 m below the underside of the pile caps.

General scour exacerbated by gravel extraction from the river upstream and downstream of the bridge has resulted in a gradual lowering of the bed level at the bridge site (Figure 1). The average bed level lowered approximately 0.9 m from 1937 to 1994, each of the piers within the river channel having exposed piles. In 1978, the average bed level was measured at a level of 1.7 m below the underside of the pile cap. The bridge at this time was concluded to be extremely vulnerable to scour damage by pier undermining arising from the progressive degradation of the bed. Concern for the stability of the bridge was accentuated by the shallowness of the foundation piles and also debris rafts forming at the site increasing the potential for local scour pier undermining and bridge damage or failure in significant floods.

Rock aprons were constructed in 1979 around each of the piers within the active channel (Figure 1). Each apron measures 5 m wide, 15 m long and 1.6 m thick. Rock riprap of a median size  $d_{50}$  of 0.5 m was used to construct the aprons, with the upper surface of each apron located beneath the riverbed surface and

approximately 2 m below the base of the pile cap. Aprons act to reduce the scour potential at piers both by armouring the bed against local scour due to local hydraulic vortices, and also by protecting against general scour by dropping at the apron extremities as this scour develops. Aprons nevertheless cannot provide total assurance against scouring, particularly for ongoing general degradation. Inspection in 1994 indicated the rock apron to be exposed at one pier only. Bed levels in the river channel continue to be regularly monitored.

The bridge has to date performed satisfactorily in the large floods over its life, even with the bed lower than its present level. Possible additional future scour damage mitigation options which have been identified include underpinning of the piers and the construction of a weir immediately downstream of the bridge, with the weir crest level no lower than the underside of the pier caps. The usual form of weir adopted is a rock riprap structure comprising a crest and downstream apron. Such weirs have been used very successfully in the West Coast and Canterbury areas of New Zealand to control degrading river channels. At the Ashburton River Road Bridge site, the weir would significantly affect fish migration, riverbed levels, and stopbank effectiveness upstream of the bridge, and also bed levels immediately downstream of the weir, which would degrade.

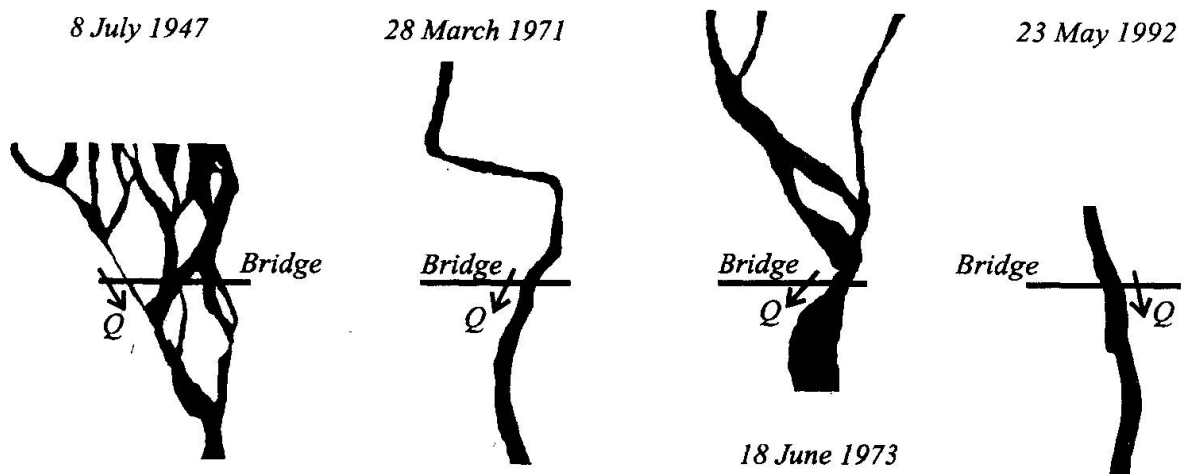
Figure 2 Development of the Principal Flow Channels of the Rangitikei River at the Bulls Road Bridge

In 1947, the river was significantly braided (Figure 2), with numerous channels upstream of the bridge site. Bed levels were relatively uniform over the width of the cross-section. With gravel extraction occurring from 1949 upstream and downstream of the bridge site, the number of braided channel branches reduced to 1-2 main channels meandering within the wider channel (Figure 2). The new flow channels were deeper and narrower than the previous channels. Such developments arising from gravel extraction from a river can be forecasted based on qualitative methodologies describing channel development. River control works were developed over the period from 1949 to 1973 to protect the outsides of the meander bends upstream of the bridge. A high terrace that is relatively erosion-resistant defines the true-left bank of the wider channel. The river meanders reinforced by the bend protection works immediately upstream of the bridge resulted in the main flow channel deflecting off the true-left terrace just upstream of the bridge and passing underneath the end of the bridge at an angle of about 55° to the bridge centreline in the early 1970s (Figure 2).

Each of Piers P and Q was replaced by a single column of 1.83 m diameter supported by a cylinder of 2.13 m diameter. The respective cylinders for Piers P and Q extend to 17.1 m and 18.9 m below the level of the base of the old pile cap. Piers R, S and H to O were also underpinned by 2 cylinders of 1.7 m diameter spaced at 12.95 m centres, the cylinders extending down to 17.1 m below the level of the underside of the original pile cap. To control bed levels, strict control has also been introduced on gravel extraction. It is of interest to note that from 1992 to 1997, the main river channel passed principally between Piers J-M (Figure 2).

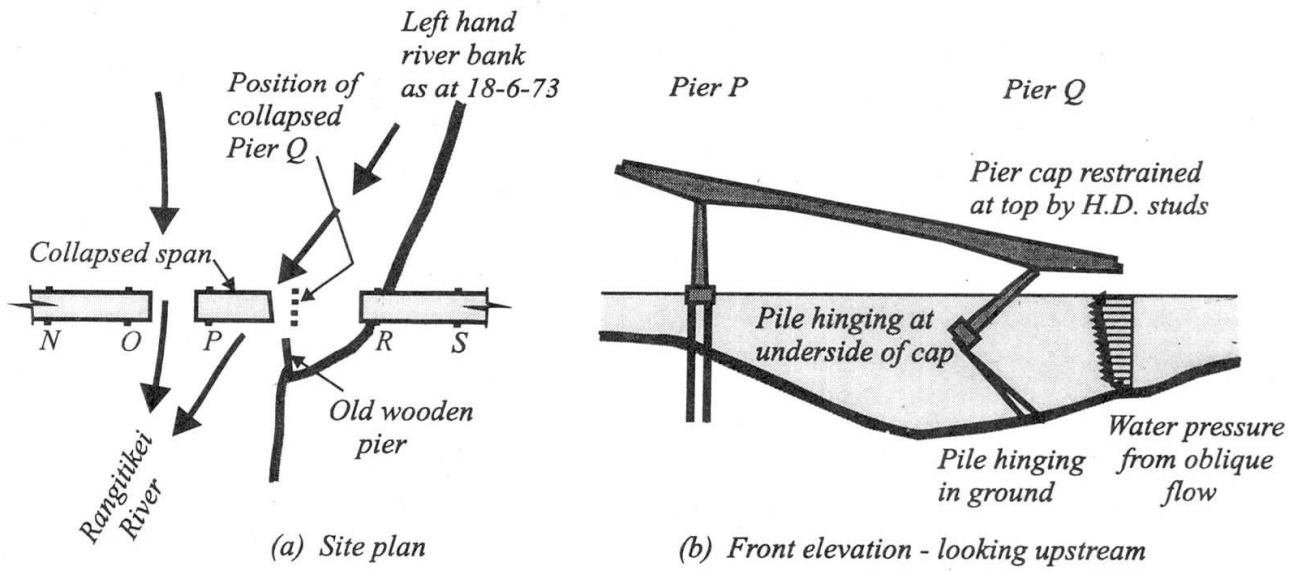
Figure 3 The Bulls Road Bridge Failure

In conjunction with the gravel extraction, mean and minimum bed levels at the bridge site fell relatively steadily over the period from 1945 to 1972. Anecdotal evidence based on cross-section measurements indicates the existence of about 6 m depth of scour at Pier Q about one month prior to failure. With the deepening of the main flow channel under the bridge, an old timber pier was exposed immediately downstream of Pier Q in 1971-1972 (Figure 3).

On June 15, 1973, failure of the bridge occurred on the falling limb of a flood hydrograph estimated as approximating an annual flood event. The flood flows oblique to Pier Q (Figure 3) are estimated to have eroded through the thin papa layer and exposed the underlying fine river sand to the flow. The oblique angle of the flows to the slab-type pier and the increase in material erodibility would then have increased the depth and rate of development of the local scour at this pier. Flow between Pier Q and the exposed

debris-enlarged old timber pier immediately downstream (Figure 3) would also have induced increased local flow velocities around Pier Q, further increasing local scour rates and depths. The reduced fixity at the base of the piles as the scour developed, combined with the flows oblique to the pier exerting lateral pressures on the exposed piles, resulted in hinging occurring both at the base of the piles and also at the underside of the pile cap for Pier Q (Figure 3). The collapse of Pier Q together with the end of the bridge deck connecting Piers P and Q also caused rotation of Pier P, with the suspended spans adjacent to Piers P and Q falling into the river (Figure 3).

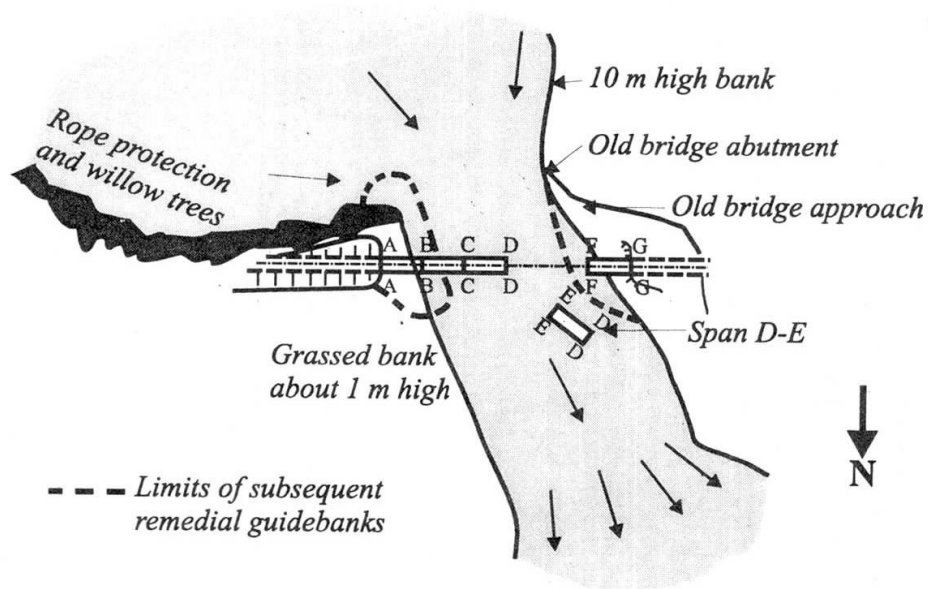
Figure 4 Schematic Site Plan of the Waitangitaona River Road Bridge Failure

The bridge, which spans a channel forming a sudden contraction for flood flows, is located at the exit from a wide channel containing a braided river at low flows (Figure 4). A shift and shortening in the river course downstream of the bridge resulted in rapid bed degradation at the bridge site during construction of the bridge in 1967. This degradation and later flooding resulted in piles extending to only 6.8 m below the minimum bed level. The angle of flow attack on the slab piers also increased at this time. The channel, which was relatively flat between the five central piers, was subsequently essentially stable in alignment and cross-section.

For the 1982 flood, it appears that the two approach embankments concentrated flow between Piers D and F at an angle of about 30° to the face of Pier E (Figure 4). The flood flows at a skewed angle to the pier, exacerbated by debris accumulation effects, resulted in increased lateral loading and increased scour depths for Pier E. Pier E was consequently scoured out, with the associated loss of the two adjoining deck spans (Figure 4). The remaining sections of the bridge were undamaged. Scour holes at the piers were noted to be infilled as the flood receded.

New guidebanks extending into the channel were subsequently established through the bridge site (Figure 4). A 1.5 m thick riprap layer at a slope of 2:1 (H:V), extended by a horizontal riprap toe apron 2 m thick with its upper surface at the existing bed level, was used to protect existing piers located within the new guidebanks. For these piers, the existing piles were also supplemented with three steel H-piles at each end

of the pile cap, these additional piles extending to 13 m below the design bed level. The riprap utilised consisted of rocks of  $d_{50} = 750$  mm. Each pier remaining in the revised stream channel was underpinned with two cylinders of 1.5 m diameter at 11 m centres, each cylinder connected to the existing pier via a 1.0 m octagonal column above the design bed level. The cylinder foundations were driven to 13 m below the bed. The existing piled foundations and mass concrete skirt for each of these piers in the revised stream channel were removed along with the base of the slab pier to 2 m above the design flood levels, this level allowing some clearance to minimise any debris accumulations at the piers.
