Artikel: New Zealand case studies of scour at bridge foundations
Autor: Coleman, Stephen / Melville, Bruce
DOI: <https://doi.org/10.5169/seals-60778>

New Zealand Case Studies of Scour at Bridge Foundations

SUMMARY

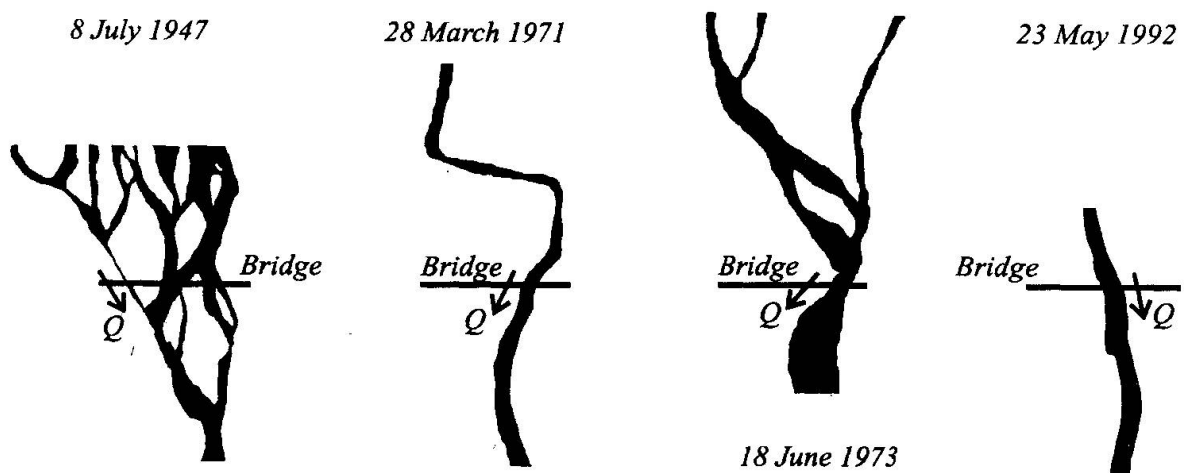
Figure 2 Development of the Principal Flow Channels of the Rangitikei River at the Bulls Road Bridge

In 1947, the river was significantly braided (Figure 2), with numerous channels upstream of the bridge site. Bed levels were relatively uniform over the width of the cross-section. With gravel extraction occurring from 1949 upstream and downstream of the bridge site, the number of braided channel branches reduced to 1-2 main channels meandering within the wider channel (Figure 2). The new flow channels were deeper and narrower than the previous channels. Such developments arising from gravel extraction from a river can be forecasted based on qualitative methodologies describing channel development. River control works were developed over the period from 1949 to 1973 to protect the outsides of the meander bends upstream of the bridge. A high terrace that is relatively erosion-resistant defines the true-left bank of the wider channel. The river meanders reinforced by the bend protection works immediately upstream of the bridge resulted in the main flow channel deflecting off the true-left terrace just upstream of the bridge and passing underneath the end of the bridge at an angle of about 55° to the bridge centreline in the early 1970s (Figure 2).

Each of Piers P and Q was replaced by a single column of 1.83 m diameter supported by a cylinder of 2.13 m diameter. The respective cylinders for Piers P and Q extend to 17.1 m and 18.9 m below the level of the base of the old pile cap. Piers R, S and H to O were also underpinned by 2 cylinders of 1.7 m diameter spaced at 12.95 m centres, the cylinders extending down to 17.1 m below the level of the underside of the original pile cap. To control bed levels, strict control has also been introduced on gravel extraction. It is of interest to note that from 1992 to 1997, the main river channel passed principally between Piers J-M (Figure 2).
