Foundation of Bridges on River Ganges in India

Vijay Kumar

Summary

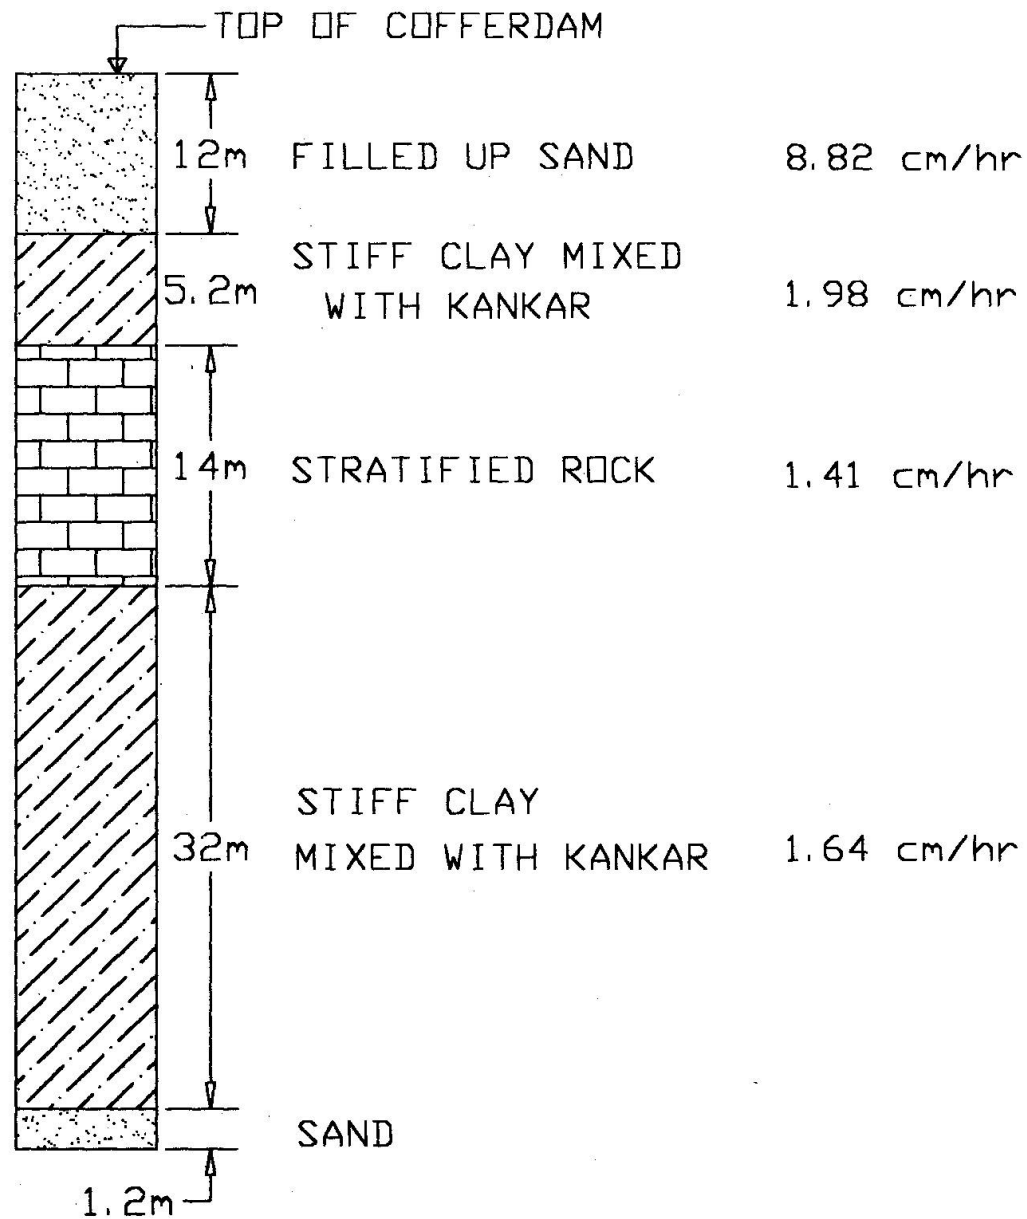
CASE STUDY 1 - DETAILS OF STRATA & RATE OF SINKINGSKETCH 1

The soil strata in general was sandy in the upper layers upto 25-30 m below bed followed by very hard and stiff clay layer, sometimes mixed with kankar. However, in the above location, there was hard clay all through with a intervening layer of hard stone in about 2 m depth. The work of this foundation was started in the month of March by making a 13 m high sheet pile Island filled with sand. The curb was cast at the top of this island and sunk through this filled up sand. After the well reached the bed of the river it met with hard and stiff clay strata mixed with kankar. The river bed was sloppy towards one side which resulted in tilting of the well. The well had to be loaded eccentrically against the direction of tilt with about 180 T load. The well was also tied by means of wire ropes with the next well which had already been completed earlier and bottom plugged. The sinking was done by chiselling and grabbing. The weight of the chiesel used for this was 2.5 T.

The rate of sinking achieved in this layer was about 1.98 Cm/hr.

The clayey layer was followed by rocky strata at about 18 m below the bed. The well was loaded by concrete blocks of about 180 T and sinking was done by chiselling and grabbing operation.

The rate of sinking achieved in this layer was about 1.41 Cm/hr.

The hard and stiff clay layer which followed after this was dealt with by chiselling and grabbing as above but under loaded conditions with 250 T concrete block over the well. The dewatering of the well was also done to make sump of the required depth to facilitate sinking. The rate of sinking in this third layer was 1.64 cm/ hr. The well was finally sunk to its founding level about 65 m below LWL in the sandy strata. The total crane hours for sinking were 3500 hrs.

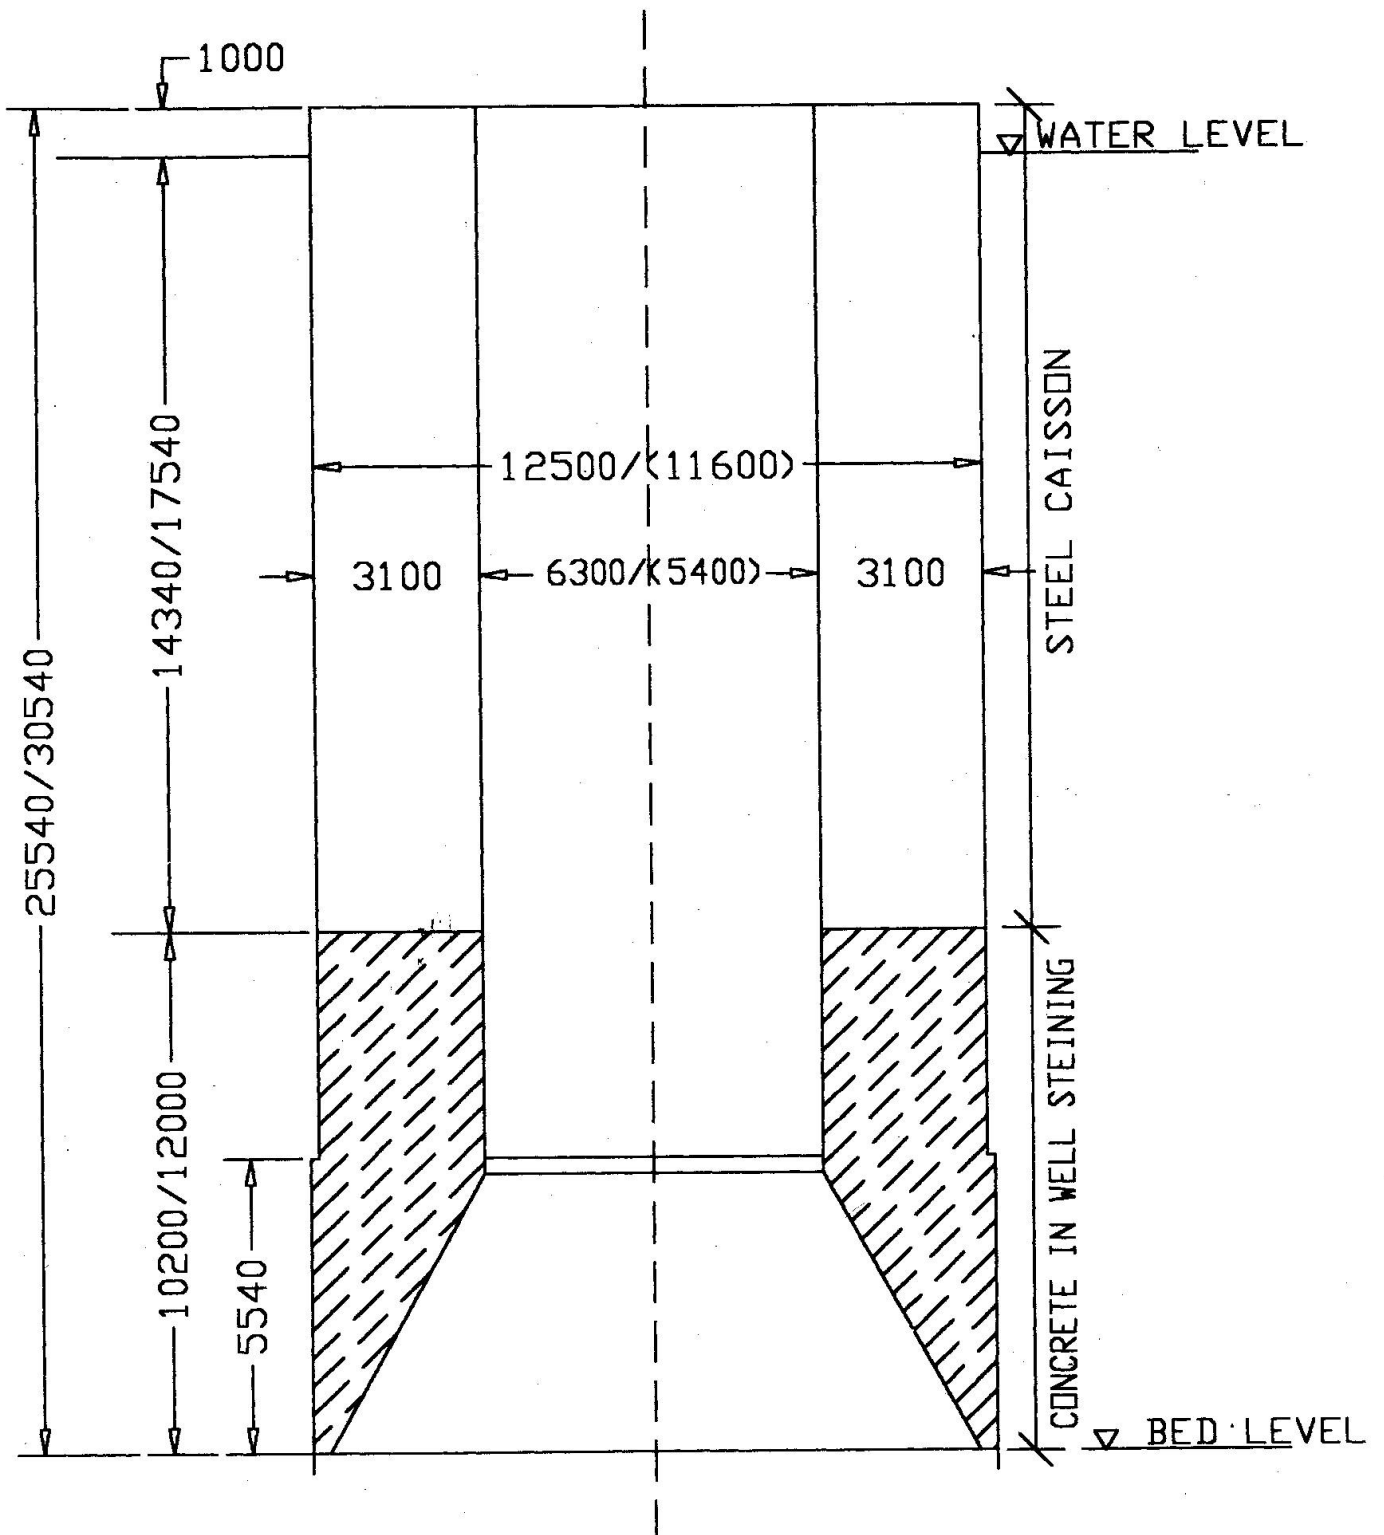
SKETCH 4

CASE STUDY 4 - TYPICAL CROSS SECTION OF PIER WELL

Because of the change in flow conditions and excessive scouring in this zone, the depth of water was in the range of 17m to 22 m. For such deep depth of water alternative I which was the construction Technique adopted for other wells, was not feasible.

As such alternative II is to be used. This is the arrangement of fabricating steel curb and steining segment, lifting in vertical direction, shifting and placing the same on the barge and taking it to the location of the well foundation, lifting with steel gantry arrangements on the gantry barge, removing the caisson barge, lowering the steel caissons segment with the gantry arrangement and concreting of the same in such a way that it remains floating all the time due to its buoyancy effect till it touches the bed level of the river at the foundation location, sinking a little bit more as considered safe for laying another segment of steel caisson over it so that the bottom of steel caisson rests in the normal bed of the river and top of the last steel caisson segment remains above the water level such that the balanced steining of the caisson could be done directly by fixing shuttering.
