Artikel: Foundation of bridges on river Ganges in India
Autor: Kumar, Vijay
DOI: <https://doi.org/10.5169/seals-60780>

Foundation of Bridges on River Ganges in India

Vijay Kumar

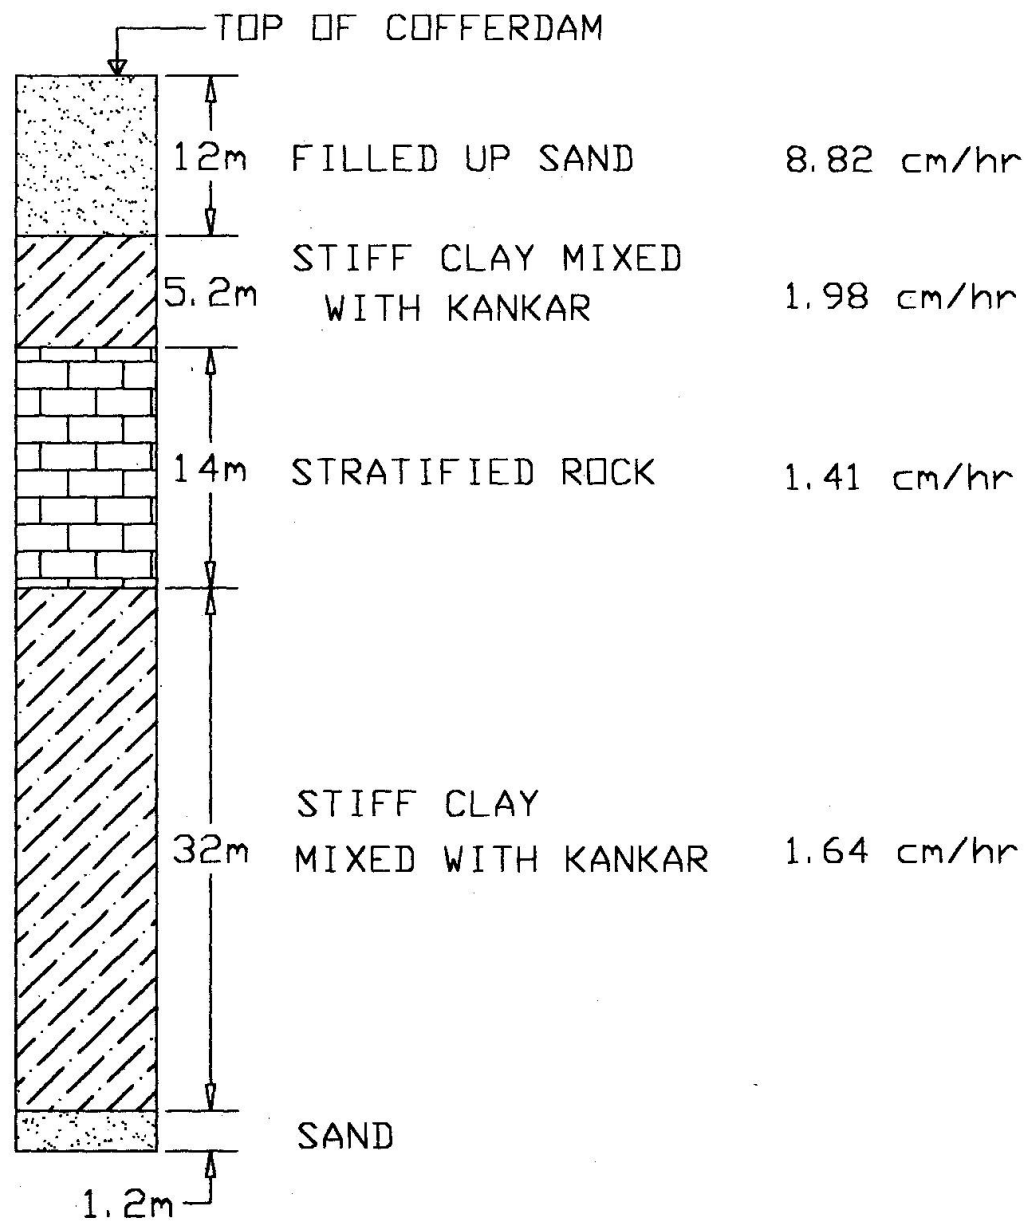
CASE STUDY 1 - DETAILS OF STRATA & RATE OF SINKINGSKETCH 1

The soil strata in general was sandy in the upper layers upto 25-30 m below bed followed by very hard and stiff clay layer, sometimes mixed with kankar. However, in the above location, there was hard clay all through with a intervening layer of hard stone in about 2 m depth. The work of this foundation was started in the month of March by making a 13 m high sheet pile Island filled with sand. The curb was cast at the top of this island and sunk through this filled up sand. After the well reached the bed of the river it met with hard and stiff clay strata mixed with kankar. The river bed was sloppy towards one side which resulted in tilting of the well. The well had to be loaded eccentrically against the direction of tilt with about 180 T load. The well was also tied by means of wire ropes with the next well which had already been completed earlier and bottom plugged. The sinking was done by chiselling and grabbing. The weight of the chiesel used for this was 2.5 T.

The rate of sinking achieved in this layer was about 1.98 Cm/hr.

The clayey layer was followed by rocky strata at about 18 m below the bed. The well was loaded by concrete blocks of about 180 T and sinking was done by chiselling and grabbing operation.

The rate of sinking achieved in this layer was about 1.41 Cm/hr.

The hard and stiff clay layer which followed after this was dealt with by chiselling and grabbing as above but under loaded conditions with 250 T concrete block over the well. The dewatering of the well was also done to make sump of the required depth to facilitate sinking. The rate of sinking in this third layer was 1.64 cm/ hr. The well was finally sunk to its founding level about 65 m below LWL in the sandy strata. The total crane hours for sinking were 3500 hrs.

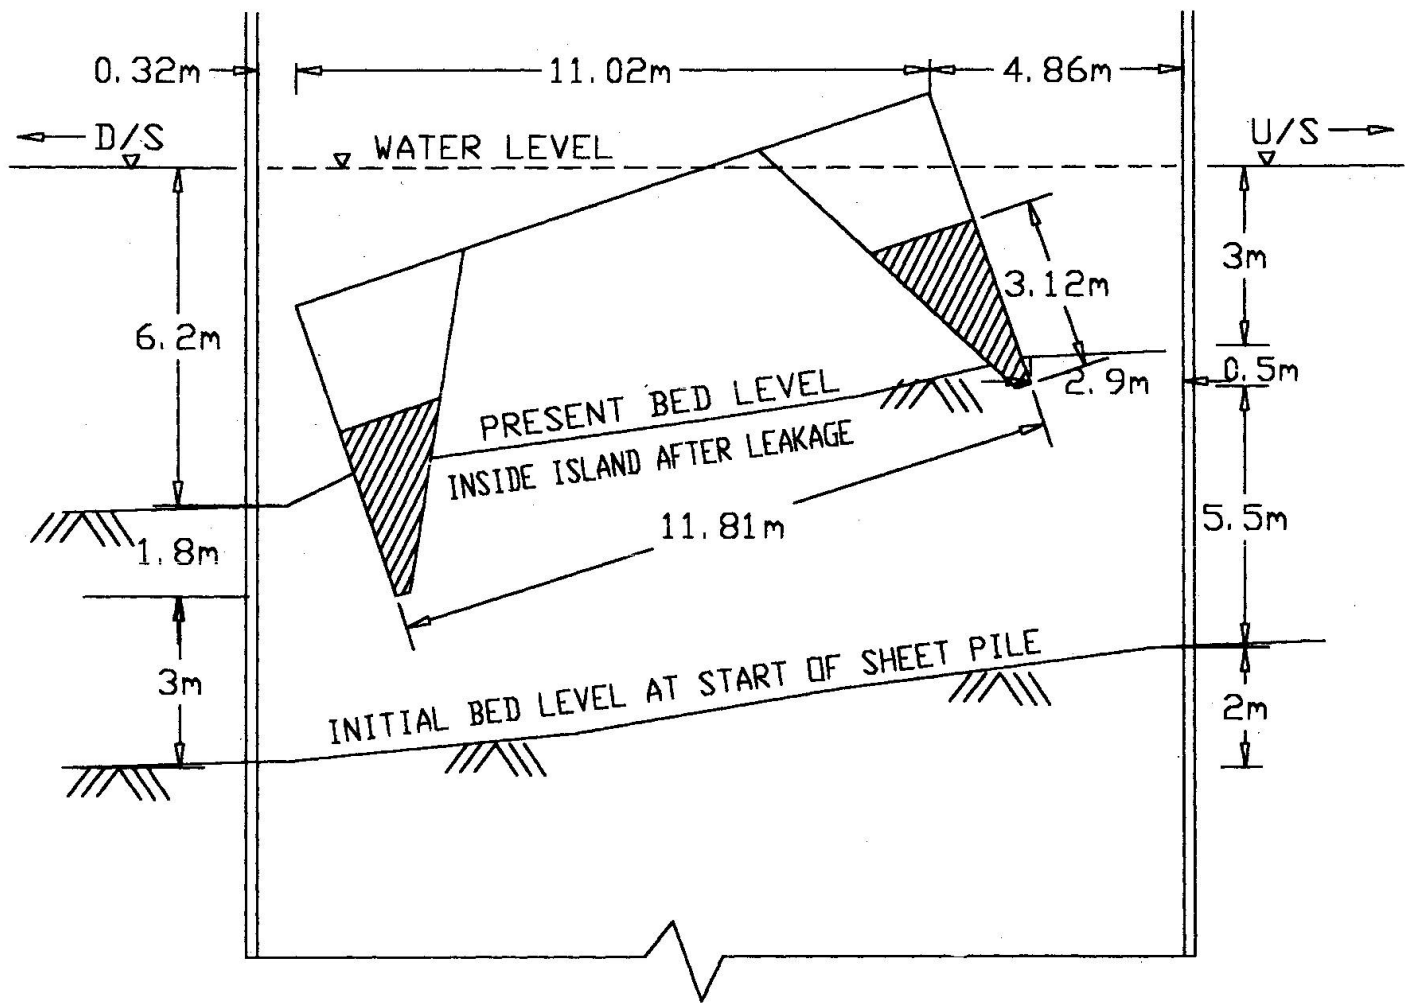
SKETCH 2

The location of this foundation was in the mid - stream of river Ganges. The diameter of well was 11.66 m with steining thickness as 3.1 m and curb was of height 5.54 m. The curb was proposed to be cast in two lifts of 3.12 m and 2.42 m respectively. Here also, the sheet pile island of 16 m dia was constructed at the location of well in a water depth of about 10m, for laying the well curb at its top. The concreting of first lift involving 180m³ of concrete was done in 2 days.

After about One and half hour of the concreting, leakage of sand from the island occurred in the upstream side. As a result, the entire curb, after getting tilted towards upstream side, sunk nearly 4.50 m below the water level.

The tilt was corrected by performing the grabbing in between the curb and sheet pile island in the down stream side. After correcting the tilt as above under water, and making the curb vertical, another sheet pile island was made inside the earlier island at a gap of 0.75m. This gap was filled with clay and bags filled with clay. After filling the gap, the dewatering of island was done by means of 4 submersible pumps of 20 KW capacity to a level lower than the concrete level of curb. The shuttering was then erected and reinforcement fixed and immediately concreting of further steining was done. This operation of dewatering and

concreting was continued for nearly 24 hours to complete the concreting of second lift, which also brought the curb top above the water level. The whole process took one complete month. Details shown in the sketch - 2

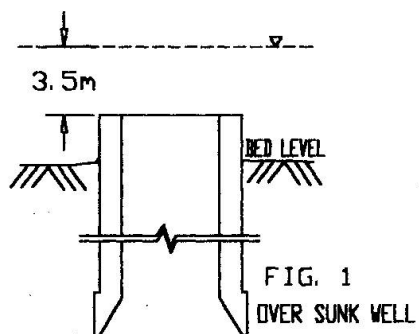
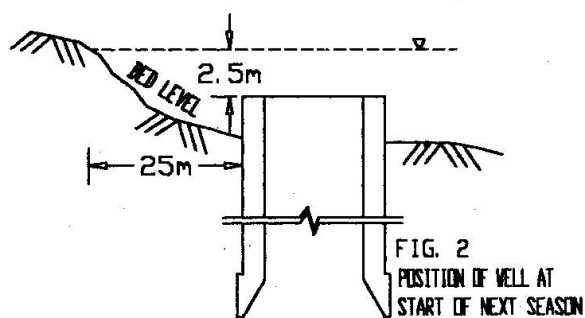
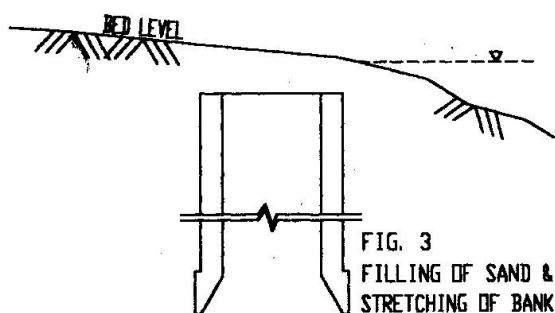
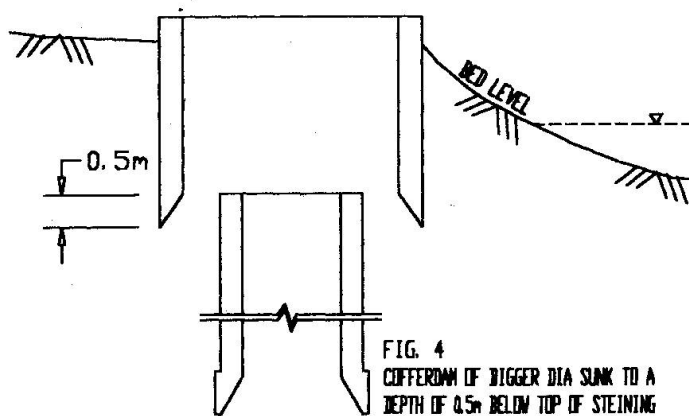
SKETCH 3

Some times, the well sink suddenly because of excessive grabbing or sump or some weak soil layer and the steining of well, done upto that stage which is always kept above the water level by regulating the sinking and concreting operations, goes below the water level making it difficult to continue further work on steining.

In this case, a well foundation was being sunk in deep waters of River Ganges. The total height of steining except last 2.00 m was completed and the well was left to be sunk finally by about 7.5 m to reach its founding level. As the strata was of stiff clay in which the well was stuck up, chiselling and grabbing operations were continued to make a sump of about 8 m below the cutting edge. This position of well remained for quite some time. Then one day the well sunk suddenly by 8.91 m, 1.43 m extra below the final founding level. Due to this extra sinking the top of steining also went below the water level by about 3.50 m. All this happened just before the monsoons when the water level started rising and work could not be continued. After the flood receded and water levels normalised, the work was resumed. It was found that the depth of water was 2.5 m. The well was in side the river bed and about 25m from bank. Sand embankment was made from the bank to extend and cover up the location of the well. A cutting edge of 2 m more dia than the dia of well was placed there and a cofferdam with 30 Cm steining thickness was made and got sunk to nearly 0.50 m below the top of the steining of the over sunk well. The concrete cofferdam was then dewatered and steining of the original well was exposed making it feasible to build up further steining to the required level. Details shown in sketch- 3.

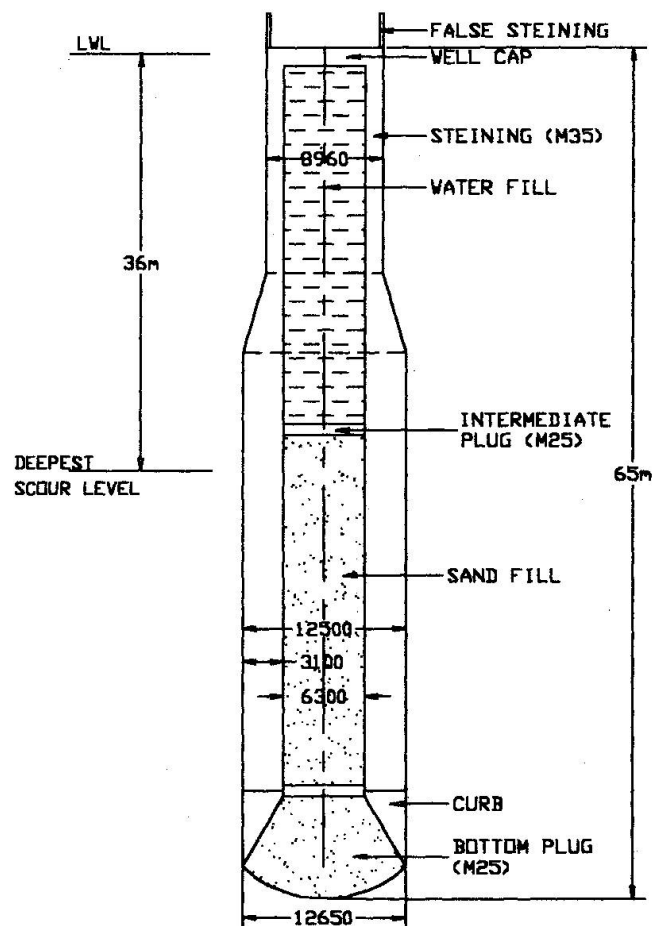
SKETCH 4

Because of the change in flow conditions and excessive scouring in this zone, the depth of water was in the range of 17m to 22 m. For such deep depth of water alternative I which was the construction Technique adopted for other wells, was not feasible.

As such alternative II is to be used. This is the arrangement of fabricating steel curb and steining segment, lifting in vertical direction, shifting and placing the same on the barge and taking it to the location of the well foundation, lifting with steel gantry arrangements on the gantry barge, removing the caisson barge, lowering the steel caissons segment with the gantry arrangement and concreting of the same in such a way that it remains floating all the time due to its buoyancy effect till it touches the bed level of the river at the foundation location, sinking a little bit more as considered safe for laying another segment of steel caisson over it so that the bottom of steel caisson rests in the normal bed of the river and top of the last steel caisson segment remains above the water level such that the balanced steining of the caisson could be done directly by fixing shuttering.
