Foundation of Bridges on River Ganges in India

Vijay Kumar
General Manager
U.P.State Bridge Corp.
486, Hawa Singh Block,
Khel Gaon, New Delhi 110049
India.

Summary

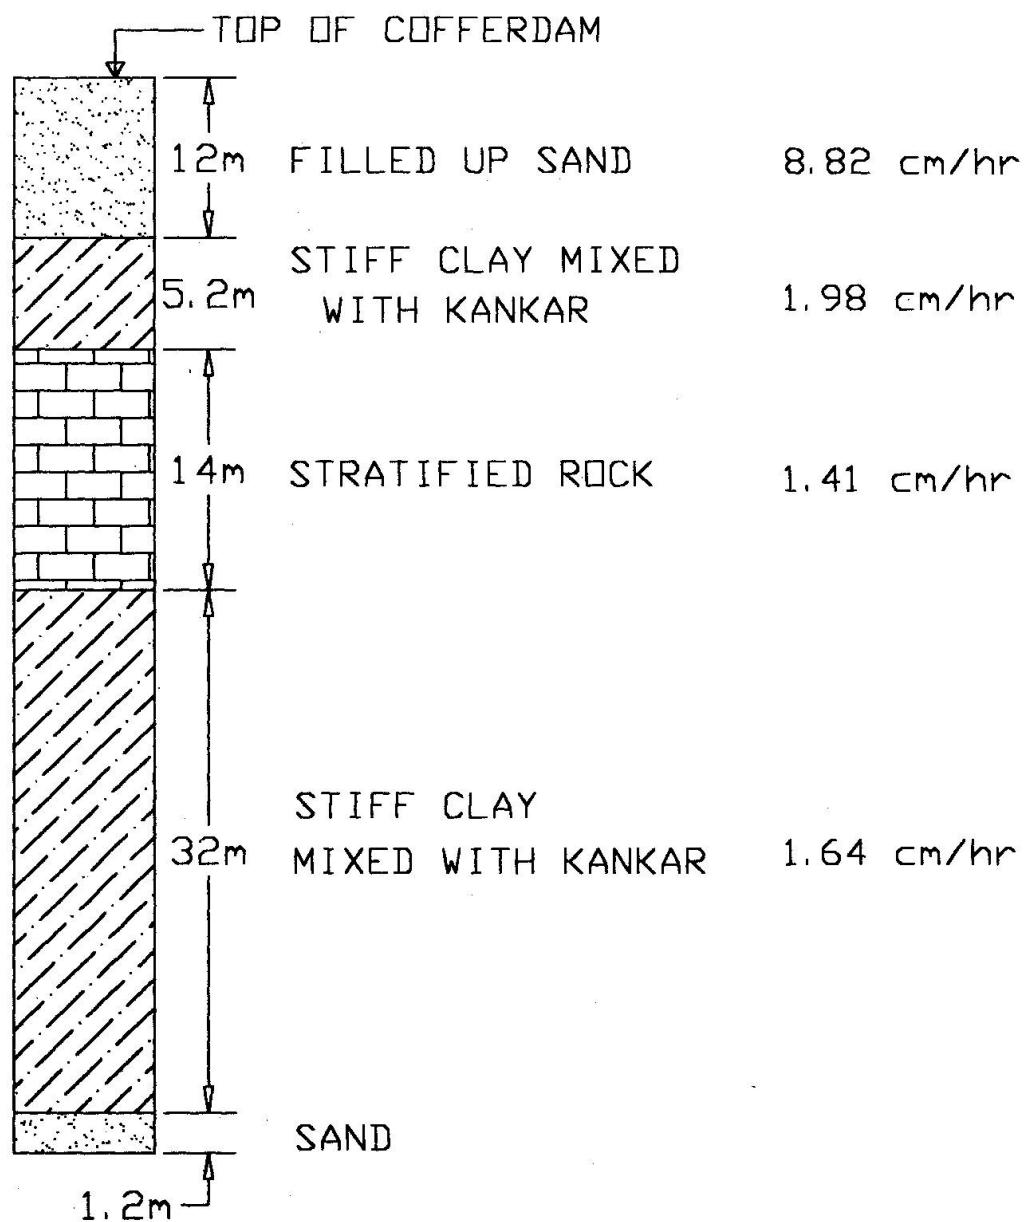
CASE STUDY 1 - DETAILS OF STRATA & RATE OF SINKINGSKETCH 1

The soil strata in general was sandy in the upper layers upto 25-30 m below bed followed by very hard and stiff clay layer, sometimes mixed with kankar. However, in the above location, there was hard clay all through with a intervening layer of hard stone in about 2 m depth.

The work of this foundation was started in the month of March by making a 13 m heigh sheet pile Island filled with sand. The curb was cast at the top of this island and sunk through this filled up sand. After the well reached the bed of the river it met with hard and stiff clay strata mixed with kankar. The river bed was sloppy towards one side which resulted in tilting of the well. The well had to be loaded eccentrically against the direction of tilt with about 180 T load. The well was also tied by means of wire ropes with the next well which had already been completed earlier and bottom plugged. The sinking was done by chiselling and grabbing. The weight of the chiesel used for this was 2.5 T.

The rate of sinking achieved in this layer was about 1.98 Cm/hr.

The clayey layer was followed by rocky strata at about 18 m below the bed. The well was loaded by concrete blocks of about 180 T and sinking was done by chiselling and grabing operation.

The rate of sinking achieved in this layer was about 1.41 Cm/hr.

The hard and stiff clay layer which followed after this was dealt with by chiselling and grabing as above but under loaded conditions with 250 T concrete block over the well. The dewatering of the well was also done to make sump of the required depth to facilitate sinking. The rate of sinking in this third layer was 1.64 cm/ hr. The well was finally sunk to its foudning level about 65 m . below LWL in the sandy strata . The total crane hours for sinking were 3500 hrs.

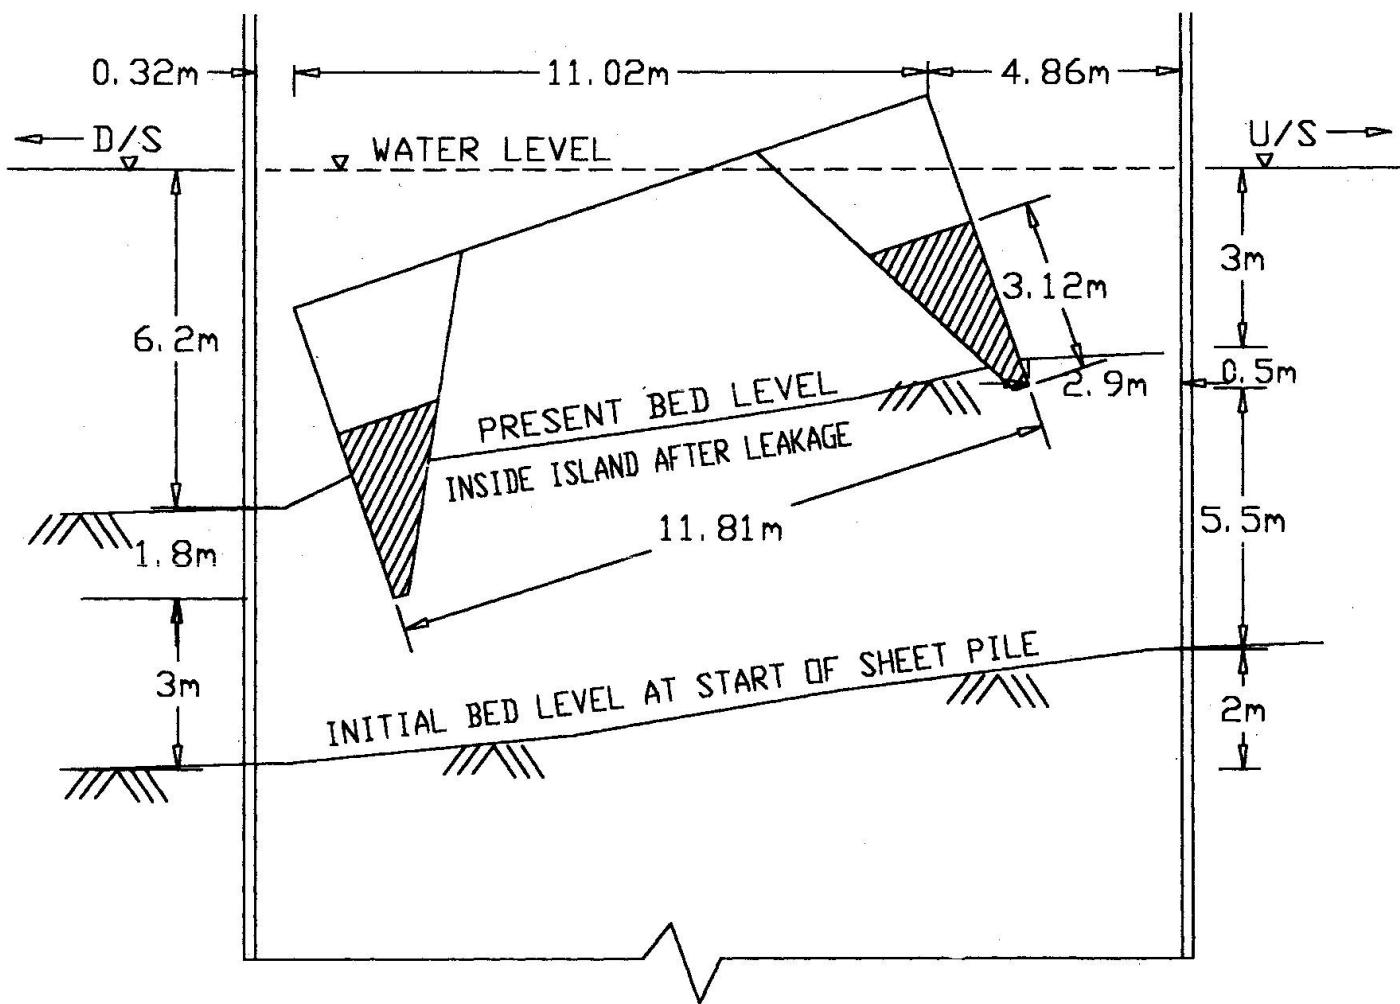
SKETCH 2

The location of this foundation was in the mid - stream of river Ganges. The diameter of well was 11.66 m with steining thickness as 3.1 m and curb was of height 5.54 m. The curb was proposed to be cast in two lifts of 3.12 m and 2.42 m respectivelty . Here also, the sheet pile island of 16 m dia was constructed at the location of well in a water depth of about 10m, for laying the well curb at its top. The concreting of first lift involving 180m³ of concrete was done in 2 days.

After about One and half hour of the concreting, leakage of sand from the island occured in the upstream side. As a result , the entire curb, after getting tilted towards upstream side, sunk nearly 4.50 m below the water level.

CASE STUDY 2 - REVIVAL OF SUBMERGED CURB

The tilt was corrected by performing the grabbing in between the curb and sheet pile island in the down stream side. After correcting the tilt as above under water, and making the curb vertical, another sheet pile island was made inside the earlier island at a gap of 0.75m. This gap was filled with clay and bags filled with clay. After filling the gap, the dewatering of island was done by means of 4 submersible pumps of 20 KW capacity to a level lower than the concrete level of curb. The shuttering was then erected and reinforcement fixed and immediately concreting of further steining was done. This operation of dewatering and

concreting was continued for nearly 24 hours to complete the concreting of second lift, which also brought the curb top above the water level. The whole process took one complete month. Details shown in the sketch - 2

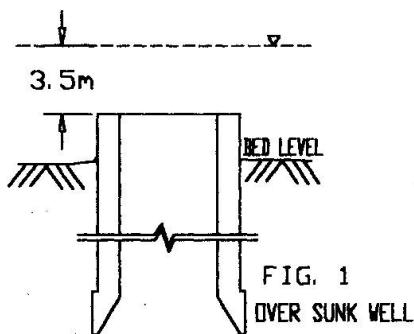
Some times, the well sink suddenly because of excessive grabing or sump or some weak soil layer and the steining of well, done upto that stage which is always kept above the water level by regulating the sinking and concreting operations, goes below the water level making it difficult to continue further work on steining.

In this case, a well foundation was being sunk in deep waters of River Ganges. The total height of steining except last 2.00 m was completed and the well was left to be sunk finally by about 7.5 m to reach its founding level. As the strata was of stiff clay in which the well was stuck up, chiselling and grabing operations were continued to make a sump of about 8 m below the cutting edge. This position of well remained for quite some time. Then one day the well sunk suddenly by 8.91 m, 1.43 m extra below the final founding level. Due to this extra sinking the top of steining also went below the water level by about 3.50 m. All this happened just before the monsoons when the water level started rising and work could not be continued. After the flood receded and water levels normalised, the work was resumed. It was found that the depth of water was 2.5 m. The well was in side the river bed and about 25m from bank. Sand embankment was made from the bank to extend and cover up the location of the well. A cutting edge of 2 m more dia than the dia of well was placed there and a cofferdam with 30 Cm steining thickness was made and got sunk to nearly 0.50 m below the top of the steining of the over sunk well. The concrete cofferdam was then dewatered and steining of the original well was exposed making it feasible to build up further steining to the required level. Details shown in sketch- 3.

FIG. 1
OVER SUNK WELL

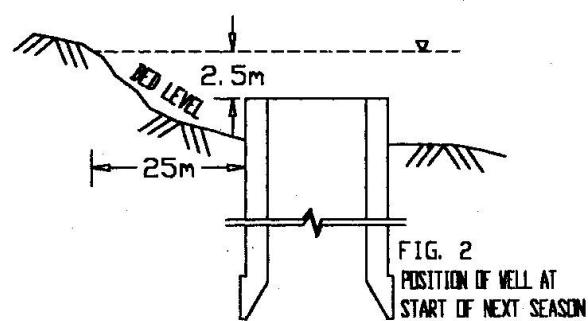
FIG. 2
POSITION OF WELL AT
START OF NEXT SEASON

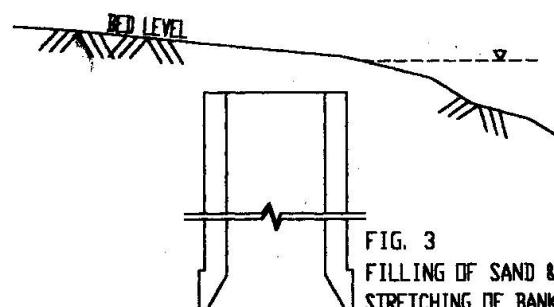
FIG. 3
FILLING OF SAND &
STRETCHING OF BANK

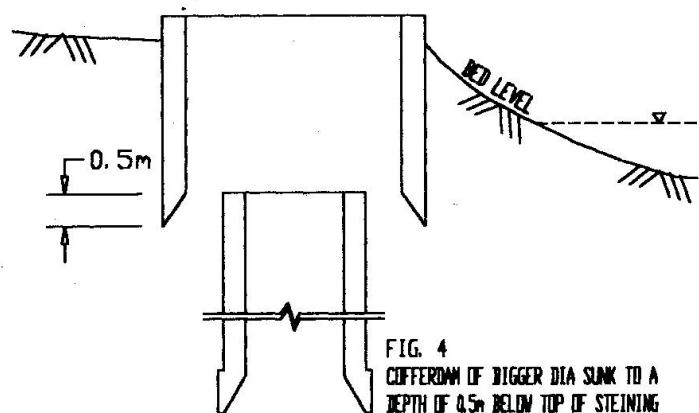
FIG. 4
COFFERDAM OF BIGGER DIA SUNK TO A
DEPTH OF 0.5m BELOW TOP OF STEINING

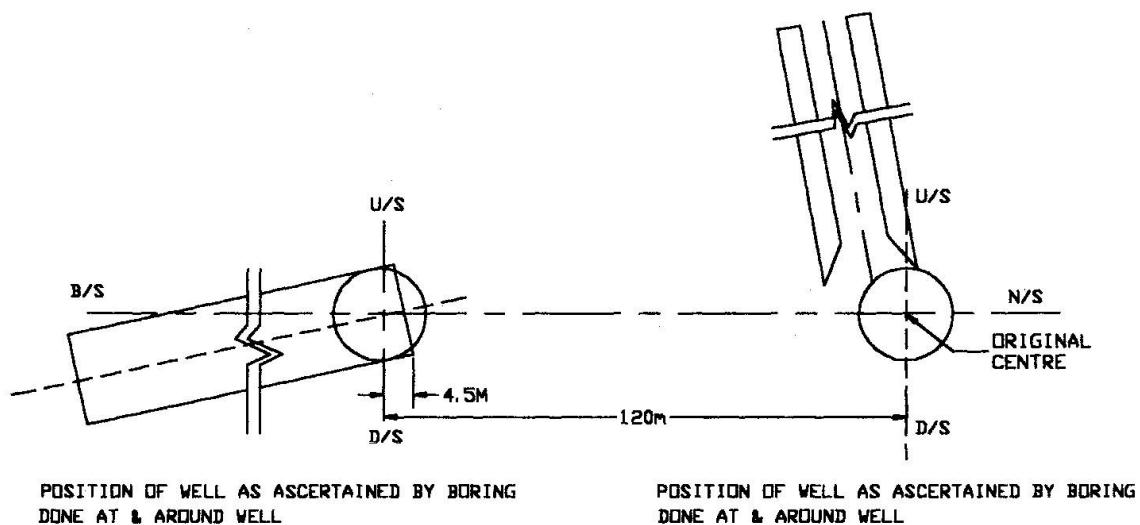
Two well foundations of a Bridge under construction over River Ganges were scoured below the cutting edge level during the floods and were carried with the flow and laid almost horizontally. The location of the well could not be traced as it was buried inside the scoured bed, later on silted. A number of methods were tried to locate the top of these well. When wells could neither be seen by naked eye nor could be located by various methods, i.e., weight dropping method, Echo sounding method and through divers after the water level receded, exploratory borings had to be done to trace out the position of the well foundations. This is shown in the sketch.

From the perusal of the data it was seen that at the time of floods these two wells were already sunk to a safer level as far as the normal design scour was concerned and the other wells sunk to this level the same time and in previous years stood well during the flood. Moreover, the design HFL was also not achieved (was about 1.5 m less) which left a 1.5 m margin of safety in the depth of foundation at that time. The detailed analysis of the foundations revealed that there was probably an unanticipated increase in the scouring of the bed of the River Ganges which resulted in excessive scouring, uniform sump and caused failure of the wells.

CASE STUDY 4 - SCOURING OF FOUNDATIONS DURING CONSTRUCTION

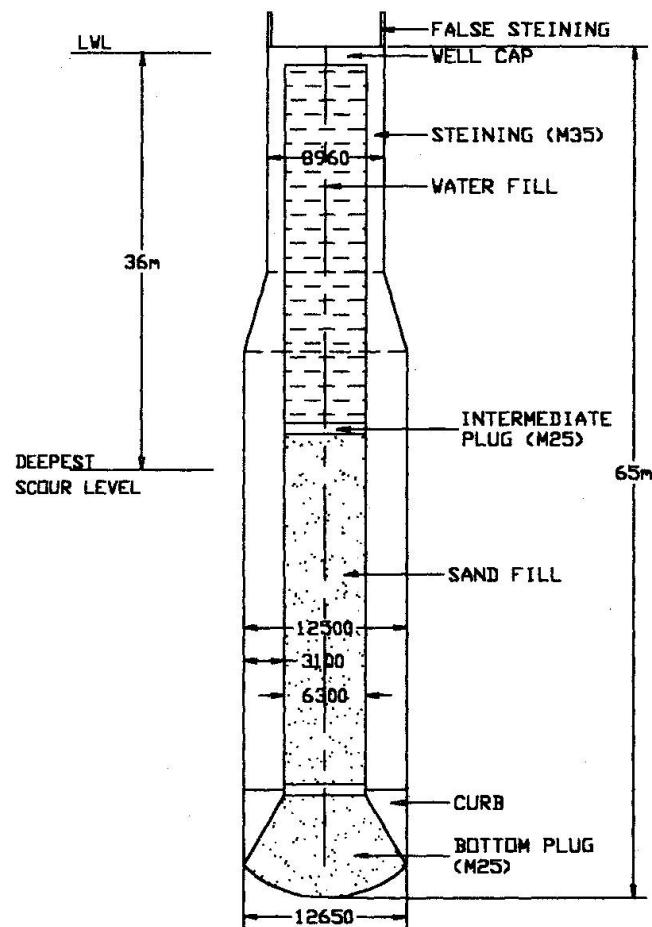
SKETCH 4

CASE STUDY 4 - TYPICAL CROSS SECTION OF PIER WELL

As the scoured wells were still obstructing the old foundation locations, the span arrangement had to be changed and two proposal were considered for laying the new well foundations.

Because of the change in flow conditions and excessive scouring in this zone, the depth of water was in the range of 17m to 22 m. For such deep depth of water alternative I which was the construction Technique adopted for other wells, was not feasible.

As such alternative II is to be used. This is the arrangement of fabricating steel curb and steining segment, lifting in vertical direction, shifting and placing the same on the barge and taking it to the location of the well foundation, lifting with steel gantry arrangements on the gantry barge, removing the caisson barge, lowering the steel caissons segment with the gantry arrangement and concreting of the same in such a way that it remains floating all the time due to its buoyancy effect till it touches the bed level of the river at the foundation location, sinking a little bit more as considered safe for laying another segment of steel caisson over it so that the bottom of steel caisson rests in the normal bed of the river and top of the last steel caisson segment remains above the water level such that the balanced steining of the caisson could be done directly by fixing shuttering.

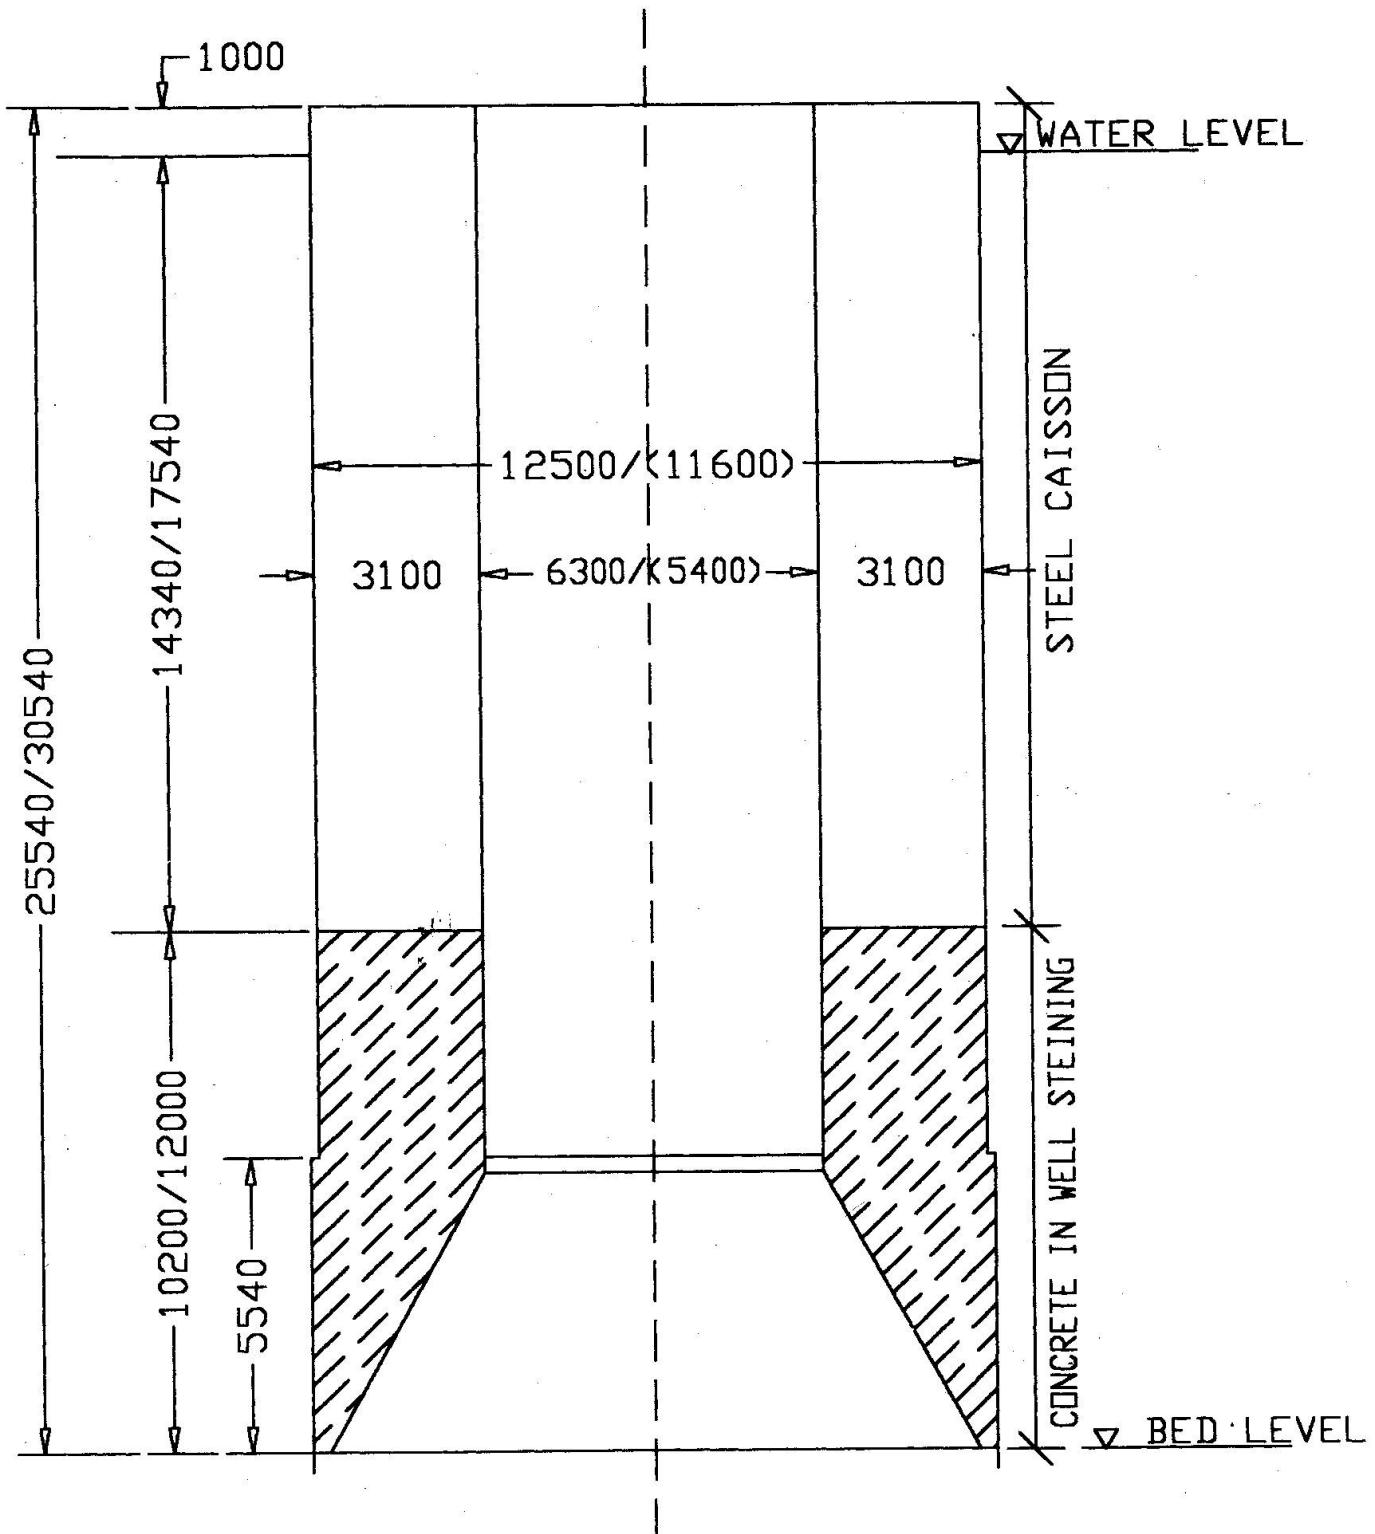
SKETCH 5

CASE STUDY 4 - LAST STAGE DURING GROUNDING OF CAISSON
