Foundation of Bridges on River Ganges in India

Vijay Kumar

U.P.State Bridge Corpn.

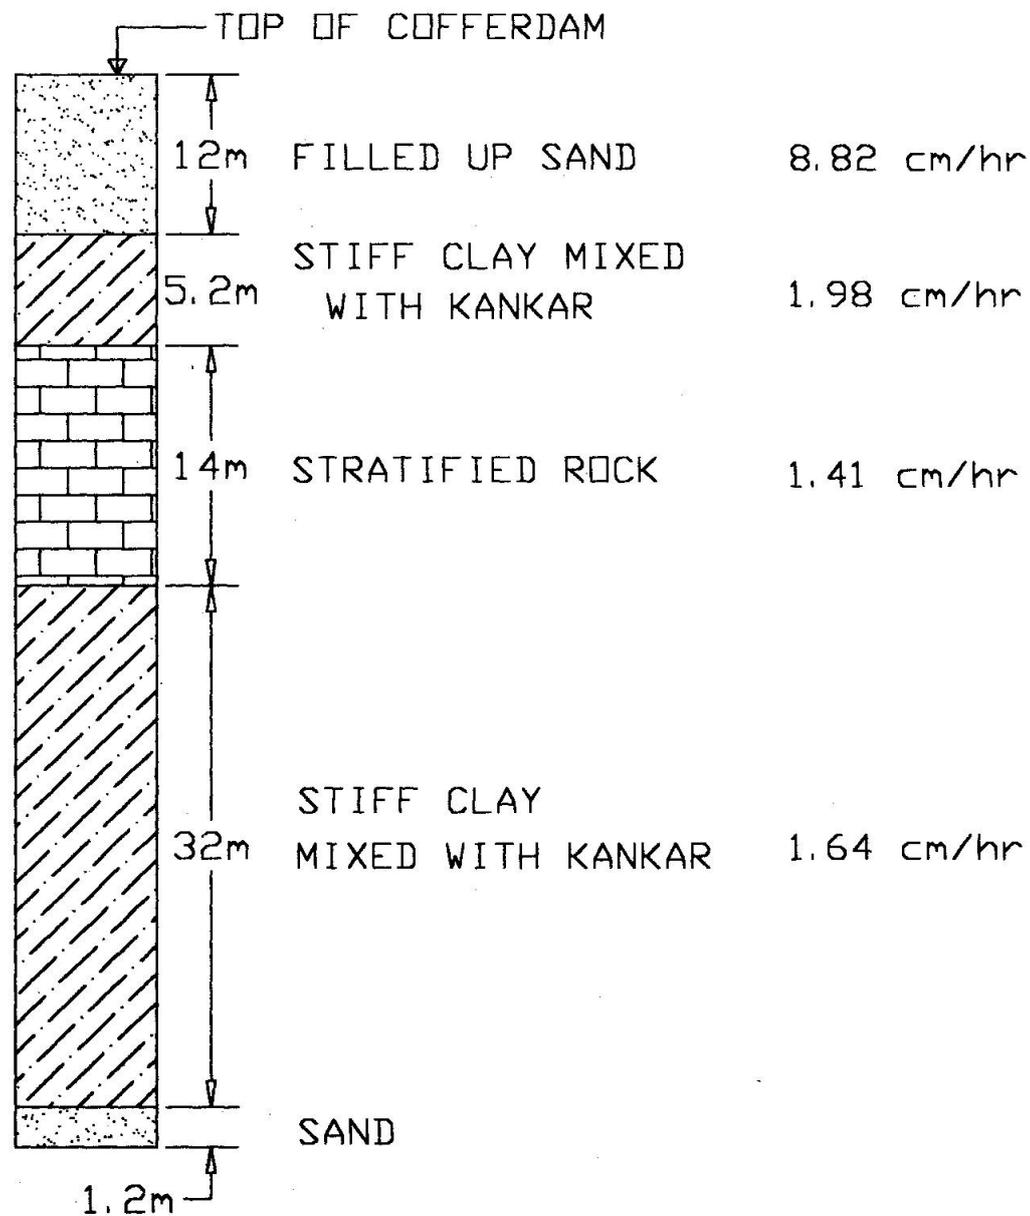
CASE STUDY 1 - DETAILS OF STRATA & RATE OF SINKINGSKETCH 1

The soil strata in general was sandy in the upper layers upto 25-30 m below bed followed by very hard and stiff clay layer, sometimes mixed with kankar. However, in the above location, there was hard clay all through with an intervening layer of hard stone in about 2 m depth. The work of this foundation was started in the month of March by making a 13 m high sheet pile island filled with sand. The curb was cast at the top of this island and sunk through this filled up sand. After the well reached the bed of the river it met with hard and stiff clay strata mixed with kankar. The river bed was slopy towards one side which resulted in tilting of the well. The well had to be loaded eccentrically against the direction of tilt with about 180 T load. The well was also tied by means of wire ropes with the next well which had already been completed earlier and bottom plugged. The sinking was done by chiselling and grabbing. The weight of the chisel used for this was 2.5 T.

The rate of sinking achieved in this layer was about 1.98 Cm/hr.

The clayey layer was followed by rocky strata at about 18 m below the bed. The well was loaded by concrete blocks of about 180 T and sinking was done by chiselling and grabbing operation.

The rate of sinking achieved in this layer was about 1.41 Cm/hr.

The hard and stiff clay layer which followed after this was dealt with by chiselling and grabbing as above but under loaded conditions with 250 T concrete block over the well. The dewatering of the well was also done to make sump of the required depth to facilitate sinking. The rate of sinking in this third layer was 1.64 cm/hr. The well was finally sunk to its founding level about 65 m below LWL in the sandy strata. The total crane hours for sinking were 3500 hrs.

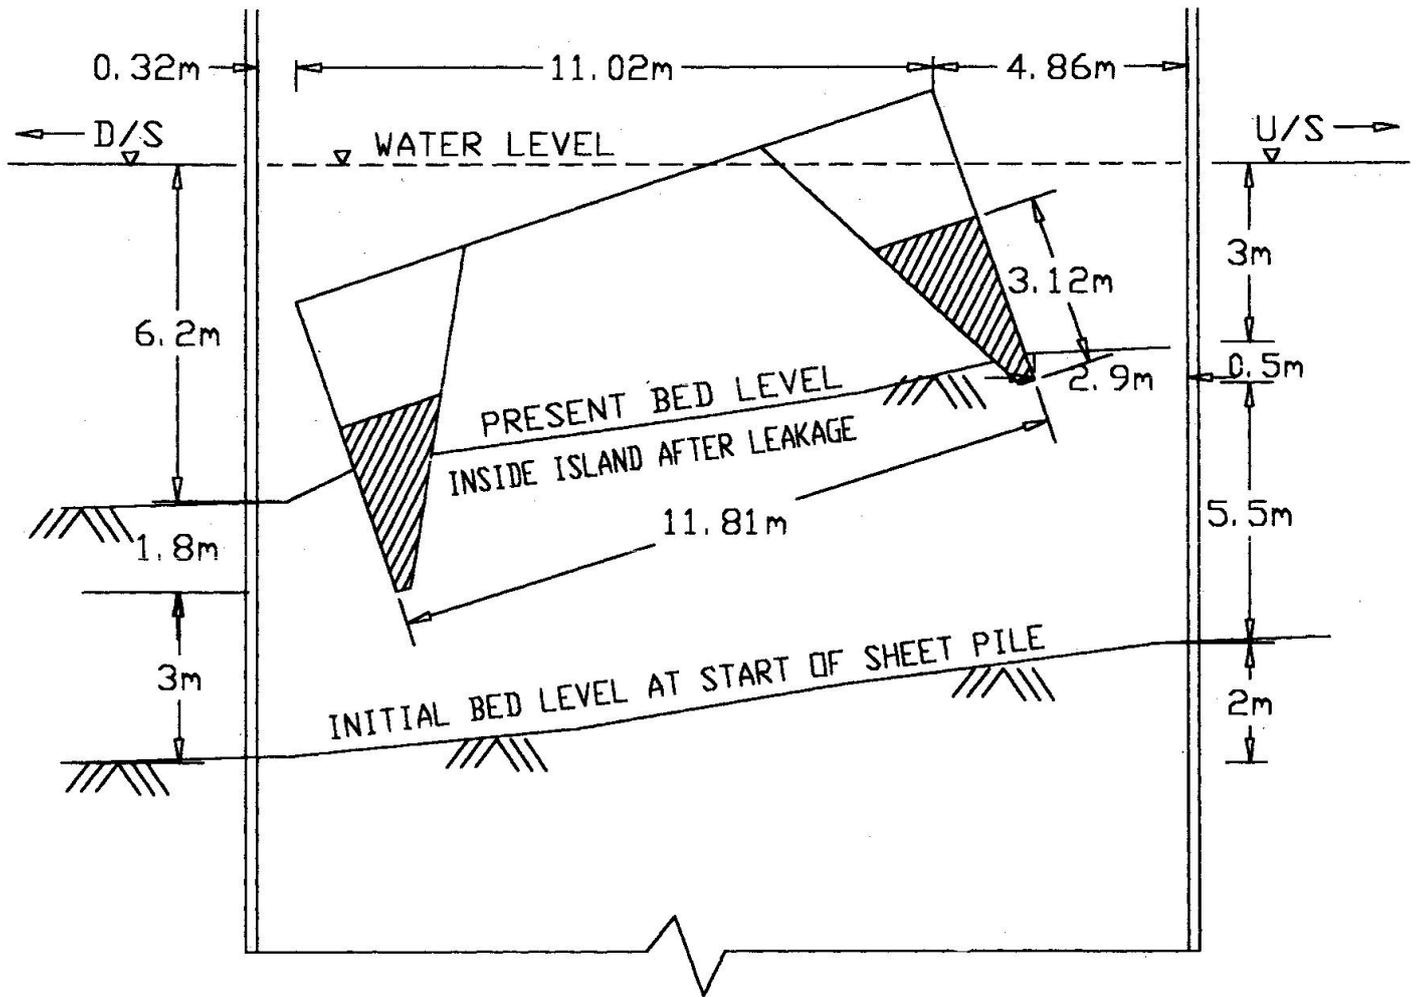
SKETCH 2

The location of this foundation was in the mid - stream of river Ganges. The diameter of well was 11.66 m with steining thickness as 3.1 m and curb was of height 5.54 m. The curb was proposed to be cast in two lifts of 3.12 m and 2.42 m respectively. Here also, the sheet pile island of 16 m dia was constructed at the location of well in a water depth of about 10m, for laying the well curb at its top. The concreting of first lift involving 180m³ of concrete was done in 2 days.

After about One and half hour of the concreting, leakage of sand from the island occurred in the upstream side. As a result, the entire curb, after getting tilted towards upstream side, sunk nearly 4.50 m below the water level.

The tilt was corrected by performing the grabbing in between the curb and sheet pile island in the down stream side. After correcting the tilt as above under water, and making the curb vertical, another sheet pile island was made inside the earlier island at a gap of 0.75m. This gap was filled with clay and bags filled with clay. After filling the gap, the dewatering of island was done by means of 4 submersible pumps of 20 KW capacity to a level lower than the concrete level of curb. The shuttering was then erected and reinforcement fixed and immediately concreting of further steining was done. This operation of dewatering and

concreting was continued for nearly 24 hours to complete the concreting of second lift, which also brought the curb top above the water level. The whole process took one complete month. Details shown in the sketch - 2

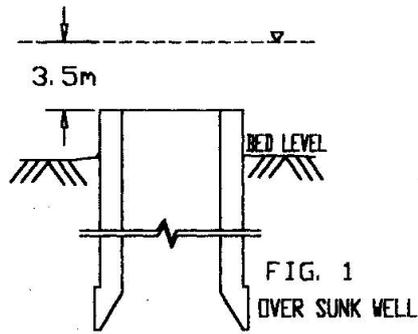
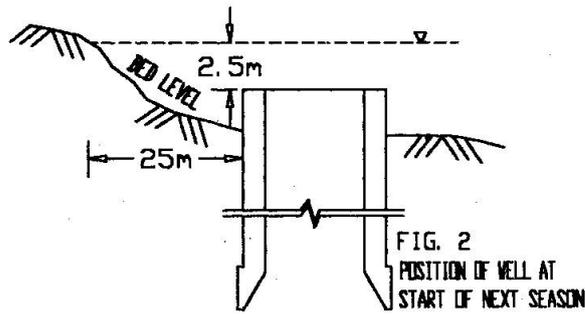
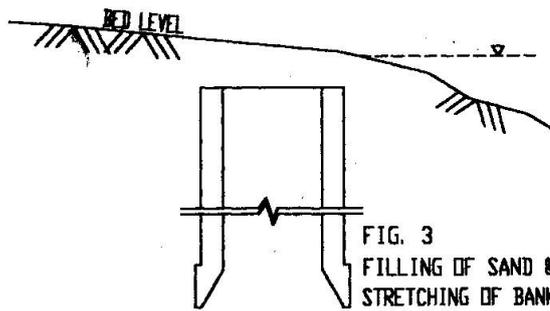
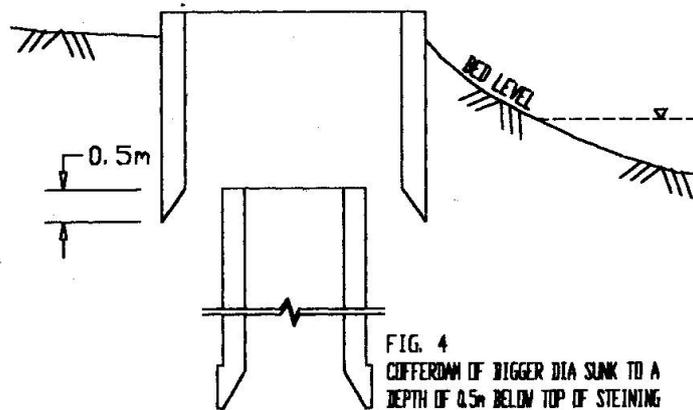
SKETCH 3

Some times, the well sink suddenly because of excessive grabing or sump or some weak soil layer and the steining of well, done upto that stage which is always kept above the water level by regulating the sinking and concreting operations, goes below the water level making it difficult to continue further work on steining.

In this case, a well foundation was being sunk in deep waters of River Ganges. The total height of steining except last 2.00 m was completed and the well was left to be sunk finally by about 7.5 m to reach its founding level. As the strata was of stiff clay in which the well was stuck up, chiselling and grabing operations were continued to make a sump of about 8 m below the cutting edge. This position of well remained for quite some time. Then one day the well sunk suddenly by 8.91 m, 1.43 m extra below the final founding level. Due to this extra sinking the top of steining also went below the water level by about 3.50 m. All this happened just before the monsoons when the water level started rising and work could not be continued. After the flood receded and water levels normalised, the work was resumed. It was found that the depth of water was 2.5 m. The well was in side the river bed and about 25m from bank. Sand embankment was made from the bank to extend and cover up the location of the well. A cutting edge of 2 m more dia than the dia of well was placed there and a cofferdam with 30 Cm steining thickness was made and got sunk to nearly 0.50 m below the top of the steining of the over sunk well. The concrete cofferdam was then dewatered and steining of the original well was exposed making it feasible to build up further steining to the required level. Details shown in sketch- 3.

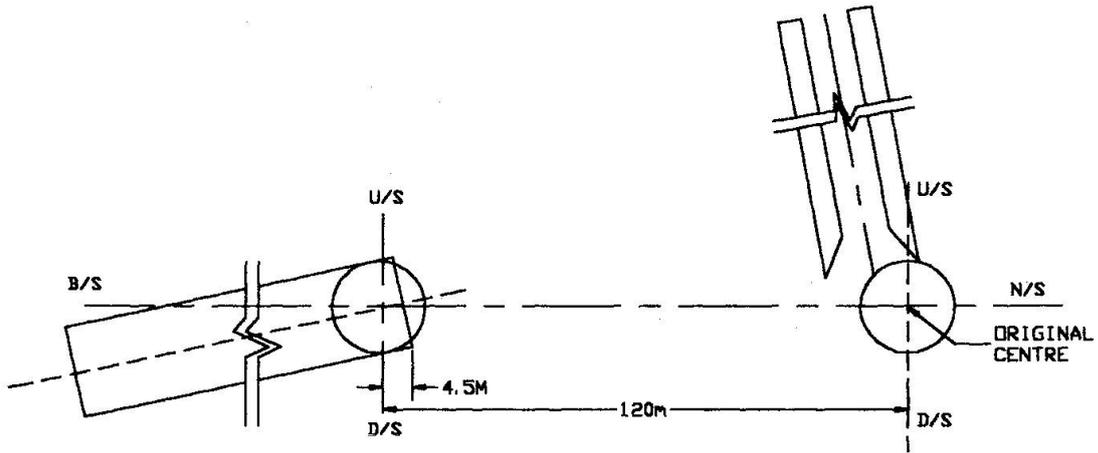
CASE STUDY 4 - SCOURING OF FOUNDATIONS DURING CONSTRUCTION

Two well foundations of a Bridge under construction over River Ganges were scoured below the cutting edge level during the floods and were carried with the flow and laid almost horizontally. The location of the well could not be traced as it was buried inside the scoured bed, later on silted. A number of methods were tried to locate the top of these well. When wells could neither be seen by naked eye nor could be located by various methods, (i.e., weight dropping method, Echo sounding method and through divers after the water level receded, exploratory borings had to be done to trace out the position of the well foundations. This is shown in the sketch.

From the perusal of the data it was seen that at the time of floods these two wells were already sunk to a safer level as far as the normal design scour was concerned and the other wells sunk to this level the same time and in previous years stood well during the floods. Moreover, the design HFL was also not achieved (was about 1.5 m less) which left a fair margin of safety in the depth of foundation at that time. The detailed account of the foundations revealed that there was probably an unforeseen scouring of the river bed along the length of the Bridge which resulted in excessive scour at uniform rate and also in some of the wells

POSITION OF WELL AS ASCERTAINED BY BORING DONE AT & AROUND WELL
