Foundation of bridges on river Ganges in India

Foundation of Bridges on River Ganges in India

Summary

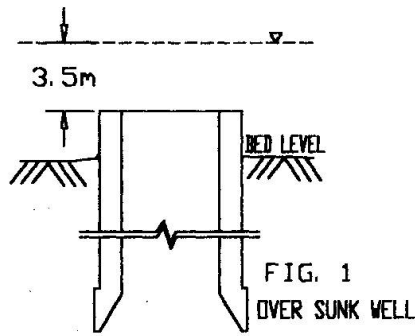
SKETCH 3

In this case, a well foundation was being sunk in deep waters of River Ganges. The total height of steining except last 2.00 m was completed and the well was left to be sunk finally by about 7.5 m to reach its founding level. As the strata was of stiff clay in which the well was stuck up, chiselling and grabing operations were continued to make a sump of about 8 m below the cutting edge. This position of well remained for quite some time. Then one day the well sunk suddenly by 8.91 m, 1.43 m extra below the final founding level. Due to this extra sinking the top of steining also went below the water level by about 3.50 m. All this happened just before the monsoons when the water level started rising and work could not be continued. After the flood receded and water levels normalised, the work was resumed. It was found that the depth of water was 2.5 m. The well was in side the river bed and about 25m from bank. Sand embankment was made from the bank to extend and cover up the location of the well. A cutting edge of 2 m more dia than the dia of well was placed there and a cofferdam with 30 Cm steining thickness was made and got sunk to nearly 0.50 m below the top of the steining of the over sunk well. The concrete cofferdam was then dewatered and steining of the original well was exposed making it feasible to build up further steining to the required level. Details shown in sketch- 3.

CASE STUDY 3 - REVIVAL OF OVERSUNK WELL

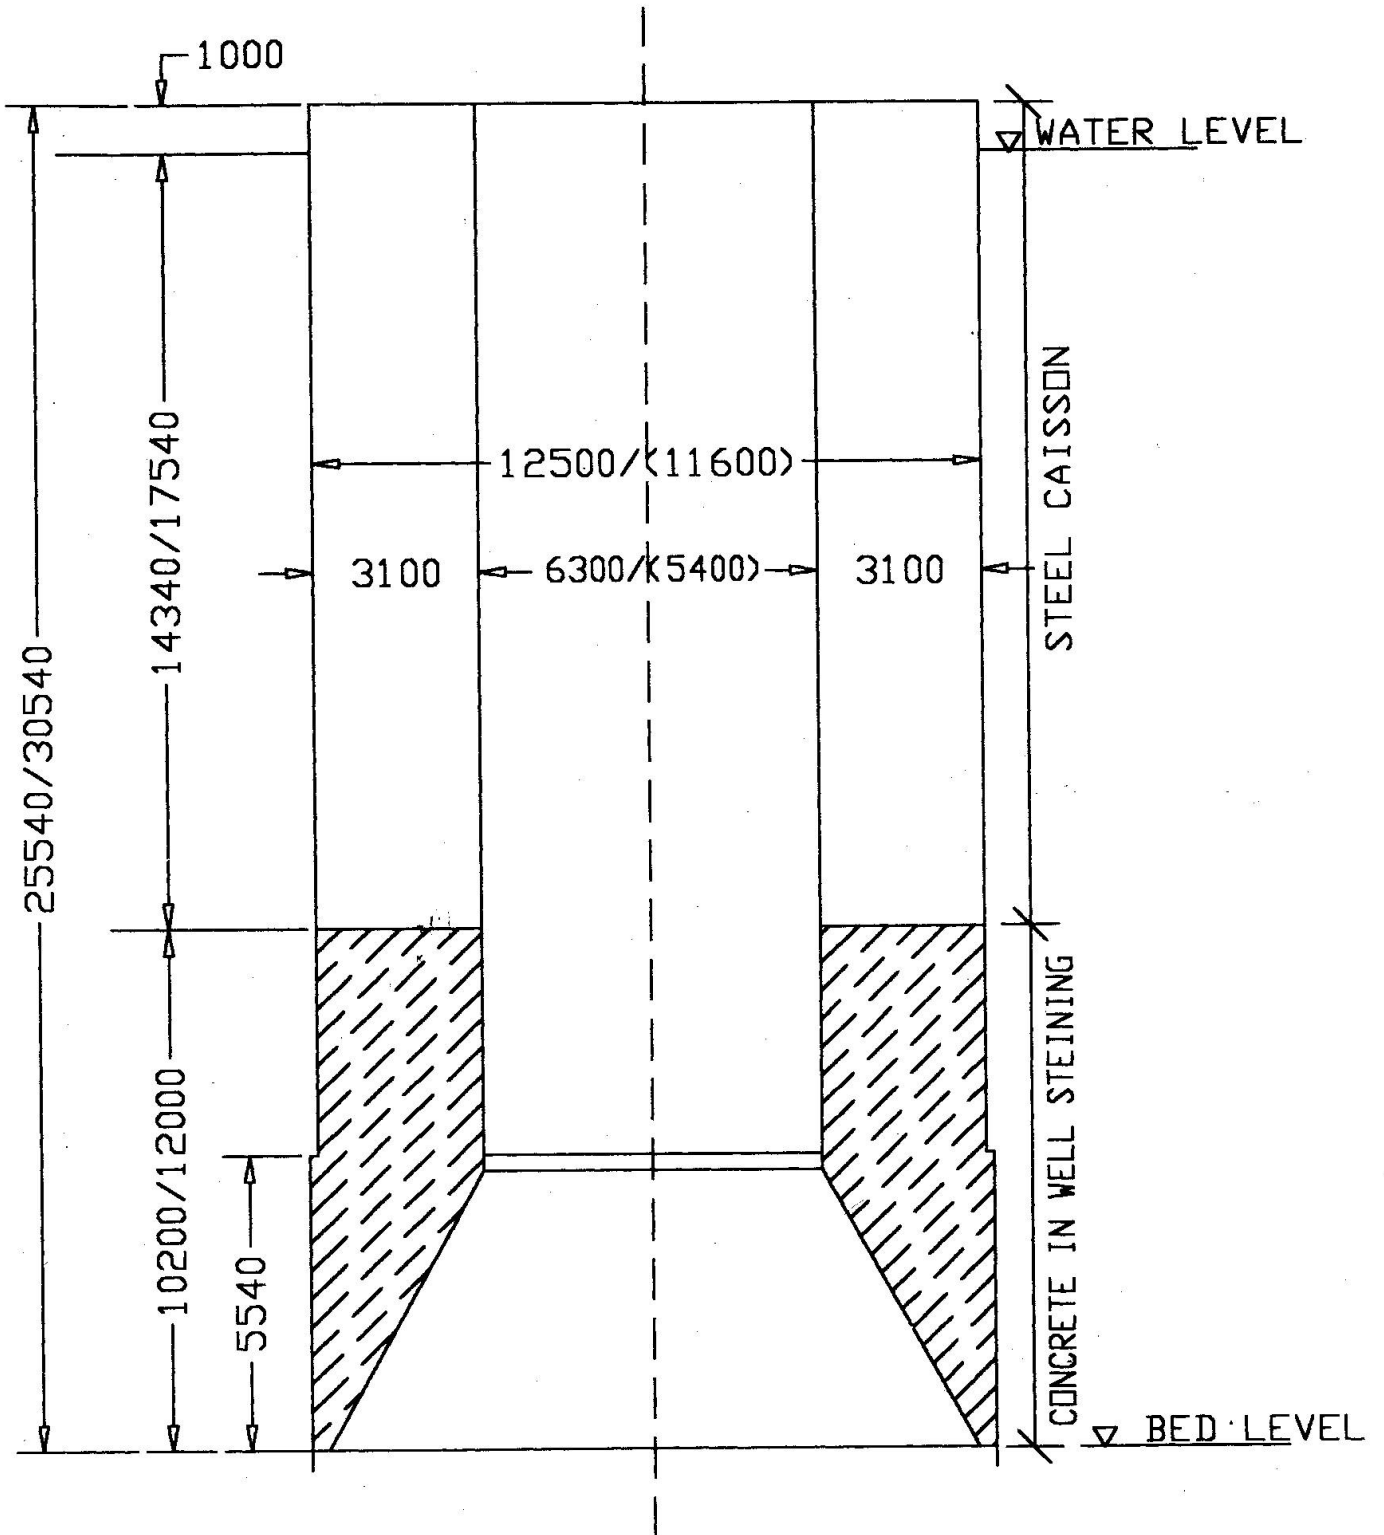
SKETCH 5

CASE STUDY 4 - LAST STAGE DURING GROUNDING OF CAISSON

As such alternative II is to be used. This is the arrangement of fabricating steel curb and steining segment, lifting in vertical direction, shifting and placing the same on the barge and taking it to the location of the well foundation, lifting with steel gantry arrangements on the gantry barge, removing the caisson barge, lowering the steel caissons segment with the gantry arrangement and concreting of the same in such a way that it remains floating all the time due to its buoyancy effect till it touches the bed level of the river at the foundation location, sinking a little bit more as considered safe for laying another segment of steel caisson over it so that the bottom of steel caisson rests in the normal bed of the river and top of the last steel caisson segment remains above the water level such that the balanced steining of the caisson could be done directly by fixing shuttering.
