CONSTRUCTION AND MAINTENANCE PROBLEMS OF KALIABHOMARA BRIDGE ACROSS RIVER BRAHMAPUTRA NEAR TEZPUR ON NH-37A

C.S.BALRAMAMURTHI
Chief Engineer, Ministry
of Surface Transport
(Roads Wing), New Delhi
India

SATISH KUMAR
Superintending Engineer
Ministry of Surface
Transport(Roads Wing)
New Delhi, India

The Kaliabhomara Road Bridge across Brahmaputra near Tezpur, Assam (India) has 24 main spans 120.00m and two shore spans 67.50m each. The span arrangement consists of Pre stressed Concrete balanced cantilever arms of 52.50m long on either side of piers with a central Reinforced Cement Concrete suspended span of 15.00m.

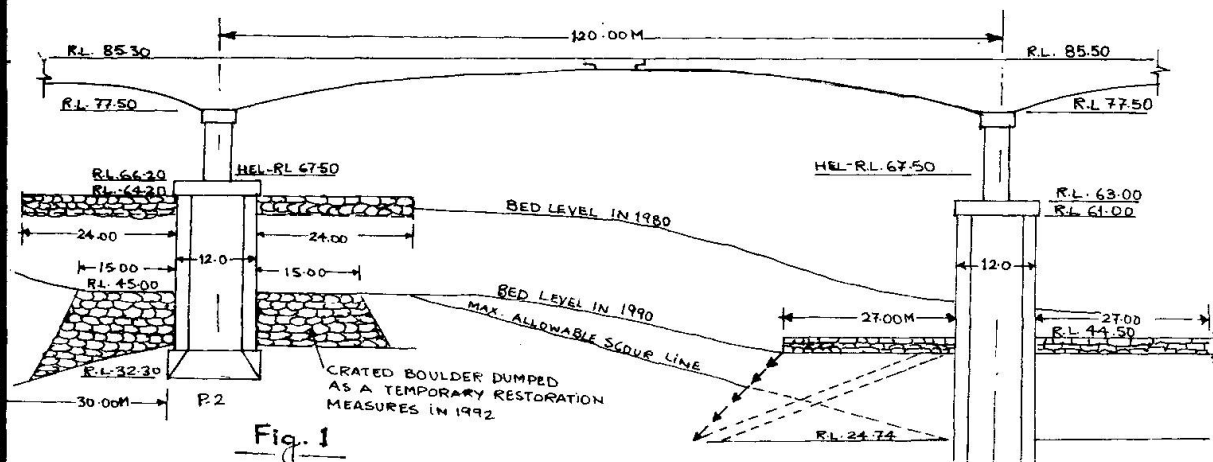
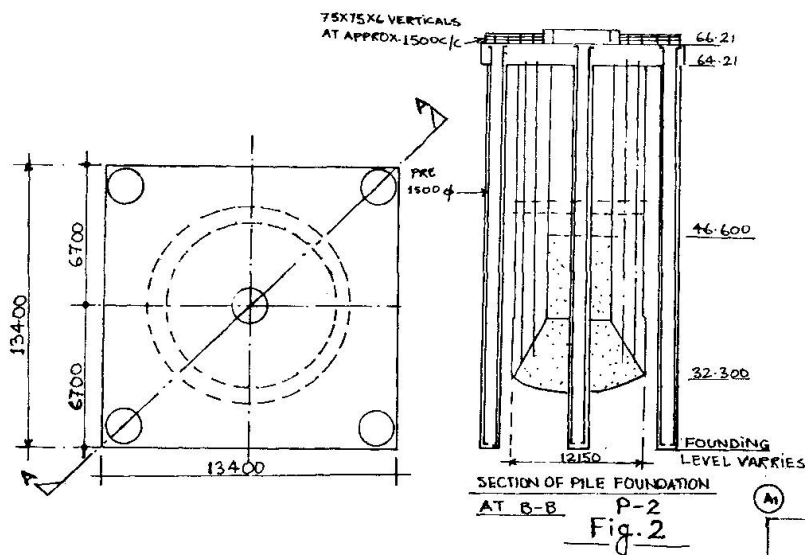
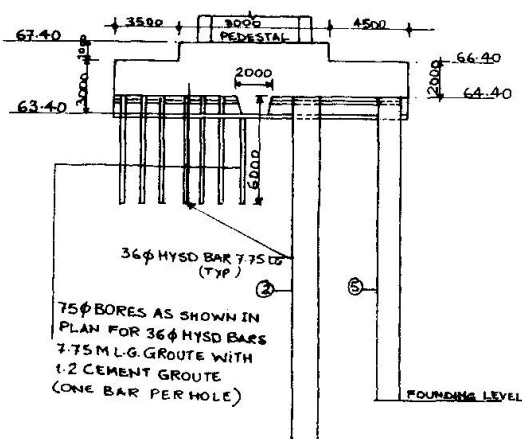
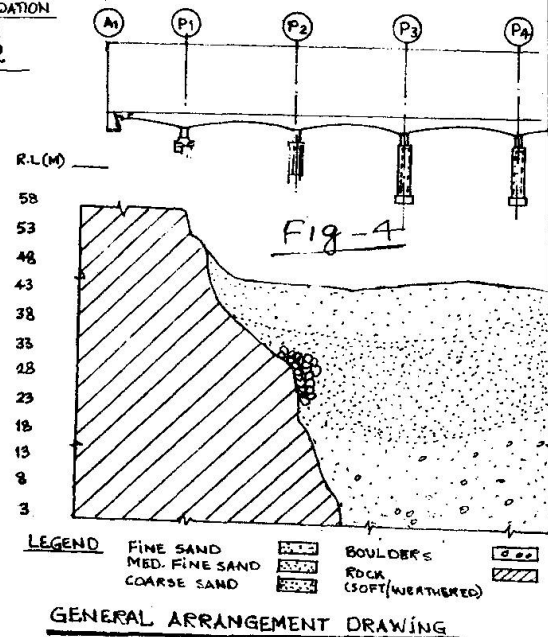
SKETCH SHOWING FOUNDATION LEVEL SCOUR LEVELS AND TENTATIVE PROTECTIVE MEASURES TO PIER WELLS P-2 AND P-3 OF KALIA BHOMARA BRIDGE ON NH-37-A

Sinking of well under Pier P2 was the first activity with which the work of Kaliabhomara Bridge commenced. It also so happened that it was the last foundation to be completed. As per preliminary sub-soil investigation report the strata for founding this well appeared to have dense sand. However after sinking for 25m deep upto RL 35.60m against the design founding level of RL 5.00m, the work slowed down as it encountered bouldery strata. For two seasons the work of removal of boulders continued and after removing 100 boulders the well reached a level of RL 32.08m. At this point the stability of the well was checked for scour considerations and it was established by the calculations that if the scour could be controlled at RL 45.00m the well will be safe. Secondly though the calculations proved that the well would be safe under normal conditions, under seismic effect there was tendency to develop tension.

The bridge work was taken up in December 1981 and completed in all respects by March 1987. When the bridge was under construction the river bed near pier P2 was dry. Later on during the floods of year 1991, the river started attacking the north bank and active channel developed near P2. The wire crated boulder garland was washed away and scour around this well extended up to RL 37.47.

During the year 1988 in the month of April and August a series of earthquakes in the region took place. A routine inspection of the bridge was carried out after the first earthquake on April 16-17/ 1988 when it was noticed that pier P3 showed a tendency of tilting towards south. Further routine inspections were continued and the following inferences were drawn: -

- 2) From the bore log for foundation of pier P3 it could be noted that the well was not seated on rock. The well is resting on 2-3m thick layer of pebbles/cobbles mixed with sand and therefore movement due to unevenness of bearing capacity could be possible.
- 3) It was possible that the repeated shaking due to the earthquakes could have triggered of the movement.
- 4) In Jan 1990 another earthquake took place when the number of shocks were seven. However this didn't cause any further movement. This showed that pier P3 appeared to have stabilized because of large passive resistance built up due to earlier movement in foundation.

To arrest scour at RL 45.00m it was decided to provide a boulder apron around the pier. This was feasible since the well was near the bank. The well was protected by providing 60.00m dia, 3.00m thick crated boulder garland packed under dry conditions prevailing at the time of construction of the bridge at the location of well under pier P2 (Figure 3). The top level of this garland was kept as RL 64.12 and it was decided that the performance of this garland should be closely monitored so that under no circumstances the scour be allowed to reach below the RL 45.00, the calculated maximum scour level for which the well was found to be safe. Regular probing is being done now to see if the level has gone below RL 45.00 in which case crated boulders are dumped to make up the level difference.

To solve the second difficulty of development of tension under seismic conditions, it was decided to provide 4 No. R.C.C. bored piles of 1.50m dia on the outer periphery outside the well and 1 No. similar pile in the middle though the dredge hole (Figure 2). Apart from this a combined well-pile cap, square in size was provided so as to act as a

Protection measures and replenishment of washed away boulders were carried out by dumping wire crated boulders and the top level of the garland was brought back to RL 45.00. A close monitoring of the top level of the garland up to RL 45.00 is being maintained by taking levels at regular intervals. This level has appeared to stabilize at RL 45.00.

- 1) The slab seals of the expansion joints are being replaced.
- 2) The pier P3 is kept under constant observation and as already mentioned in (d) in prepara no further tilt is noticed.
- 3) A garland of wire crated apron for a thickness of 2.50m has been provided with the top at RL 44.50m and for a diameter of 66m.
