**Artikel:** Construction and maintenance problems of Kallabhomara bridge across river Brahamputra near Tezpur on NH-37a  
**Autor:** Balramamurthy, C.S. / Kumar, Satish  
**DOI:** <https://doi.org/10.5169/seals-60788>

## CONSTRUCTION AND MAINTENANCE PROBLEMS OF KALIABHOMARA BRIDGE ACROSS RIVER BRAHMAPUTRA NEAR TEZPUR ON NH-37A

### **SUMMARY**

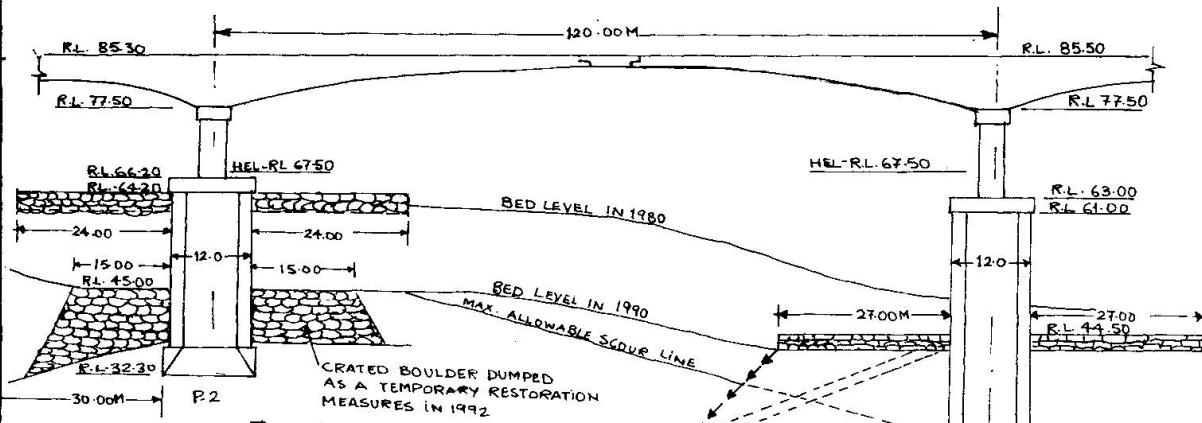
Fig. 1

Sinking of well under Pier P2 was the first activity with which the work of Kaliabhomara Bridge commenced. It also so happened that it was the last foundation to be completed. As per preliminary sub-soil investigation report the strata for founding this well appeared to have dense sand. However after sinking for 25m deep upto RL 35.60m against the design founding level of RL 5.00m, the work slowed down as it encountered bouldery strata. For two seasons the work of removal of boulders continued and after removing 100 boulders the well reached a level of RL 32.08m. At this point the stability of the well was checked for scour considerations and it was established by the calculations that if the scour could be controlled at RL 45.00m the well will be safe. Secondly though the calculations proved that the well would be safe under normal conditions, under seismic effect there was tendency to develop tension.

The bridge work was taken up in December 1981 and completed in all respects by March 1987. When the bridge was under construction the river bed near pier P2 was dry. Later on during the floods of year 1991, the river started attacking the north bank and active channel developed near P2. The wire crated boulder garland was washed away and scour around this well extended up to RL 37.47.

SKETCH SHOWING FOUNDATION LEVEL SCOUR LEVELS AND TENTATIVE  
PROTECTIVE MEASURES TO PIER WELLS P-2 AND P-3 OF KALIA BHOWMOK BRIDGE ON NH-37-A

To arrest scour at RL 45.00m it was decided to provide a boulder apron around the pier. This was feasible since the well was near the bank. The well was protected by providing 60.00m dia, 3.00m thick crated boulder garland packed under dry conditions prevailing at the time of construction of the bridge at the location of well under pier P2 (Figure 3). The top level of this garland was kept as RL 64.12 and it was decided that the performance of this garland should be closely monitored so that under no circumstances the scour be allowed to reach below the RL 45.00, the calculated maximum scour level for which the well was found to be safe. Regular probing is being done now to see if the level has gone below RL 45.00 in which case crated boulders are dumped to make up the level difference.

Protection measures and replenishment of washed away boulders were carried out by dumping wire crated boulders and the top level of the garland was brought back to RL 45.00. A close monitoring of the top level of the garland up to RL 45.00 is being maintained by taking levels at regular intervals. This level has appeared to stabilize at RL 45.00.

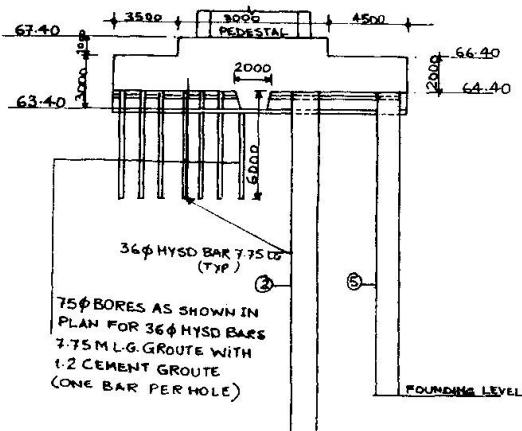
Fig. 3

During initial sub-soil investigations conducted in 1980 it was observed that the founding strata for pier well P1 would be on a dipping surface of rock. To overcome this the bridge was shifted by about 60m towards northwards. However when detailed boring was conducted at the shifted location of P1, it indicated the presence of a combination of hard

strata in northern half at a higher location and soft strata in southern half. On practical considerations, it was clear that it was not possible to provide a well foundation for shallow depth due to risk of tilting. Thus there was a design problem.

SECTIONAL ELEVATION AT A-A P-1

A separate design for pier P1 was carried out by providing a raft foundation for supporting the pier. The raft was designed in the following way: -

- 1) On the south side where the strata was soft, the raft was supported on 6 No. of bored piles of 1.50m dia.
- 2) On the north side where hard strata was found, the raft was anchored into the rock by means of 98 Nos. 36 mm dia HYSD rock anchors.

Further in the design it was assumed that the piles would not share any longitudinal force. However the rock anchors would share part of the longitudinal force. They were designed for 9 t of uplift force. Balance force was proposed to be taken care of by providing shear keys underneath the raft in the form of beams embedded in the strata below. For this purpose large size R.C.C. shear keys were provided in both directions under the pile cap (raft) by cutting trenches below soil in a grid pattern and casting beams which formed an integral part of the raft.
