Artikel: Construction and maintenance problems of Kallabhomara bridge across river Brahmaputra near Tezpur on NH-37a
Autor: Balramamurthy, C.S. / Kumar, Satish
DOI: <https://doi.org/10.5169/seals-60788>

CONSTRUCTION AND MAINTENANCE PROBLEMS OF KALIABHOMARA BRIDGE ACROSS RIVER BRAHMAPUTRA NEAR TEZPUR ON NH-37A

The Kaliabhomara Road Bridge across Brahmaputra near Tezpur, Assam (India) has 24 main spans 120.00m and two shore spans 67.50m each. The span arrangement consists of Pre stressed Concrete balanced cantilever arms of 52.50m long on either side of piers with a central Reinforced Cement Concrete suspended span of 15.00m.

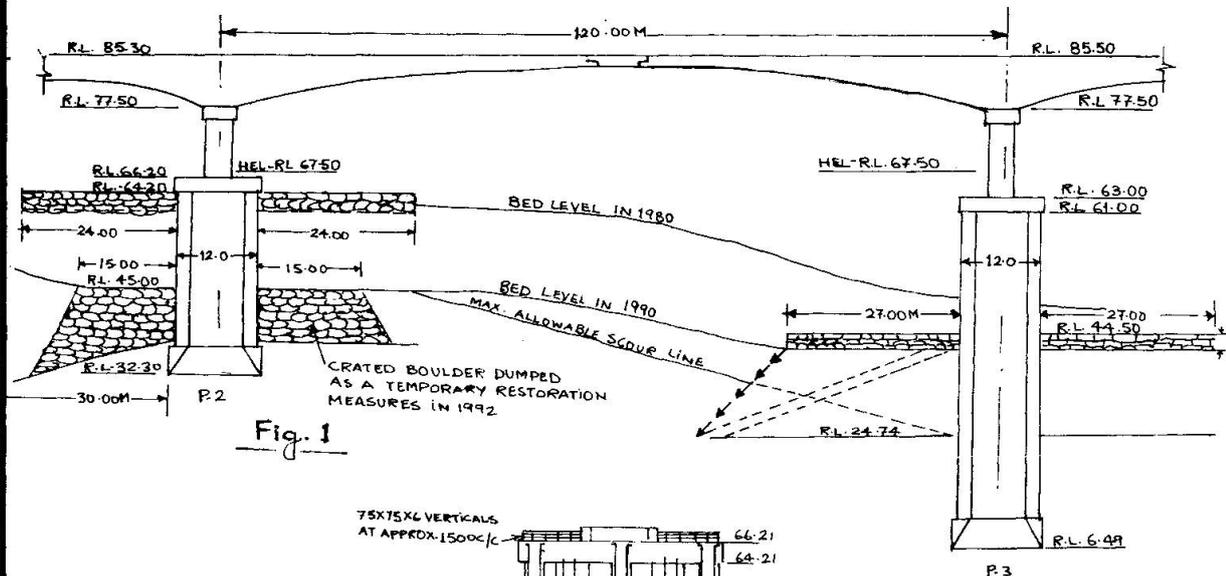
Fig. 1

The bridge work was taken up in December 1981 and completed in all respects by March 1987. When the bridge was under construction the river bed near pier P2 was dry. Later on during the floods of year 1991, the river started attacking the north bank and active channel developed near P2. The wire crated boulder garland was washed away and scour around this well extended up to RL 37.47.

During the year 1988 in the month of April and August a series of earthquakes in the region took place. A routine inspection of the bridge was carried out after the first earthquake on April 16-17/ 1988 when it was noticed that pier P3 showed a tendency of tilting towards south. Further routine inspections were continued and the following inferences were drawn: -

SKETCH SHOWING FOUNDATION LEVEL SCOUR LEVELS AND TENTATIVE PROTECTIVE MEASURES TO PIER WELLS P-2 AND P-3 OF KALIA BHOMARA BRIDGE ON NH-37-A

To arrest scour at RL 45.00m it was decided to provide a boulder apron around the pier. This was feasible since the well was near the bank. The well was protected by providing 60.00m dia, 3.00m thick crated boulder garland packed under dry conditions prevailing at the time of construction of the bridge at the location of well under pier P2 (Figure 3). The top level of this garland was kept as RL 64.12 and it was decided that the performance of this garland should be closely monitored so that under no circumstances the scour be allowed to reach below the RL 45.00, the calculated maximum scour level for which the well was found to be safe. Regular probing is being done now to see if the level has gone below RL 45.00 in which case crated boulders are dumped to make up the level difference.

Protection measures and replenishment of washed away boulders were carried out by dumping wire crated boulders and the top level of the garland was brought back to RL 45.00. A close monitoring of the top level of the garland up to RL 45.00 is being maintained by taking levels at regular intervals. This level has appeared to stabilize at RL 45.00.

- 1) The slab seals of the expansion joints are being replaced.
- 2) The pier P3 is kept under constant observation and as already mentioned in (d) in prepara no further tilt is noticed.
- 3) A garland of wire crated apron for a thickness of 2.50m has been provided with the top at RL 44.50m and for a diameter of 66m.

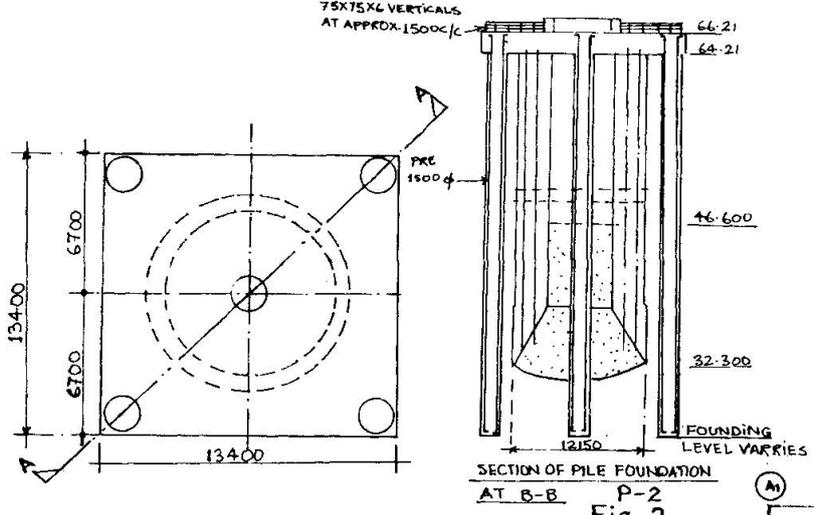
SECTION OF PILE FOUNDATION AT B-B P-2 Fig. 2

Sinking of well under Pier P2 was the first activity with which the work of Kaliabhomara Bridge commenced. It also so happened that it was the last foundation to be completed. As per preliminary sub-soil investigation report the strata for founding this well appeared to have dense sand. However after sinking for 25m deep upto RL 35.60m against the design founding level of RL 5.00m, the work slowed down as it encountered bouldery strata. For two seasons the work of removal of boulders continued and after removing 100 boulders the well reached a level of RL 32.08m. At this point the stability of the well was checked for scour considerations and it was established by the calculations that if the scour could be controlled at RL 45.00m the well will be safe. Secondly though the calculations proved that the well would be safe under normal conditions, under seismic effect there was tendency to develop tension.

To solve the second difficulty of development of tension under seismic conditions, it was decided to provide 4 No.R.C.C.bored piles of 1.50m dia on the outer periphery outside the well and 1 No. similar pile in the middle though the dredge hole (Figure 2). Apart from this a combined well-pile cap, square in size was provided so as to act as a

composite unit. This was based on the analogy of stays for a tower. The piles however had to be terminated at different levels due to the rock sloping steeply towards the riverside. The central pile has been taken to RL 24.00m and other piles to levels varying from RL 29.00 TO RL 32.00m. Thus the piles take care of the tensile (uplift) forces under seismic condition and ensure stability of the foundation as a whole. The above solution was preferred since the other alternative of anchoring well by inserting anchor rods through well steining or driving piles through the bottom plug was not considered satisfactory due to bouldery strata.

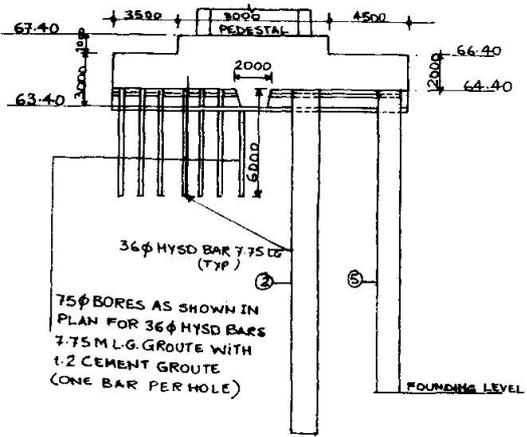
SECTIONAL ELEVATION AT A-A P-1 Fig. 3

During initial sub-soil investigations conducted in 1980 it was observed that the founding strata for pier well P1 would be on a dipping surface of rock. To overcome this the bridge was shifted by about 60m towards northwards. However when detailed boring was conducted at the shifted location of P1, it indicated the presence of a combination of hard

strata in northern half at a higher location and soft strata in southern half. On practical considerations, it was clear that it was not possible to provide a well foundation for shallow depth due to risk of tilting. Thus there was a design problem.

A separate design for pier P1 was carried out by providing a raft foundation for supporting the pier. The raft was designed in the following way: -

- 1) On the south side where the strata was soft, the raft was supported on 6 No. of bored piles of 1.50m dia.
- 2) On the north side where hard strata was found, the raft was anchored into the rock by means of 98 Nos.36 mm dia HYSD rock anchors.

Further in the design it was assumed that the piles would not share any longitudinal force. However the rock anchors would share part of the longitudinal force. They were designed for 9 t of uplift force. Balance force was proposed to be taken care of by providing shear keys underneath the raft in the form of beams embedded in the strata below. For this purpose large size R.C.C. shear keys were provided in both directions under the pile cap (raft) by cutting trenches below soil in a grid pattern and casting beams which formed an integral part of the raft.
