Zeitschrift: IABSE reports = Rapports AIPC = IVBH Berichte

Rehabilitation of the Luangwa Bridge

Abstract

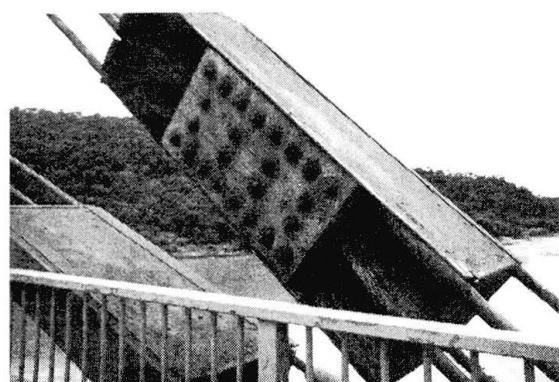
Fig. 1 Cable Clamps

- Shortening of stays by applying clamps to improve the vertical alignment of the bridge
- Mounting inside the bridge girder of horizontal compression steel tubes near the towers and horizontal tension cables near the middle of the bridge
- Replacement of failed friction grip bolts in the main steel boxes of the bridge girder.

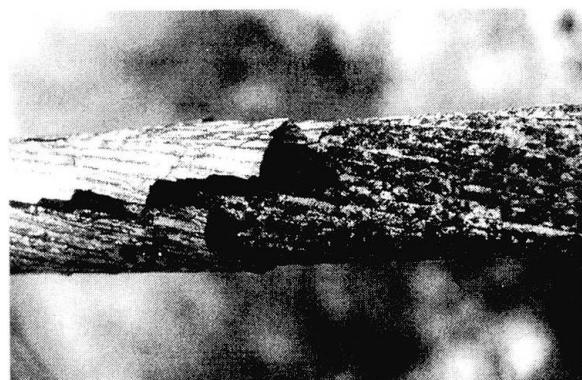
Fig. 2 Severe pitting of cables

Severe pitting corrosion was found on the cable stays. The painting of the cable stays was cracked and there was virtually no adhesion to the cable surface any more.

A rehabilitation of the bridge was carried out in 1997 to strengthen the bridge and enhance its load bearing capacity. The rehabilitation included replacement of all cables and strengthening of the bridge girder. Construction work had to be completed within a time slot between two rainy seasons, which represented a serious constraint on the project.
