**Artikel:** Rehabilitation of the Luangwa Bridge  
**Autor:** Reinholdt, Peter / Veje, Ejgil / Kalvslund, Jimmy  
**DOI:** <https://doi.org/10.5169/seals-62169>

## Rehabilitation of the Luangwa Bridge

### Abstract

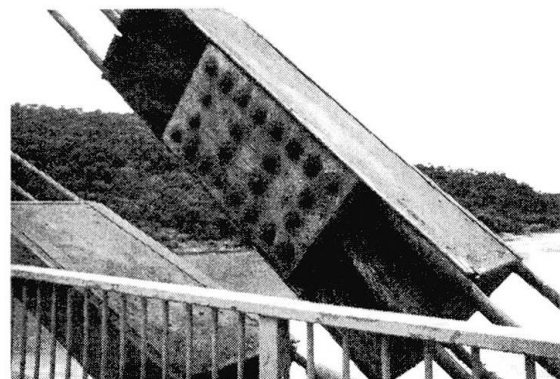
Shortly after the opening of the bridge it became evident that it was not behaving as intended. The traffic on the bridge was then restricted to the crossing of one vehicle at a time travelling with a maximum speed of 15 km/h with a maximum gross weight of 50 tonnes.

*Fig. 1 Cable Clamps*

In spite of the remedial works carried out in 1972-73 with the intention of rectifying the longitudinal profile there was still a considerable sag in the main span.

- Shortening of stays by applying clamps to improve the vertical alignment of the bridge
- Mounting inside the bridge girder of horizontal compression steel tubes near the towers and horizontal tension cables near the middle of the bridge
- Replacement of failed friction grip bolts in the main steel boxes of the bridge girder.

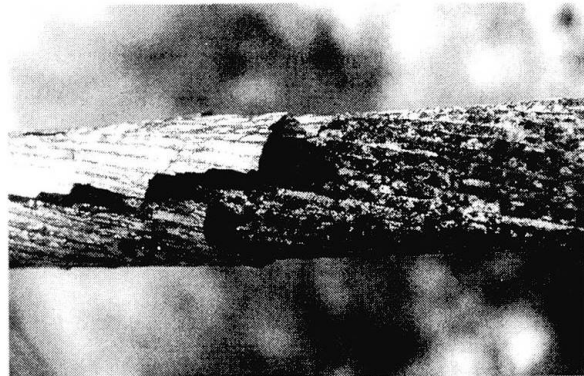
Severe pitting corrosion was found on the cable stays. The painting of the cable stays was cracked and there was virtually no adhesion to the cable surface any more.

*Fig. 2 Severe pitting of cables*

A rehabilitation of the bridge was carried out in 1997 to strengthen the bridge and enhance its load bearing capacity. The rehabilitation included replacement of all cables and strengthening of the bridge girder. Construction work had to be completed within a time slot between two rainy seasons, which represented a serious constraint on the project.
