Artikel: Emergency rehabilitation of the Zárate-Brazo Largo Bridges, Argentina
Autor: Andersen, Henrik / Hommel, Dietrich L. / Veje, Ejgil M.
DOI: <https://doi.org/10.5169/seals-62172>

Emergency Rehabilitation of the Zárate-Brazo Largo Bridges, Argentina

In November 1996 a cable ruptured on the Guazú Bridge across the Paraná River in Argentina, one of the two almost identical Zárate-Brazo Largo Bridges. COWI was immediately after retained as consultant by the bridge owner Dirección Nacional de Vialidad in order to ensure and document the safety of the bridges and to investigate the causes of the cable failure.

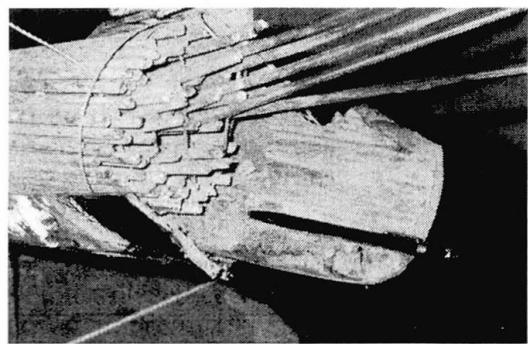
The evaluations revealed that a combination of corrosion and fatigue damage caused the failure of one cable, see Fig. 2, and large damages to a number of other cables. The corrosion was due to insufficient performance of the corrosion protection of the original cables. The cement grout, which was supposed to be the main active corrosion protection, was insufficient in the anchorage zone due to the presence of a non-protecting epoxy tar.

The fatigue damage has been severe due to larger traffic loads than accounted for in the original design, but not least due to large amplitude cable vibrations.

These amplitudes of the vibrations have been in the order of up to 1 m, which theoretically causes stress ranges well above the endurance limit of the wires. The corrosion has furthermore increased the fatigue stresses locally due to stress concentration.

Fig. 2 Ruptured cable

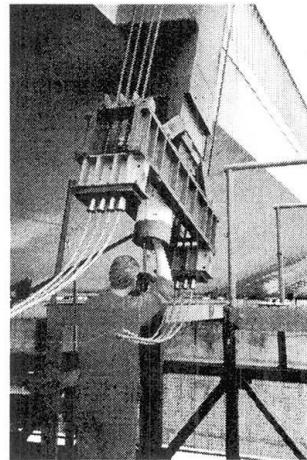
*Fig. 3 Ultrasonic inspection of original cable.
Temporary strengthening also shown.*

The present condition of the cables were investigated through ultrasonic inspection as shown in Fig. 3. The investigations revealed that a number of cables were deteriorated with up to 62% damage of the original cable cross section. The material properties of the wires were established from tensile and fatigue tests carried out on specimens from the cables replaced first. The tests revealed that the tensile strength of the tested wires were below the original design values and that severe fatigue damage had taken place. The wires did no longer have an endurance limit.

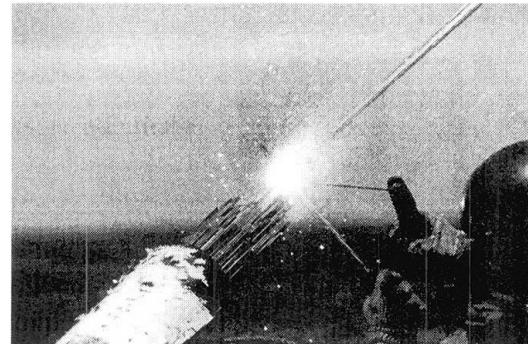
Fig. 4 Removal of existing cable by cutting of individual wires

A total of 13 cables were replaced during the emergency rehabilitation. The existing cables have been removed by cutting of the individual wires as seen in Fig. 4. It has been recommended to provide temporary wind ropes between the cables in order to limit the large amplitude cable vibrations. Furthermore, installation of guide deviators has been recommended in order to reduce the bending stresses in the anchorage zone.
