Artikel: Emergency rehabilitation of the Zárate-Brazo Largo Bridges, Argentina
Autor: Andersen, Henrik / Hommel, Dietrich L. / Veje, Ejgil M.
DOI: <https://doi.org/10.5169/seals-62172>

Emergency Rehabilitation of the Zárate-Brazo Largo Bridges, Argentina

In November 1996 a cable ruptured on the Guazú Bridge across the Paraná River in Argentina, one of the two almost identical Zárate-Brazo Largo Bridges. COWI was immediately after retained as consultant by the bridge owner Dirección Nacional de Vialidad in order to ensure and document the safety of the bridges and to investigate the causes of the cable failure.

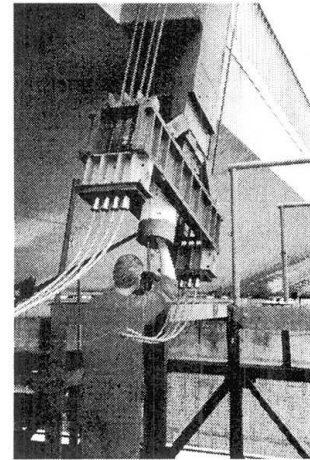
Fig. 3 Ultrasonic inspection of original cable. Temporary strengthening also shown.

The present condition of the cables were investigated through ultrasonic inspection as shown in Fig. 3. The investigations revealed that a number of cables were deteriorated with up to 62% damage of the original cable cross section. The material properties of the wires were established from tensile and fatigue tests carried out on specimens from the cables replaced first. The tests revealed that the tensile strength of the tested wires were below the original design values and that severe fatigue damage had taken place. The wires did no longer have an endurance limit.

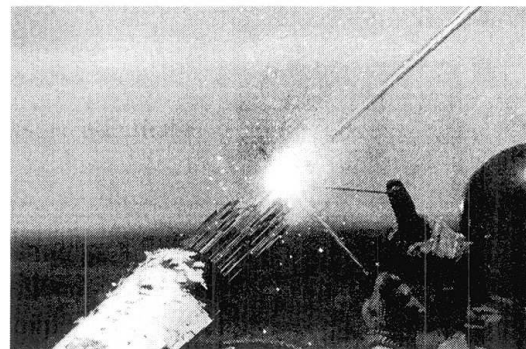
Fig. 4 Removal of existing cable by cutting of individual wires

A total of 13 cables were replaced during the emergency rehabilitation. The existing cables have been removed by cutting of the individual wires as seen in Fig. 4. It has been recommended to provide temporary wind ropes between the cables in order to limit the large amplitude cable vibrations. Furthermore, installation of guide deviators has been recommended in order to reduce the bending stresses in the anchorage zone.
