Repairing to Extend the Lifespan: the Multi - Strategy Criteria

The paper aims to describe the story of the “APS Terminal Petroleiro Access Viaduct”, located at Sines, south of Portugal, some ten metres distant from sea, a prestressed reinforced concrete structure with a very low thickness of concrete cover that has been exposed, since its construction, to a heavily aggressive marine environment.

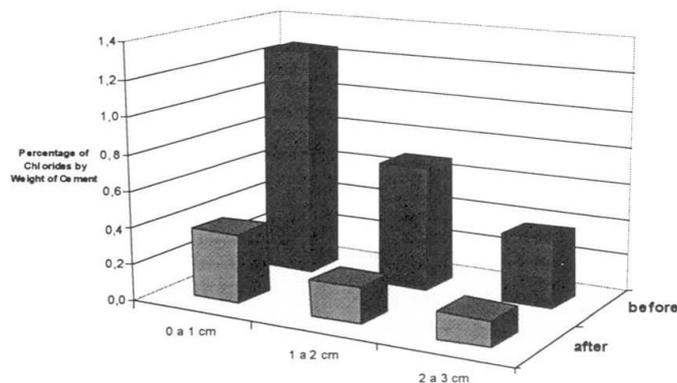
About once in a week, the structure's concrete is sampled for the determination of the chloride content and to support the decision of concluding the treatment, if the required level (less than 0,3 % of the cement weight) is achieved. Now, desalination is in progress and the removal of chlorides has already been successfully performed on 1400 m_2 . Values of about 0,2 % of cement weight were obtained at reinforcements, against the initial values of about 0,6 % (see figure below).
