Repairing to Extend the Lifespan: the Multi – Strategy Criteria

The paper aims to describe the story of the “APS Terminal Petroleiro Access Viaduct”, located at Sines, south of Portugal, some ten metres distant from sea, a prestressed reinforced concrete structure with a very low thickness of concrete cover that has been exposed, since its construction, to a heavily aggressive marine environment.

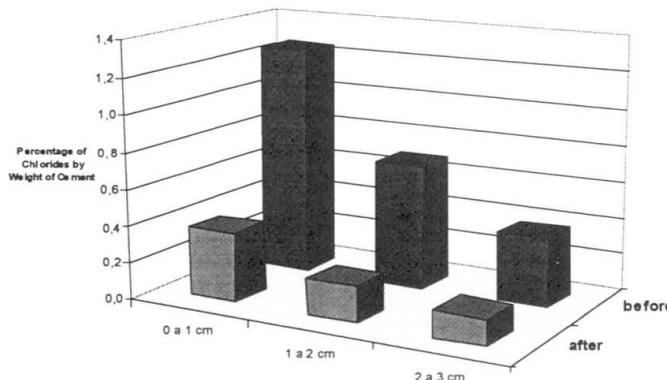
About once in a week, the structure's concrete is sampled for the determination of the chloride content and to support the decision of concluding the treatment, if the required level (less than 0,3 % of the cement weight) is achieved. Now, desalination is in progress and the removal of chlorides has already been successfully performed on 1400 m². Values of about 0,2 % of cement weight were obtained at reinforcements, against the initial values of about 0,6 % (see figure below).

Desalination of concrete is an electrochemical treatment intended to stop and avoid corrosion of steel in reinforced concrete when it is contaminated by chlorides and to reduce the chloride content to permissible values by applying an electric field (a current with a density nearly equal to 1 A/m²) between the concrete reinforcement and an external anodic system, a titanium mesh fastened to the structure by insulating nails in plastic material and coated through projection of cellulose fibres, forming the electrolyte as the fibres are kept damp.
