Repairing to Extend the Lifespan: the Multi – Strategy Criteria

The paper aims to describe the story of the “APS Terminal Petroleiro Access Viaduct”, located at Sines, south of Portugal, some ten metres distant from sea, a prestressed reinforced concrete structure with a very low thickness of concrete cover that has been exposed, since its construction, to a heavily aggressive marine environment.

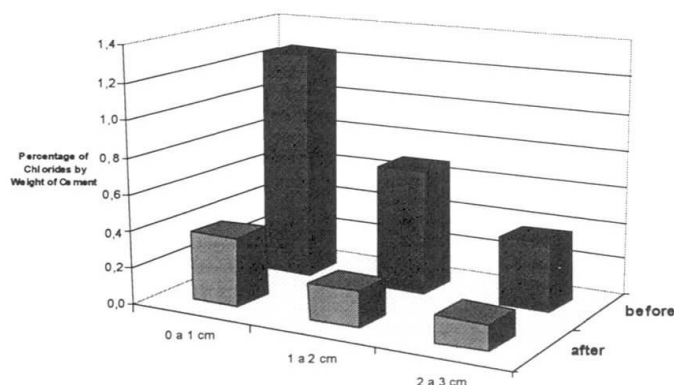
About once in a week, the structure's concrete is sampled for the determination of the chloride content and to support the decision of concluding the treatment, if the required level (less than 0,3 % of the cement weight) is achieved. Now, desalination is in progress and the removal of chlorides has already been successfully performed on 1400 m^2 . Values of about 0,2 % of cement weight were obtained at reinforcements, against the initial values of about 0,6 % (see figure below).
