Artikel: Dynamic test of a pedestrian bridge as part of safety assessment
Autor: Clemente, Paolo / Buffarini, Giacomo
DOI: <https://doi.org/10.5169/seals-62873>

Dynamic Test of a Pedestrian Bridge as Part of Safety Assessment

The results of the dynamic tests carried out on the approach pedestrian bridge to Civita di Bagnoregio, Italy, are shown. The structural elements were in bad conditions due to the carbonation of concrete. The results of the experimental campaign allowed to state that the structural behaviour of the bridge was quite similar to that we could expect. Under ambient vibrations the structure behaved as a whole, formed by the piers linked at their tops by means of the beams.

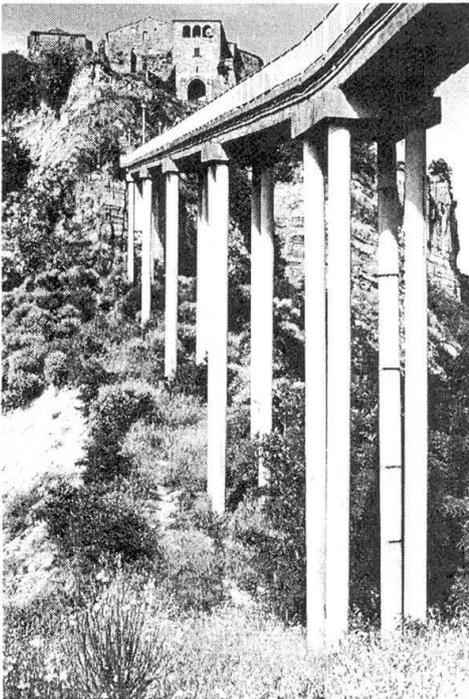
Fig. 1 Piers 1 to 5

The approach pedestrian bridge to Civita di Bagnoregio is composed by 14 spans, which are simply supported on the piers. These are spaced by about 19.00 m. Starting from Civita we first find a 20% steep slope, which interests five spans. The heights of the piers from pier 1 to pier 5 vary from 11 to 15 m, pier 4 being the highest. The viaduct between pier 5 and pier 9 is almost horizontal while in the last part, from pier 9 to pier 13, it shows a 6% slope. Piers from 6 to 13 are much shorter than the others. The girder is composed by three pre-stressed concrete beams and a concrete slab. The total height of the cross-section is 80 cm. The horizontal distance between the beam axes is 90 cm, the total width of the bridge is 2.50 m, included the two longitudinal parapets. Each span has a length of about 16.70 m, but the first one is 16 m. The beams are supported by the upper plate of the piers by means of leaden pads. All the piers are composed by 4 circular pillars, whose diameter is 50 cm, and by an upper plate of 65 cm height. The pillars start from a rectangular foundation plate, supported by concrete piles with a maximum length of 25 m. The structural elements were in bad conditions due to the carbonation of concrete. All the external beams were damaged, the phenomenon being favoured by the combined action of rain and wind. Several cracks could be seen in the pillars, where the concrete cover was split and the reinforcement bars was uncovered. The upper plates of the piers were damaged too.

The structure showed a very high deformability, more evident in the part where are the highest piers. This characteristic, due to the slenderness of the vertical elements was emphasised by the structural damages, which resulted in a reduction of the effective cross-sections of the pillars. Therefore the viaduct was very vulnerable to wind actions, which are particularly insidious in the area. Besides, when the bridge is very crowded the natural wind flow is obstructed, the vertical structures very stressed and the vibrations could be amplified very much.

We suggested that all the piers should be repaired, in order to be suitable to support the vertical and horizontal loads that can act on the structure. No works were needed on the foundation structures. These may be damaged in the future because of the landslides and the continuous erosion of the soil surface. Therefore they should be monitored or frequently tested.

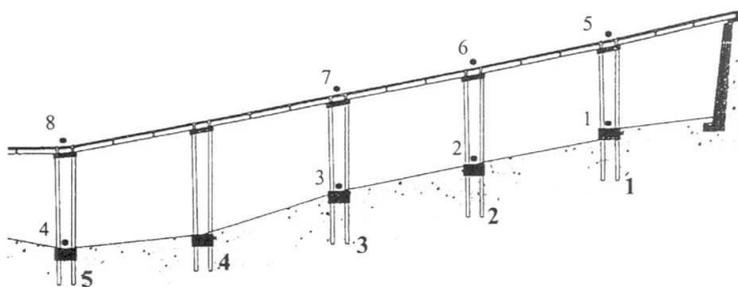
Fig. 2 Sensor locations in configuration A

Piers 2 and 3 were particularly analysed. The already observed resonance frequencies were found. We could also state that no torsional modes were associated to these frequencies. The experimental results were compared with those obtained from the analysis of a finite element model. The girder was modelled by means of a spatial beam, having the same geometrical and mechanical properties of the bridge and elastically supported by the piers in the transversal horizontal direction. Vertical displacements and torsional rotations were not allowed in correspondence of the piers. The stiffness of the elastic restraints were equal to the
