Artikel: Dynamic test of a pedestrian bridge as part of safety assessment
Autor: Clemente, Paolo / Buffarini, Giacomo
DOI: <https://doi.org/10.5169/seals-62873>

Dynamic Test of a Pedestrian Bridge as Part of Safety Assessment

The results of the dynamic tests carried out on the approach pedestrian bridge to Civita di Bagnoregio, Italy, are shown. The structural elements were in bad conditions due to the carbonation of concrete. The results of the experimental campaign allowed to state that the structural behaviour of the bridge was quite similar to that we could expect. Under ambient vibrations the structure behaved as a whole, formed by the piers linked at their tops by means of the beams.

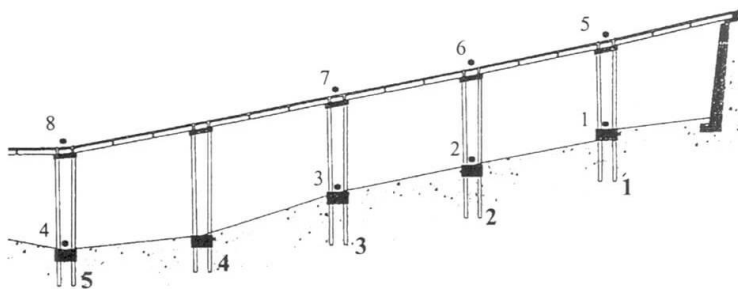
Fig. 2 Sensor locations in configuration A

The recorded data allowed to analyse the behaviour of the viaduct, with particular attention to its part between pier 1 and pier 5. The following frequencies are particularly apparent in the spectra: 0.95, 1.38, 2.07, 2.83 Hz. This occurrence suggested that the viaduct behaved as a whole, the records at the piers presenting the same features. Records at the basement of each pier were always in phase with those at the top, at all the found resonance frequencies. Peaks at the same frequencies are apparent in all the cross spectra between the sensors at the tops of the piers, with significant values of the phase factor and the coherence function.

The analysis of the phase factors allowed to find out the modal shapes associated to these resonance frequencies. We concluded that the girder behaved as a beam supported by horizontal elastic restraints at the piers. In the longitudinal direction vibration amplitudes were much lower.
