Zeitschrift: IABSE reports = Rapports AIPC = IVBH Berichte
Band: 83 (1999)

Artikel: Dynamic test of a pedestrian bridge as part of safety assessment
Autor: Clemente, Paolo / Buffarini, Giacomo
DOI: <https://doi.org/10.5169/seals-62873>

Dynamic Test of a Pedestrian Bridge as Part of Safety Assessment

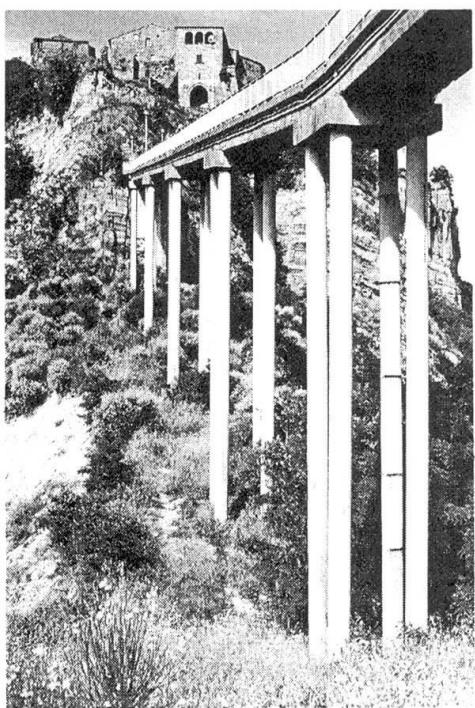
Fig. 1 Piers 1 to 5

The approach pedestrian bridge to Civita di Bagnoregio is composed by 14 spans, which are simply supported on the piers. These are spaced by about 19.00 m. Starting from Civita we first find a 20% steep slope, which interests five spans. The heights of the piers from pier 1 to pier 5 vary from 11 to 15 m, pier 4 being the highest. The viaduct between pier 5 and pier 9 is almost horizontal while in the last part, from pier 9 to pier 13, it shows a 6% slope. Piers from 6 to 13 are much shorter than the others. The girder is composed by three pre-stressed concrete beams and a concrete slab. The total height of the cross-section is 80 cm. The horizontal distance between the beam axes is 90 cm, the total width of the bridge is 2.50 m, included the two longitudinal parapets. Each span has a length of about 16.70 m, but the first one is 16 m. The beams are supported by the upper plate of the piers by means of leaden pads. All the piers are composed by 4 circular pillars, whose diameter is 50 cm, and by an upper plate of 65 cm height. The pillars start from a rectangular foundation plate, supported by concrete piles with a maximum length of 25 m. The structural elements were in bad conditions due to the carbonation of concrete. All the external beams were damaged, the phenomenon being favoured by the combined action of rain and wind. Several cracks could be seen in the pillars, where the concrete cover was split and the reinforcement bars were uncovered. The upper plates of the piers were damaged too.

The structure showed a very high deformability, more evident in the part where are the highest piers. This characteristic, due to the slenderness of the vertical elements was emphasised by the structural damages, which resulted in a reduction of the effective cross-sections of the pillars. Therefore the viaduct was very vulnerable to wind actions, which are particularly insidious in the area. Besides, when the bridge is very crowded the natural wind flow is obstructed, the vertical structures very stressed and the vibrations could be amplified very much.

We suggested that all the piers should be repaired, in order to be suitable to support the vertical and horizontal loads that can act on the structure. No works were needed on the foundation structures. These may be damaged in the future because of the landslides and the continuous erosion of the soil surface. Therefore they should be monitored or frequently tested.

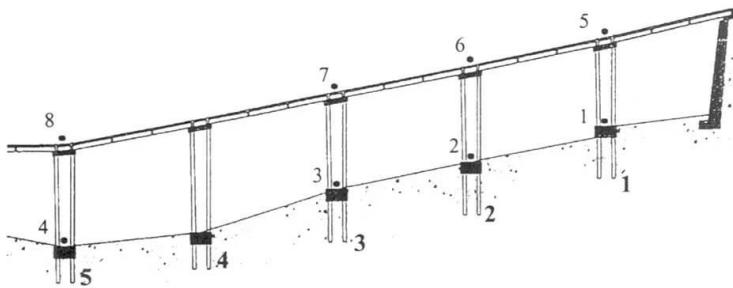
Fig. 2 Sensor locations in configuration A

characterise the dynamic behaviour of the piers. The experimental set-up was composed by eight seismometers Kinemetrix SS1, an HP3566A signal conditioner and a HP laptop. Measurements were carried out on June 1997. Sensors were deployed in several configurations. Both ambient and forced vibrations were considered, the latest being caused by the passing of pedestrians or vehicles of small size. The recorded data were analysed both in the time domain and in the frequency domain.
