# Railway bridges of corrosion resistant steel in Japan

# Railway Bridges of Corrosion Resistant Steel in Japan

#### Hidehiko ABE

## Kenji SAKAMOTO

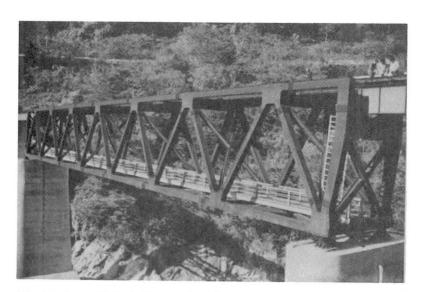
Photo 1. Third Okawa Bridge

5) The edge of the upper side of concrete pier is raised and water is gathered to the drain pipe, so that rainwater washing the bridge may not stain the flank of pier, as

seen in Photo 1.

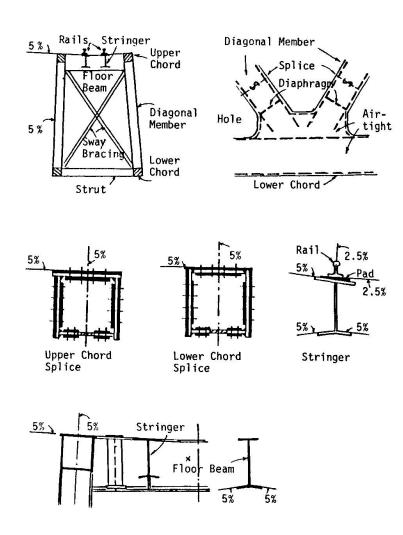
Fig.1. Examples of structural details

The structural details of the weathering steel bridges for railways in Japan are so modified, as to fit the use of weathering steel without painting. They have been carefully designed, so that water and dust staying on the structural members should be minimized as shown in Fig. 1. Such considerations will be useful also to ordinary painted bridges for better durability. In Third Okawa Bridge (Photo 1), for instance, 1) The upper surfaces of horizontal mem-

bers, even the flanges of stringer and

floor beam and chord members are inclined by 5%.

Larger horizontal gusset plates are provided with large openings.

3) The chord members and the panel point portions are closed for air-tightness, except for their splice portions, the inside of which is coated with tar - epoxy

resin paint.
