Band: 57 (1979)

Artikel: Corrosion of lead sheathed cables in plastics multiway ducts. Part I

Autor: Brunold, Armin

Corrosion of Lead Sheathed Cables in Plastics Multiway Ducts (Part I)1

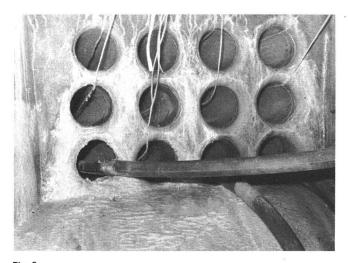
Fig. 2
Multiway duct at Auvernier
The white traces show that lime-precipitating water is penetrating through all the joints of a chamber adjacent to the site of the fault

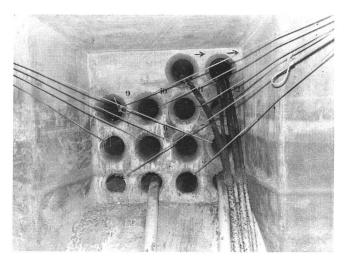
Fig. 4 Multiway duct at Arbon

At the multiway duct inlet opposite to the fault site, white traces of lime show that, at times, small quantities of water have seeped through between the plastics ducts and the concrete block. Lime sediment precipitated from the accumulated water in the jointing chamber due to atmospheric carbonic acid is deposited on the arch of the concrete funnel and on the cables

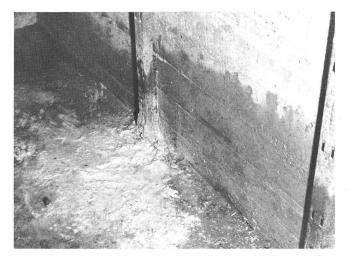
Fig. 7
Multiway duct at Egnach
In this chamber, water has penetrated at the point where the steel profile has been set into the floor of the chamber, as can be seen from the lime crust formation

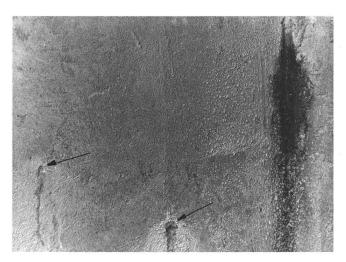
Fig. 8

Multiway duct at Egnach
In another chamber, strongly basic water penetrates the concrete at two points on a longitudinal wall — marked by two arrows in the Figure

chamber had been pumped dry the floor was covered once more with water to a depth of 7 cm. This corresponds to a water inflow of about 20 litres per hour. Figure 8 provides proof that water can break through massive concrete walls. Here, water is penetrating at a rate of about 21 per hour at two points in the chamber wall. In addition, water is flowing at the rate of 5 l/h by capillary action between the plastics duct no 5 and the concrete in the same chamber, as is indicated in Figure 9 (arrow). In spite of this, the cable fault in a subscriber cable did not occur in the area of the chamber inlet but instead 30 m inside the duct, where an obstacle had to be avoided by means of a soft polyethylene insert. In this installation, the bare lead sheaths had been protected two years previously against direct contact with water emerging at the vulnerable outlet points by means of polyethylene hose sections slit open and wrapped around the cable sheaths.
