**Zeitschrift:** Technische Mitteilungen / Schweizerische Post-, Telefon- und Telegrafienbetriebe = Bulletin technique / Entreprise des postes, téléphones et télégraphes suisses = Bollettino tecnico / Azienda delle poste, dei telefoni e dei telegrafi svizzeri

**Band:** 57 (1979)

**Artikel:** Corrosion of lead sheathed cables in plastics multiway ducts. Part I

**Autor:** Brunold, Armin

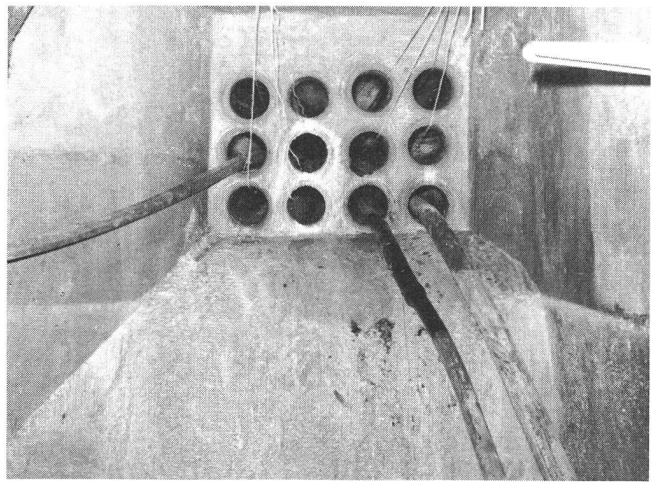
**Fig. 1**  
**Multiway duct at Auvernier, site of fault**

Water is entering the jointing chamber chiefly through the lower joint between the multiway duct and the concrete inlet funnel. Thick layers of lime sediment have been deposited on the arch of the funnel. The area of greater thickness, painted black, shows where the corroded lead sheath had to be mended

1970 for the duct installation, nevertheless temporarily contained so much water that it could drain off through the lowest row of ducts of the twelve-duct block into the next jointing chamber in the direction of Colombier which is located at a lower level. At the time of inspection the jointing chamber had been largely emptied of water. The maximum water level could however be clearly determined from the marks remaining on the chamber walls. We were informed that the drainage system in this jointing chamber had failed because the outlet pipe had been blocked by extraordinary mud deposits. Although the jointing chamber had been cleaned, considerable amounts of fine lime sediment could again be seen on the floor. Thick crusts of precipitated material had been deposited particularly on the lower arch of the concrete inlet funnel through which the cables enter the jointing chamber from the direction of Neuchâtel as is shown in *Figure 1*. It was quite obvious that the water which flows over the funnel arch in large amounts enters the jointing chamber mainly through the lower connection joint between the inlet funnel and the multiway duct. However, some of the water enters the jointing chamber via the plastics tubes. As can be seen from *Figure 1*, only three of the 12 ducts are occupied by one cable each. Illumination of the individual ducts allowed inspection to a depth of approximately 3 m, revealing that only five of the 12 duct pipes were dry and free of sediment while six contained, as far as it was possible to see, a white, wet deposit with a small stream of water trickling along. In the case of one duct pipe, sediment had been deposited at the inlet only. Some of the ducts affected by sediment can be identified in *Figure 1* by the white traces of the deposit.

While the cable from Neuchâtel to Areuse is located in a clean and dry duct (centre row, left) and therefore does not show any signs of corrosion, the ducts containing junction cable 20084 and long distance cable 20010 (bottom row, ducts 3 and 4) carry some water. The lead sheaths of these cables are affected by corrosion not so much in the region of the ducts as immediately after the duct outlet and particularly in where the cable sheaths

rest on the arc of the concrete inlet funnel. The junction cable was corroded through at that point and had to be mended by means of a lead pipe insert. The lead sheath of the long distance cable is affected to a depth of approximately 1 mm at the area of contact with the inlet funnel but is not yet perforated. Slope pressure water has penetrated even into the three next following jointing chambers in the direction of Colombier where the terrain slopes gently. For example, *Figure 2* shows the entry of the ducts in one of these neighbouring jointing chambers. The white traces of lime deposit show that in this case water has seeped through all the connection joints between the multiway duct and the concrete inlet funnel and also between the plastics ducts and the surrounding concrete.

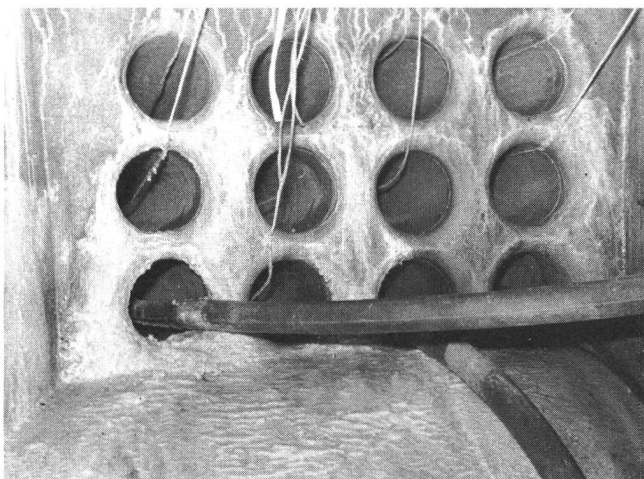
**Fig. 2**  
**Multiway duct at Auvernier**  
The white traces show that lime-precipitating water is penetrating through all the joints of a chamber adjacent to the site of the fault

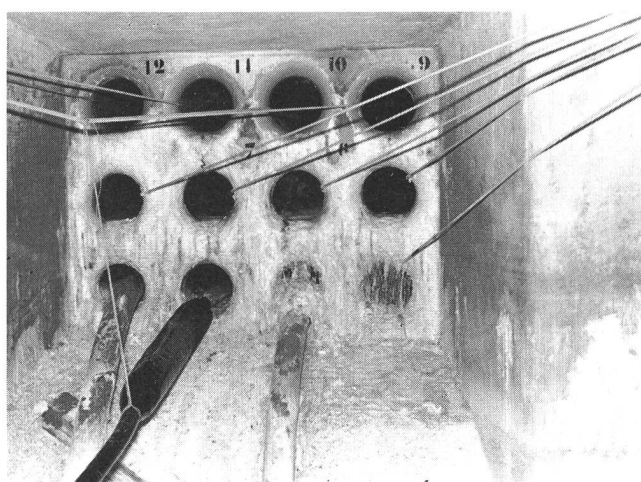
The multiway duct system was completed about one year prior to pulling in the cables. The lead sheath of the subscriber cable, which is 2 mm thick, was corroded through within less than two years. *Figures 3* and *4* show the condition found in E. 6, the jointing chamber containing the fault, on 24. 8. 1972. The inlets of the duct

**Fig. 3**  
**Multiway duct at Arbon, site of fault**  
The front of the multiway duct is largely covered by a thick lime crust. In some places, stalactite-type structures have formed. Highly basic water is flowing into the jointing chamber between the layers of lime and in the stalactite tubules. All the cables are corroded at the point of contact with the arch of the concrete funnel. The area of increased thickness which is painted black shows where the corroded cable has been mended

sections coming from the exchange are shown in Figure 3. Duct section 2 is occupied by junction cable 60139 St. Gall—Romanshorn. Duct sections 3 and 4 contain subscriber cables. The corrosion breakthrough at the 100-pair subscriber cable has been repaired by means of a lead pipe as can be seen from the illustration. The junction cable and an 800-pair subscriber cable pass through the opposite jointing chamber wall (Fig. 4) using the same duct section numbers as before, while the 100-pair subscriber cable is divided into four smaller Type B cables which leave the multiway duct system by two unnumbered outlets.

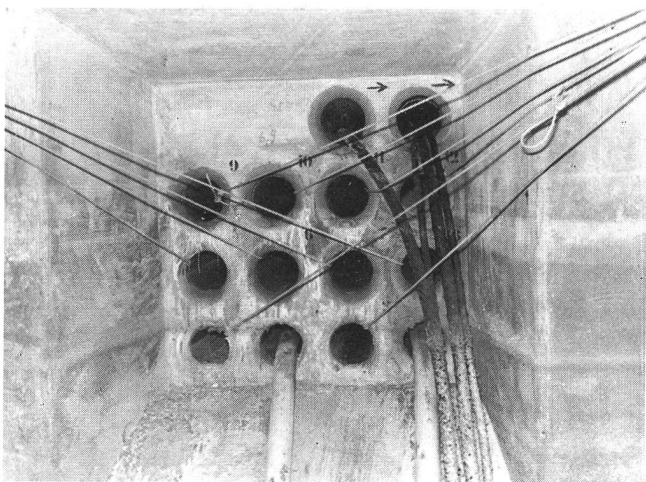
**Fig. 4**  
**Multiway duct at Arbon**

At the multiway duct inlet opposite to the fault site, white traces of lime show that, at times, small quantities of water have seeped through between the plastics ducts and the concrete block. Lime sediment precipitated from the accumulated water in the jointing chamber due to atmospheric carbonic acid is deposited on the arch of the concrete inlet funnel and on the cables

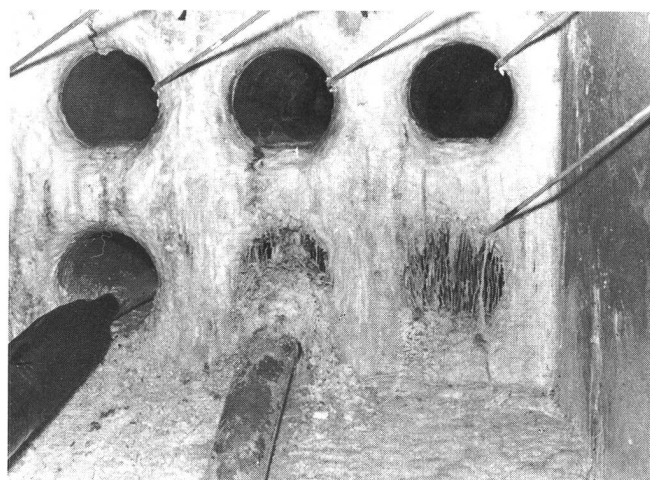
**Fig. 5**  
**Multiway duct at Arbon, fault site**

Here, the thick lime crusts deposited round the plastics duct inlets can be recognized particularly clearly. Water-carrying stalactite-type lime tubules overhang two of the duct section inlets

If one breaks off the stalactites, clearly visible in Figure 5, one can observe that these are of the form of tubules and contain dripping water which, if tested by means of indicator paper, exhibits a considerably stronger alkaline reaction than the water flowing in the duct sections. Wiping off the stalactites revealed a «water spring». The hand in Figure 6 points at this site from which approximately 0.25 l of water were obtained within about five minutes. The fact that water emerges between the plastics inlet funnels and the concrete in which they are packed is obvious from the opposite wall (Fig. 4) because it is only slightly encrusted so that one can see exactly how the white traces of eliminated lime emanate from the boundary line between the external surface of the plastics duct and the concrete.

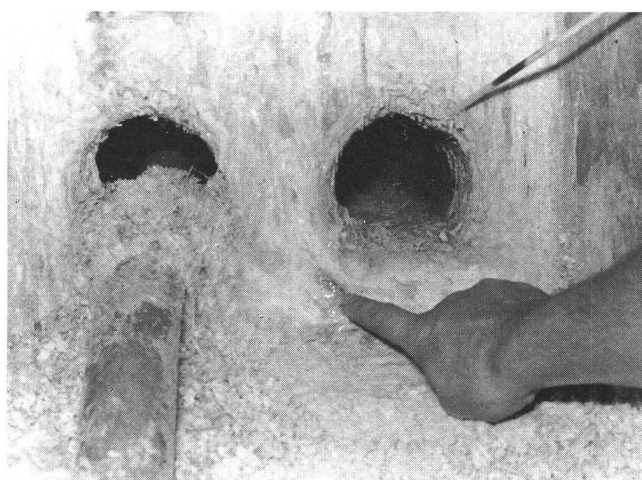
**Fig. 6**  
**Multiway duct at Arbon, fault site**

The hand in this illustration points at a «water spring» which appeared when the stalactites had been wiped away. The highly basic water (pH 12.6) is emerging between the plastics inlet funnel and the concrete packing

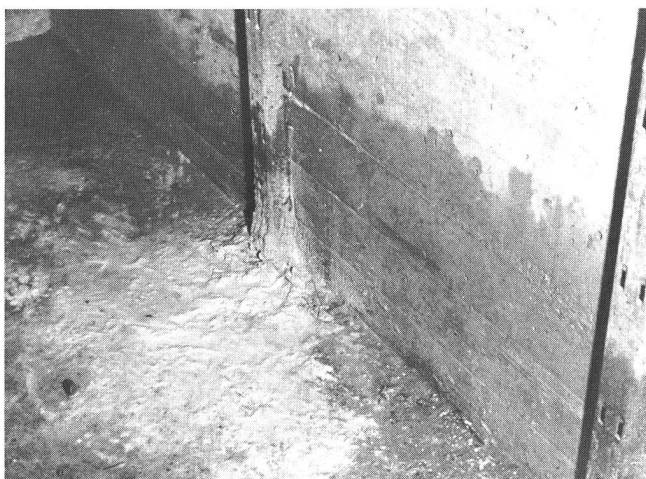
**Fig. 7**  
**Multiway duct at Egnach**

In this chamber, water has penetrated at the point where the steel profile has been set into the floor of the chamber, as can be seen from the lime crust formation

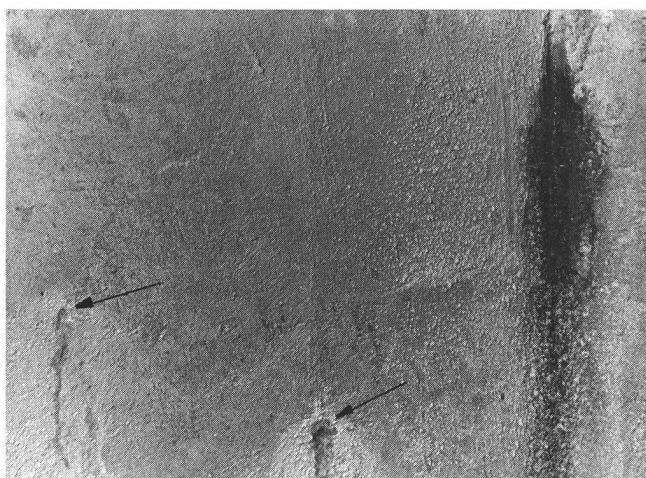
**Fig. 8**  
**Multiway duct at Egnach**

In another chamber, strongly basic water penetrates the concrete at two points on a longitudinal wall — marked by two arrows in the Figure

chamber had been pumped dry the floor was covered once more with water to a depth of 7 cm. This corresponds to a water inflow of about 20 litres per hour. *Figure 8* provides proof that water can break through massive concrete walls. Here, water is penetrating at a rate of about 2 l per hour at two points in the chamber wall. In addition, water is flowing at the rate of 5 l/h by capillary action between the plastics duct no 5 and the concrete in the same chamber, as is indicated in *Figure 9* (arrow). In spite of this, the cable fault in a subscriber cable did not occur in the area of the chamber inlet but instead 30 m inside the duct, where an obstacle had to be avoided by means of a soft polyethylene insert. In this installation, the bare lead sheaths had been protected two years previously against direct contact with water emerging at the vulnerable outlet points by means of polyethylene hose sections slit open and wrapped around the cable sheaths.

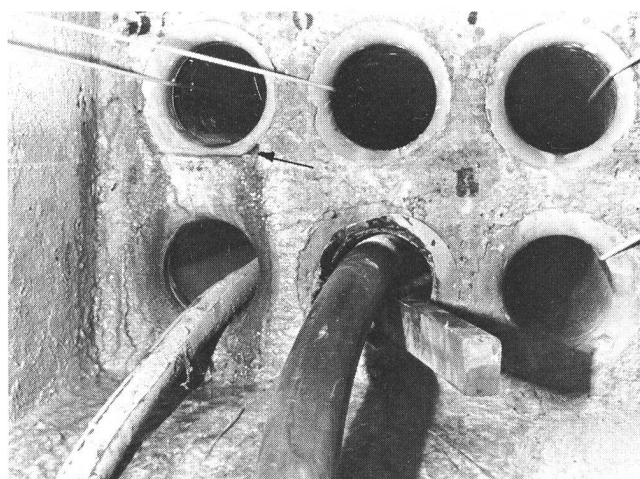
**Fig. 9**  
**Multiway duct at Egnach**

In the same chamber as that shown in Figure 8 about 5 l of water per hour flow into the chamber at duct no 5 between the plastics tube and concrete packing (arrow)

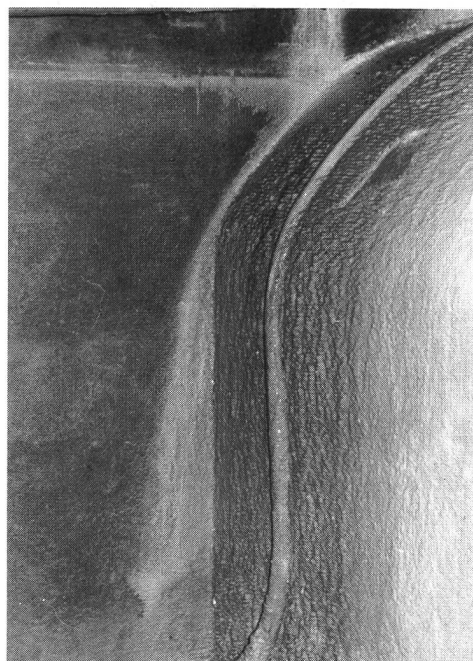
**Fig. 10**

ter entered mainly through the ventilation pipe. Level marks and lime sediments on the walls and in the upper ducts show that an even higher water level prevailed for a sometime. A particularly gross example of lime deposits produced by water seepage was encountered in chamber 28 where the water had spread and rippled down over the whole width of the concrete inlet funnel and formed centimetre thick lime crusts so that the cable resting on the funnel was virtually petrified as can be seen in *Figure 10*.

In this chamber strongly basic water flows into the chamber distributed over the full width of the concrete inlet funnel so that the precipitating lime crust has virtually petrified the cable resting on the funnel
