Zeitschrift:	Technische Mitteilungen / Schweizerische Post-, Telefon- und Telegrafenbetriebe = Bulletin technique / Entreprise des postes, téléphones et télégraphes suisses = Bollettino tecnico / Azienda delle poste, dei telefoni e dei telegraфи svizzeri
Herausgeber:	Schweizerische Post-, Telefon- und Telegrafenbetriebe
Band:	57 (1979)
Heft:	9
Artikel:	Corrosion of lead sheathed cables in plastics multiway ducts. Part I
Autor:	Brunold, Armin
DOI:	https://doi.org/10.5169/seals-875571

1 Introduction

3 Description of the locations of the faults in some of the instances of damage investigated

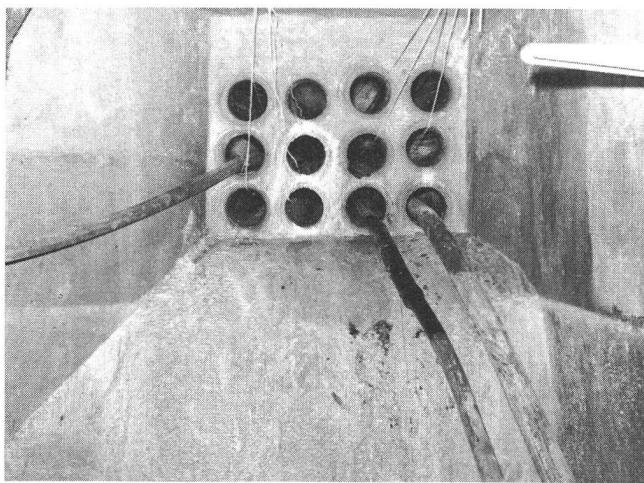
Fig. 1

Multiway duct at Auvernier, site of fault

Water is entering the jointing chamber chiefly through the lower joint between the multiway duct and the concrete inlet funnel. Thick layers of lime sediment have been deposited on the arch of the funnel. The area of greater thickness, painted black, shows where the corroded lead sheath had to be mended

1970 for the duct installation, nevertheless temporarily contained so much water that it could drain off through the lowest row of ducts of the twelve-duct block into the next jointing chamber in the direction of Colombier which is located at a lower level. At the time of inspection the jointing chamber had been largely emptied of water. The maximum water level could however be clearly determined from the marks remaining on the chamber walls. We were informed that the drainage system in this jointing chamber had failed because the outlet pipe had been blocked by extraordinary mud deposits. Although the jointing chamber had been cleaned, considerable amounts of fine lime sediment could again be seen on the floor. Thick crusts of precipitated material had been deposited particularly on the lower arch of the concrete inlet funnel through which the cables enter the jointing chamber from the direction of Neuchâtel as is shown in *Figure 1*. It was quite obvious that the water which flows over the funnel arch in large amounts enters the jointing chamber mainly through the lower connection joint between the inlet funnel and the multiway duct. However, some of the water enters the jointing chamber via the plastics tubes. As can be seen from *Figure 1*, only three of the 12 ducts are occupied by one cable each. Illumination of the individual ducts allowed inspection to a depth of approximately 3 m, revealing that only five of the 12 duct pipes were dry and free of sediment while six contained, as far as it was possible to see, a white, wet deposit with a small stream of water trickling along. In the case of one duct pipe, sediment had been deposited at the inlet only. Some of the ducts affected by sediment can be identified in *Figure 1* by the white traces of the deposit.

While the cable from Neuchâtel to Areuse is located in a clean and dry duct (centre row, left) and therefore does not show any signs of corrosion, the ducts containing junction cable 20084 and long distance cable 20010 (bottom row, ducts 3 and 4) carry some water. The lead sheaths of these cables are affected by corrosion not so much in the region of the ducts as immediately after the duct outlet and particularly in where the cable sheaths

rest on the arc of the concrete inlet funnel. The junction cable was corroded through at that point and had to be mended by means of a lead pipe insert. The lead sheath of the long distance cable is affected to a depth of approximately 1 mm at the area of contact with the inlet funnel but is not yet perforated. Slope pressure water has penetrated even into the three next following jointing chambers in the direction of Colombier where the terrain slopes gently. For example, *Figure 2* shows the entry of the ducts in one of these neighbouring jointing chambers. The white traces of lime deposit show that in this case water has seeped through all the connection joints between the multiway duct and the concrete inlet funnel and also between the plastics ducts and the surrounding concrete.

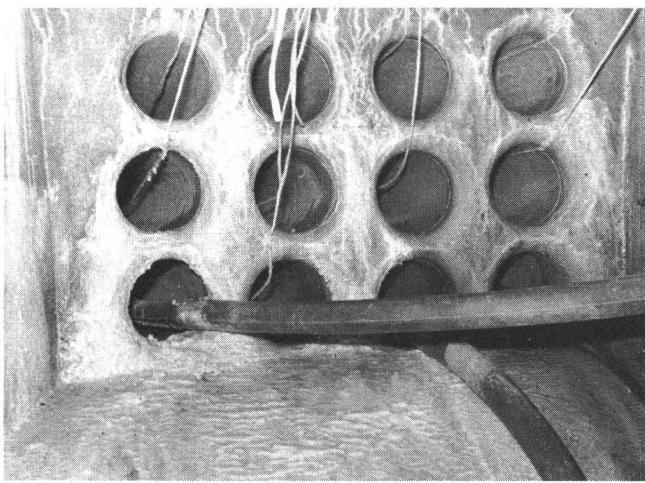
Fig. 2
Multiway duct at Auvernier

The white traces show that lime-precipitating water is penetrating through all the joints of a chamber adjacent to the site of the fault

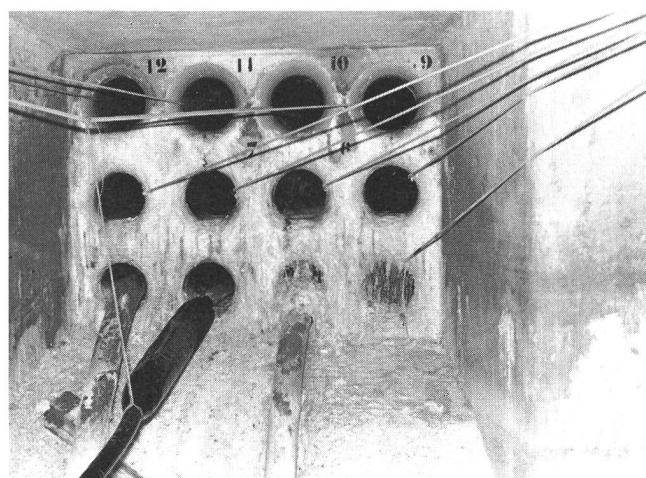
Fig. 3
Multiway duct at Arbon, site of fault

The multiway duct system was completed about one year prior to pulling in the cables. The lead sheath of the subscriber cable, which is 2 mm thick, was corroded through within less than two years. *Figures 3 and 4* show the condition found in E. 6, the jointing chamber containing the fault, on 24. 8. 1972. The inlets of the duct

The front of the multiway duct is largely covered by a thick lime crust. In some places, stalactite-type structures have formed. Highly basic water is flowing into the jointing chamber between the layers of lime and in the stalactite tubules. All the cables are corroded at the point of contact with the arch of the concrete funnel. The area of increased thickness which is painted black shows where the corroded cable has been mended

sections coming from the exchange are shown in Figure 3. Duct section 2 is occupied by junction cable 60139 St. Gall—Romanshorn. Duct sections 3 and 4 contain subscriber cables. The corrosion breakthrough at the 100-pair subscriber cable has been repaired by means of a lead pipe as can be seen from the illustration. The junction cable and an 800-pair subscriber cable pass through the opposite jointing chamber wall (Fig. 4) using the same duct section numbers as before, while the 100-pair subscriber cable is divided into four smaller Type B cables which leave the multiway duct system by two unnumbered outlets.

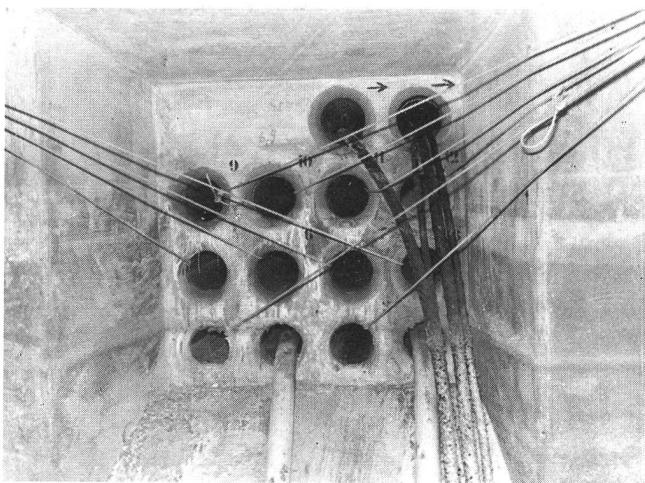
Fig. 4
Multiway duct at Arbon

At the multiway duct inlet opposite to the fault site, white traces of lime show that, at times, small quantities of water have seeped through between the plastics ducts and the concrete block. Lime sediment precipitated from the accumulated water in the jointing chamber due to atmospheric carbonic acid is deposited on the arch of the concrete funnel and on the cables

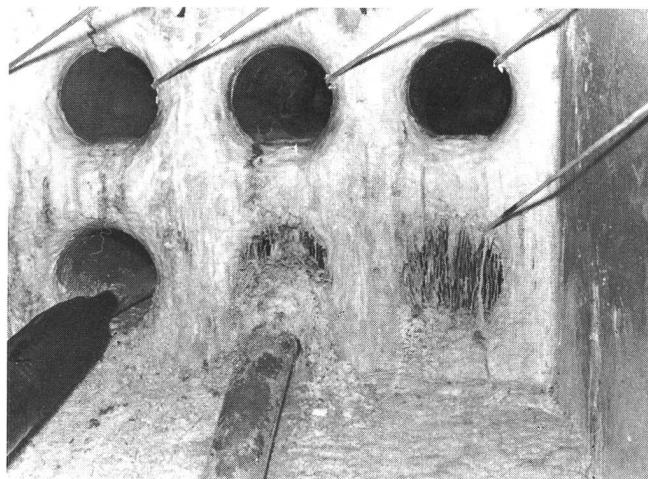
Fig. 5
Multiway duct at Arbon, fault site

Here, the thick lime crusts deposited round the plastics duct inlets can be recognized particularly clearly. Water-carrying stalactite-type lime tubules overhang two of the duct section inlets

If one breaks off the stalactites, clearly visible in Figure 5, one can observe that these are of the form of tubules and contain dripping water which, if tested by means of indicator paper, exhibits a considerably stronger alkaline reaction than the water flowing in the duct sections. Wiping off the stalactites revealed a «water spring». The hand in Figure 6 points at this site from which approximately 0.25 l of water were obtained within about five minutes. The fact that water emerges between the plastics inlet funnels and the concrete in which they are packed is obvious from the opposite wall (Fig. 4) because it is only slightly encrusted so that one can see exactly how the white traces of eliminated lime emanate from the boundary line between the external surface of the plastics duct and the concrete.

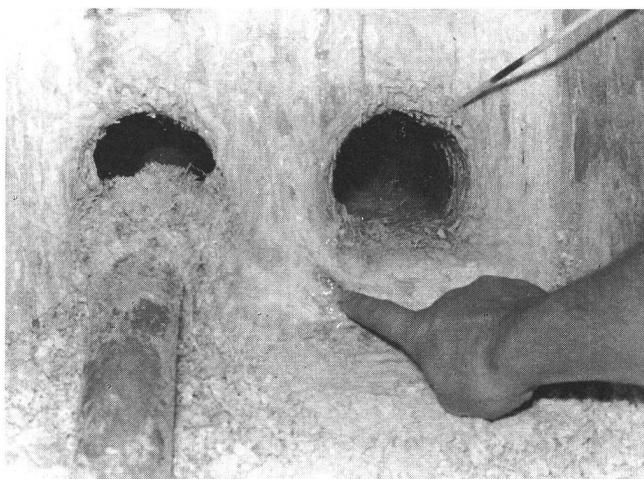
Fig. 6
Multiway duct at Arbon, fault site

The hand in this illustration points at a «water spring» which appeared when the stalactites had been wiped away. The highly basic water (pH 12.6) is emerging between the plastics inlet funnel and the concrete packing

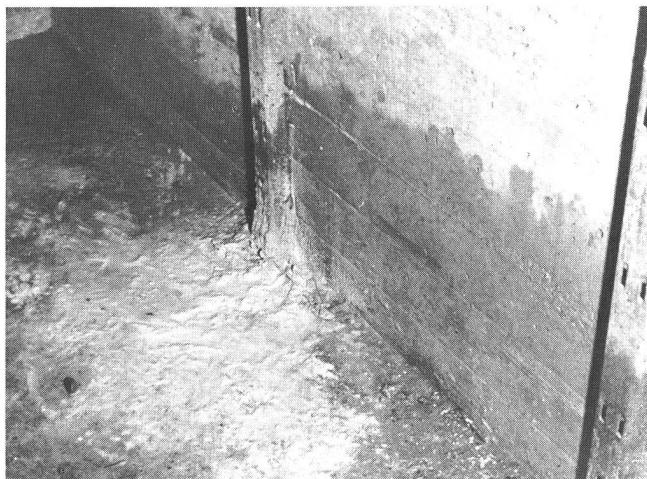
Fig. 7
Multiway duct at Egnach

In this chamber, water has penetrated at the point where the steel profile has been set into the floor of the chamber, as can be seen from the lime crust formation

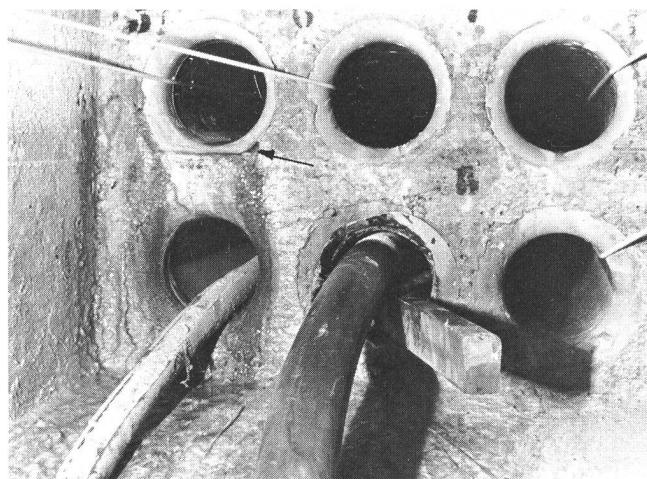
Fig. 9
Multiway duct at Egnach

In the same chamber as that shown in Figure 8 about 5 l of water per hour flow into the chamber at duct no 5 between the plastics tube and concrete packing (arrow)

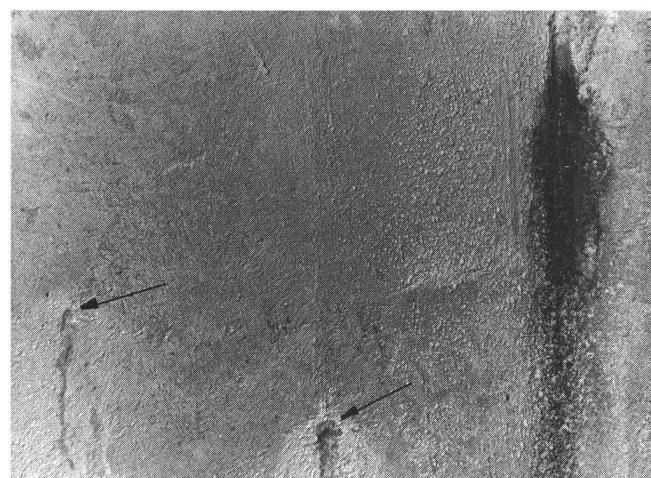
Fig. 8
Multiway duct at Egnach

chamber had been pumped dry the floor was covered once more with water to a depth of 7 cm. This corresponds to a water inflow of about 20 litres per hour. Figure 8 provides proof that water can break through massive concrete walls. Here, water is penetrating at a rate of about 2 l per hour at two points in the chamber wall. In addition, water is flowing at the rate of 5 l/h by capillary action between the plastics duct no 5 and the concrete in the same chamber, as is indicated in Figure 9 (arrow). In spite of this, the cable fault in a subscriber cable did not occur in the area of the chamber inlet but instead 30 m inside the duct, where an obstacle had to be avoided by means of a soft polyethylene insert. In this installation, the bare lead sheaths had been protected two years previously against direct contact with water emerging at the vulnerable outlet points by means of polyethylene hose sections slit open and wrapped around the cable sheaths.

In another chamber, strongly basic water penetrates the concrete at two points on a longitudinal wall — marked by two arrows in the Figure

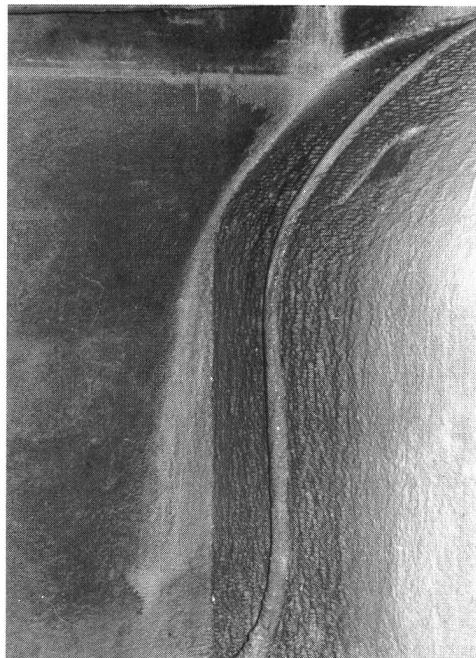
Fig. 10

ter entered mainly through the ventilation pipe. Level marks and lime sediments on the walls and in the upper ducts show that an even higher water level prevailed for a sometime. A particularly gross example of lime deposits produced by water seepage was encountered in chamber 28 where the water had spread and rippled down over the whole width of the concrete inlet funnel and formed centimetre thick lime crusts so that the cable resting on the funnel was virtually petrified as can be seen in *Figure 10*.

Multiway duct at Wollerau

In this chamber strongly basic water flows into the chamber distributed over the full width of the concrete inlet funnel so that the precipitating lime crust has virtually petrified the cable resting on the funnel
