**Zeitschrift:** Technische Mitteilungen / Schweizerische Post-, Telefon- und Telegrafienbetriebe = Bulletin technique / Entreprise des postes, téléphones et télégraphes suisses = Bollettino tecnico / Azienda delle poste, dei telefoni e dei telegrafi svizzeri

**Band:** 57 (1979)

**Artikel:** Corrosion of lead sheathed cables in plastics multiway ducts. Part I

**Autor:** Brunold, Armin

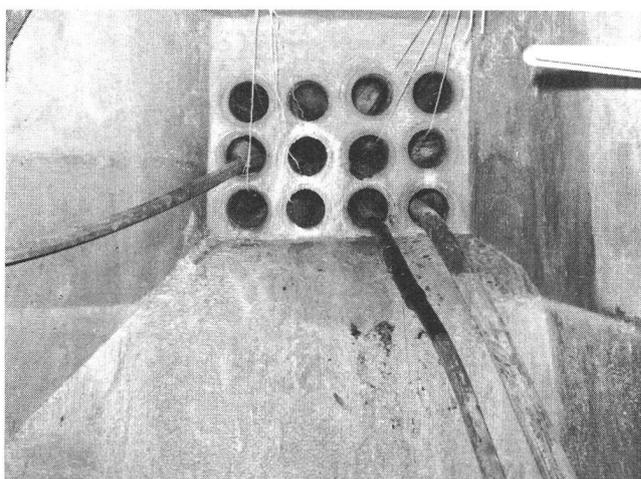
Fig. 1  
Multiway duct at Auvernier, site of fault

Water is entering the jointing chamber chiefly through the lower joint between the multiway duct and the concrete inlet funnel. Thick layers of lime sediment have been deposited on the arch of the funnel. The area of greater thickness, painted black, shows where the corroded lead sheath had to be mended

1970 for the duct installation, nevertheless temporarily contained so much water that it could drain off through the lowest row of ducts of the twelve-duct block into the next jointing chamber in the direction of Colombier which is located at a lower level. At the time of inspection the jointing chamber had been largely emptied of water. The maximum water level could however be clearly determined from the marks remaining on the chamber walls. We were informed that the drainage system in this jointing chamber had failed because the outlet pipe had been blocked by extraordinary mud deposits. Although the jointing chamber had been cleaned, considerable amounts of fine lime sediment could again be seen on the floor. Thick crusts of precipitated material had been deposited particularly on the lower arch of the concrete inlet funnel through which the cables enter the jointing chamber from the direction of Neuchâtel as is shown in *Figure 1*. It was quite obvious that the water which flows over the funnel arch in large amounts enters the jointing chamber mainly through the lower connection joint between the inlet funnel and the multiway duct. However, some of the water enters the jointing chamber via the plastics tubes. As can be seen from *Figure 1*, only three of the 12 ducts are occupied by one cable each. Illumination of the individual ducts allowed inspection to a depth of approximately 3 m, revealing that only five of the 12 duct pipes were dry and free of sediment while six contained, as far as it was possible to see, a white, wet deposit with a small stream of water trickling along. In the case of one duct pipe, sediment had been deposited at the inlet only. Some of the ducts affected by sediment can be identified in *Figure 1* by the white traces of the deposit.

While the cable from Neuchâtel to Areuse is located in a clean and dry duct (centre row, left) and therefore does not show any signs of corrosion, the ducts containing junction cable 20084 and long distance cable 20010 (bottom row, ducts 3 and 4) carry some water. The lead sheaths of these cables are affected by corrosion not so much in the region of the ducts as immediately after the duct outlet and particularly in where the cable sheaths

rest on the arc of the concrete inlet funnel. The junction cable was corroded through at that point and had to be mended by means of a lead pipe insert. The lead sheath of the long distance cable is affected to a depth of approximately 1 mm at the area of contact with the inlet funnel but is not yet perforated. Slope pressure water has penetrated even into the three next following jointing chambers in the direction of Colombier where the terrain slopes gently. For example, *Figure 2* shows the entry of the ducts in one of these neighbouring jointing chambers. The white traces of lime deposit show that in this case water has seeped through all the connection joints between the multiway duct and the concrete inlet funnel and also between the plastics ducts and the surrounding concrete.

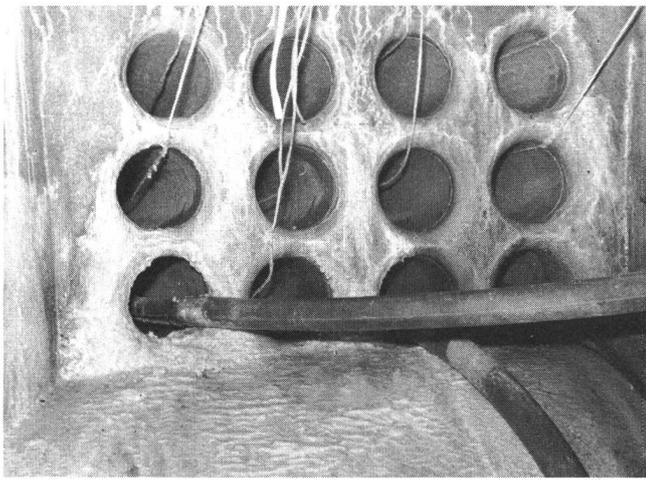
**Fig. 2**  
**Multiway duct at Auvernier**  
 The white traces show that lime-precipitating water is penetrating through all the joints of a chamber adjacent to the site of the fault

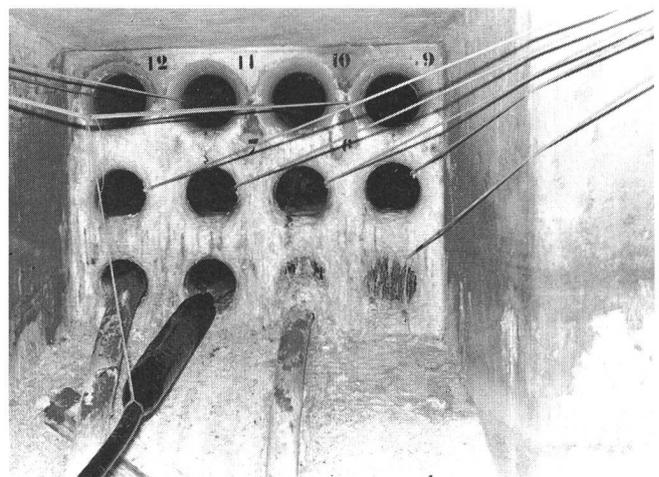
The multiway duct system was completed about one year prior to pulling in the cables. The lead sheath of the subscriber cable, which is 2 mm thick, was corroded through within less than two years. *Figures 3* and *4* show the condition found in E. 6, the jointing chamber containing the fault, on 24. 8. 1972. The inlets of the duct

**Fig. 3**  
**Multiway duct at Arbon, site of fault**  
 The front of the multiway duct is largely covered by a thick lime crust. In some places, stalactite-type structures have formed. Highly basic water is flowing into the jointing chamber between the layers of lime and in the stalactite tubules. All the cables are corroded at the point of contact with the arch of the concrete funnel. The area of increased thickness which is painted black shows where the corroded cable has been mended

sections coming from the exchange are shown in Figure 3. Duct section 2 is occupied by junction cable 60139 St. Gall—Romanshorn. Duct sections 3 and 4 contain subscriber cables. The corrosion breakthrough at the 100-pair subscriber cable has been repaired by means of a lead pipe as can be seen from the illustration. The junction cable and an 800-pair subscriber cable pass through the opposite jointing chamber wall (Fig. 4) using the same duct section numbers as before, while the 100-pair subscriber cable is divided into four smaller Type B cables which leave the multiway duct system by two unnumbered outlets.

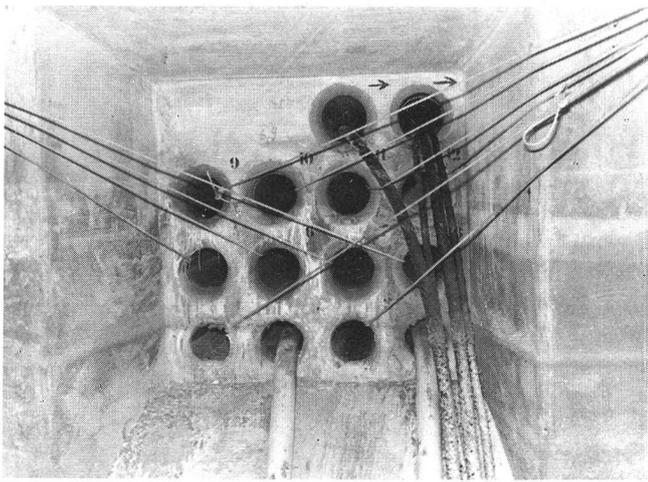
**Fig. 4**  
**Multiway duct at Arbon**

At the multiway duct inlet opposite to the fault site, white traces of lime show that, at times, small quantities of water have seeped through between the plastics ducts and the concrete block. Lime sediment precipitated from the accumulated water in the jointing chamber due to atmospheric carbonic acid is deposited on the arch of the concrete funnel and on the cables

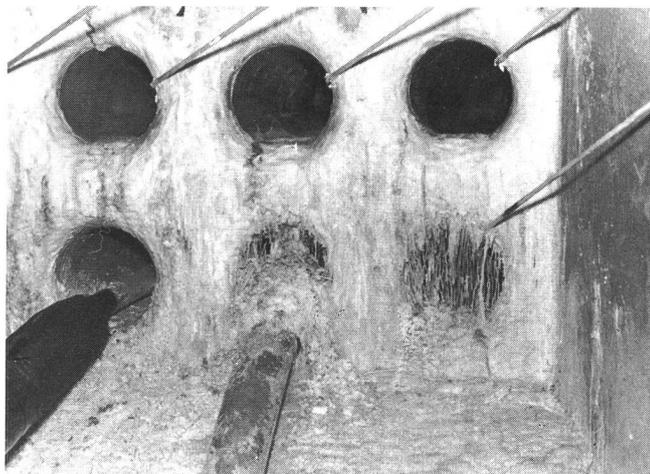
**Fig. 5**  
**Multiway duct at Arbon, fault site**

Here, the thick lime crusts deposited round the plastics duct inlets can be recognized particularly clearly. Water-carrying stalactite-type lime tubules overhang two of the duct section inlets

If one breaks off the stalactites, clearly visible in Figure 5, one can observe that these are of the form of tubules and contain dripping water which, if tested by means of indicator paper, exhibits a considerably stronger alkaline reaction than the water flowing in the duct sections. Wiping off the stalactites revealed a «water spring». The hand in Figure 6 points at this site from which approximately 0.25 l of water were obtained within about five minutes. The fact that water emerges between the plastics inlet funnels and the concrete in which they are packed is obvious from the opposite wall (Fig. 4) because it is only slightly encrusted so that one can see exactly how the white traces of eliminated lime emanate from the boundary line between the external surface of the plastics duct and the concrete.

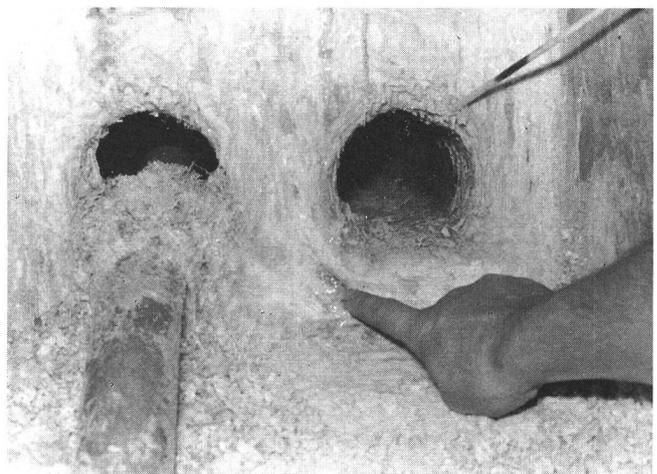
**Fig. 6**  
**Multiway duct at Arbon, fault site**

The hand in this illustration points at a «water spring» which appeared when the stalactites had been wiped away. The highly basic water (pH 12.6) is emerging between the plastics inlet funnel and the concrete packing

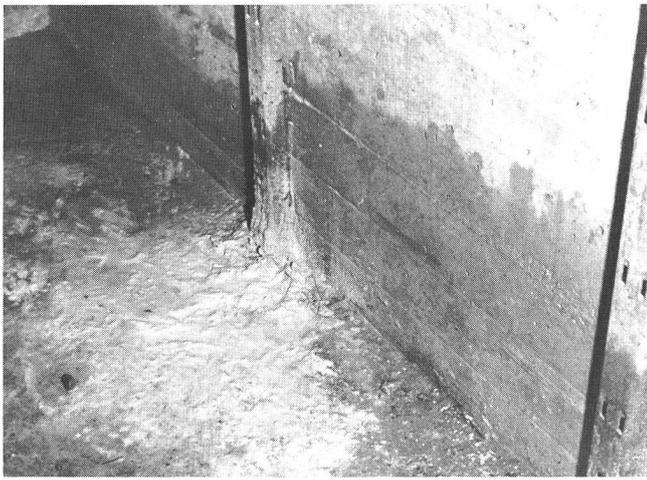
**Fig. 7**  
**Multiway duct at Egnach**  
 In this chamber, water has penetrated at the point where the steel profile has been set into the floor of the chamber, as can be seen from the lime crust formation

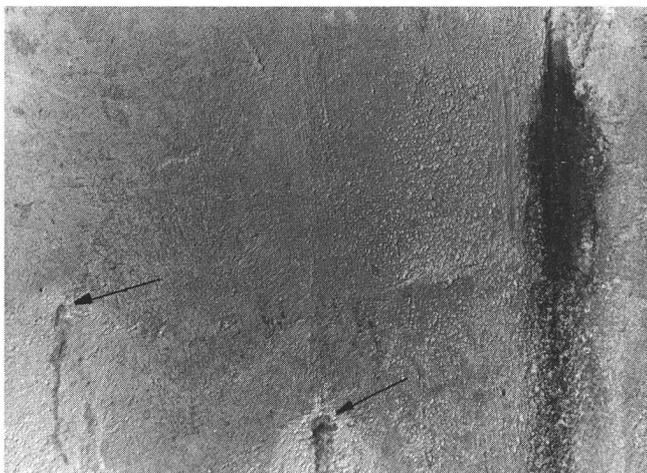
**Fig. 8**  
**Multiway duct at Egnach**  
 In another chamber, strongly basic water penetrates the concrete at two points on a longitudinal wall — marked by two arrows in the Figure

chamber had been pumped dry the floor was covered once more with water to a depth of 7 cm. This corresponds to a water inflow of about 20 litres per hour. *Figure 8* provides proof that water can break through massive concrete walls. Here, water is penetrating at a rate of about 2 l per hour at two points in the chamber wall. In addition, water is flowing at the rate of 5 l/h by capillary action between the plastics duct no 5 and the concrete in the same chamber, as is indicated in *Figure 9* (arrow). In spite of this, the cable fault in a subscriber cable did not occur in the area of the chamber inlet but instead 30 m inside the duct, where an obstacle had to be avoided by means of a soft polyethylene insert. In this installation, the bare lead sheaths had been protected two years previously against direct contact with water emerging at the vulnerable outlet points by means of polyethylene hose sections slit open and wrapped around the cable sheaths.

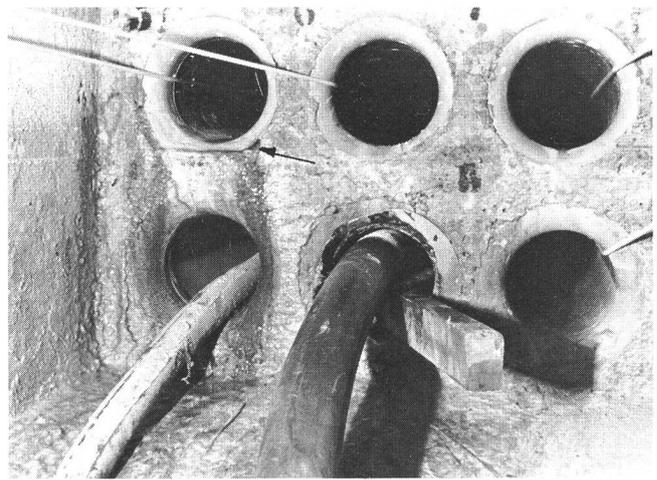
**Fig. 9**  
**Multiway duct at Egnach**  
 In the same chamber as that shown in Figure 8 about 5 l of water per hour flow into the chamber at duct no 5 between the plastics tube and concrete packing (arrow)

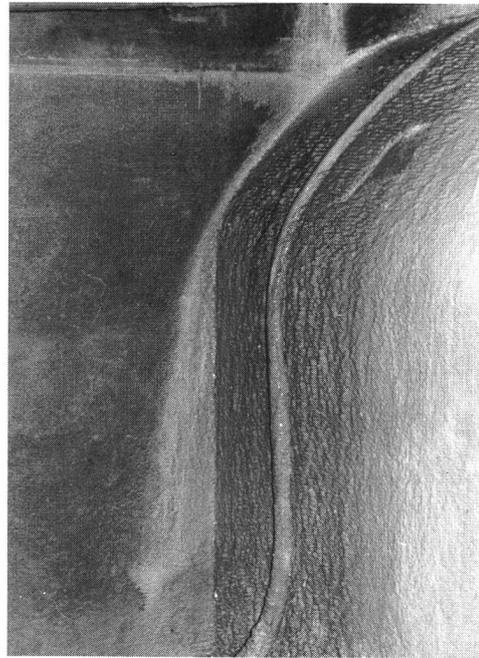
**Fig. 10**

ter entered mainly through the ventilation pipe. Level marks and lime sediments on the walls and in the upper ducts show that an even higher water level prevailed for a sometime. A particularly gross example of lime deposits produced by water seepage was encountered in chamber 28 where the water had spread and rippled down over the whole width of the concrete inlet funnel and formed centimetre thick lime crusts so that the cable resting on the funnel was virtually petrified as can be seen in *Figure 10*.

**Multivay duct at Wollerau**

In this chamber strongly basic water flows into the chamber distributed over the full width of the concrete inlet funnel so that the precipitating lime crust has virtually petrified the cable resting on the funnel
