Zeitschrift: Schweizerische Bauzeitung
Herausgeber: Verlags-AG der akademischen technischen Vereine
Band: 83 (1965)
Heft: 42: Prof. G. Schnitter zum 65. Geburtstag, 1. Heft

Artikel: Design and construction of Mänika Dam
Autor: Bjerrum, Laurits / Kjaernsli, Björn
DOI: <https://doi.org/10.5169/seals-68283>

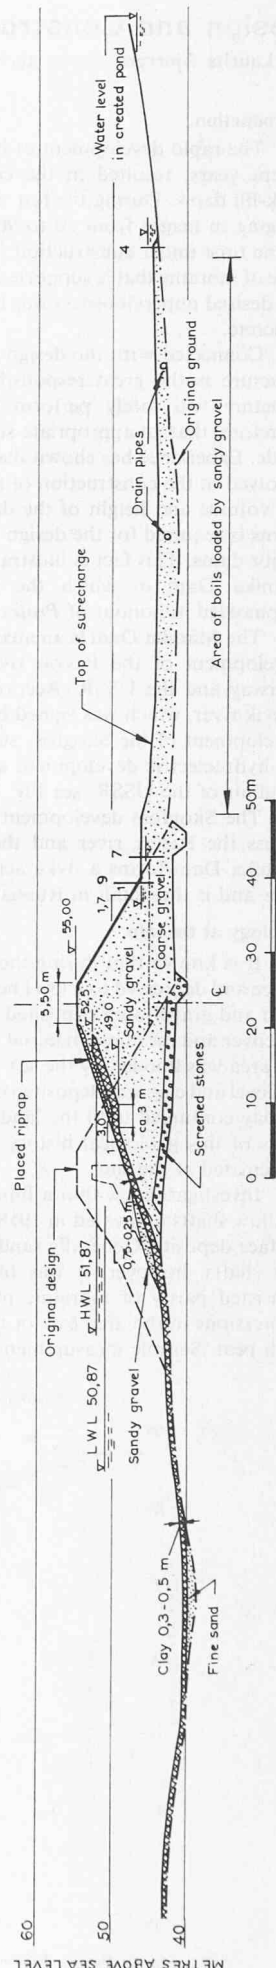
Fig. 4. Mänika Dam as constructed, scale 1:1000

After realizing the ineffectiveness of a flatter upstream slope and of a counterweight, consideration was given to the possibility of eliminating the internal clay core and instead placing the clay as an impervious facing on the upstream slope without any surcharge as an extension of the impervious blanket. It was felt that the clay would be stable on a slope of 1 vertical to 3 horizontal and the design which was agreed upon is shown in Fig. 4. At this stage, however, the loaded area downstream of the dam in figure 4 was not included in the design. To take advantage of the gravel fill that had already been constructed the dam was moved downstream so that the fill could be incorporated into the new structure simply by flattening the upstream slope of the fill to 1 on 3. To protect the clay facing from the deteriorating effect of ice and waves the clay from the top of the dam down to 1,0 m below the lowest regulated water level was protected by a riprap of stones with a minimum weight of 50 kg placed on a layer of sand and gravel; below this level, the facing and clay blanket were left unprotected.

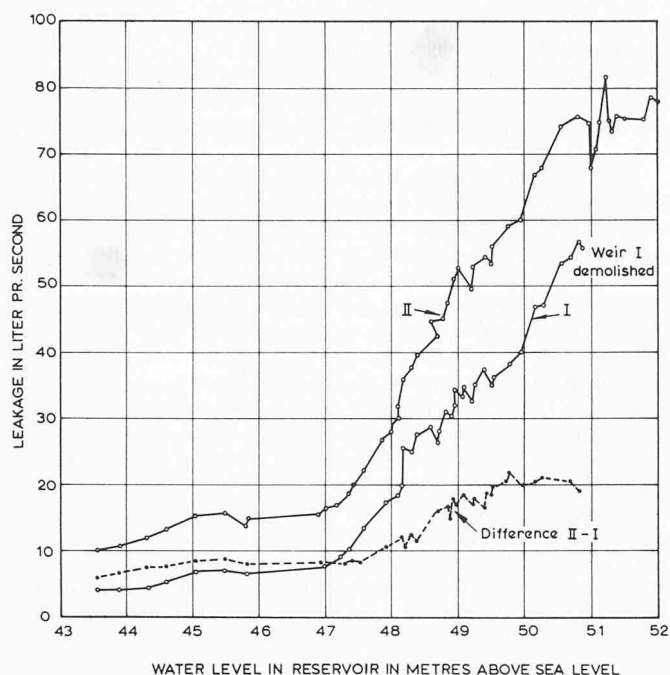
Fig. 6a. Leakage measured at temporary Weirs I and II versus Water Level in Reservoir

Before closing the main branch of the river at the Skogfoss Dam and raising the water level in the reservoir, the seepage and standpipe levels were measured for a water level upstream of the Mänika Dam which very nearly corresponded to the normal river level that existed prior to construction of the dam. For example, at the end of May 1964 the water level in the Pasvik river upstream of the cofferdam was 44,12 m above sea level and the water level in the pond between the cofferdam and the Mänika Dam was 43,55 m above sea level. Under these conditions, the seepage at the two overflow weirs was found to be 4,2 l/s and 10,3 l/s respectively, see Fig. 6a. The standpipe levels at the five measuring points for the same situation is shown in Fig. 6b.

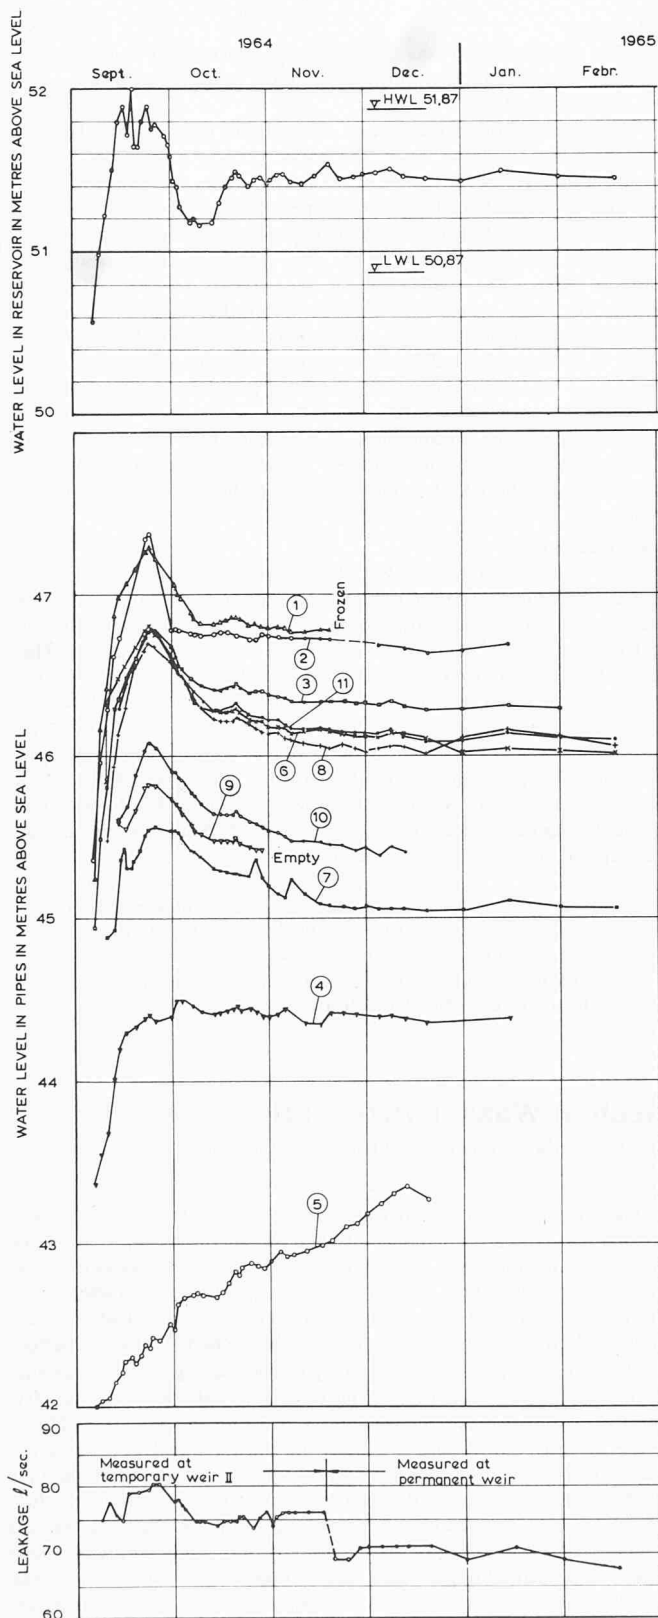
Fig. 7. Water Level in Reservoir, Standpipe Level and Leakage versus Time

The task of loading and draining the area downstream of the dam was completed as the water level in the reservoir reached its maximum at 52,0 m above sea level on September 18th. The leakage under full reservoir head increased to 78 l/s which is, of course, fairly large but of no economical importance for this hydroelectric development. Since then the water level in the reservoir has fluctuated between 51 and 52 m above sea level. The measured leakage as well as the standpipe levels for all installations are shown in Fig. 7.
