# RECORDED FAILURES OF ELECTRICALLY WELDED WROUGHT-IRON AND MILD STEEL BRIDGES.

H. J. L. BRUFF, Bridge Engineer, North Eastern Area, London and North Eastern Railway,  
York.

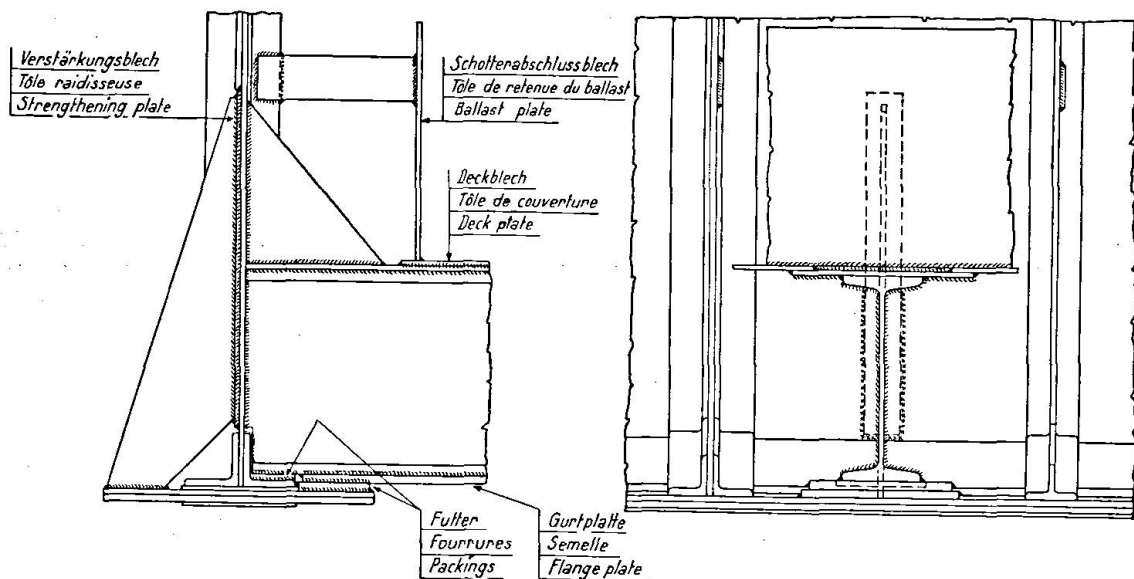
Einzelheiten von Knotenblech- und Stegblechsaussteifungen (Brücke No. 32, South shields Linie).  
 Détails des goussets et raidisseurs de l'âme. (Pont n° 32, ligne South shields).  
 Details of gussets and web stiffeners. (Bridge N° 32, South shields branch).

The first experience of this type of failure occurred in the case of the reconditioning of a large plate main girder of a wrought iron bridge the floor of which was entirely renewed. As it was necessary to place the new cross girders between the old cross girders, where there were no web stiffeners, provision had to be made at these points for proper distribution of end fixing moments and shear from the cross girder ends. A strengthening plate was therefore welded to the outside of the web of the main girders and a triangular gusset plate welded on to it directly opposite the new cross girder end, as shown on Fig. 1.

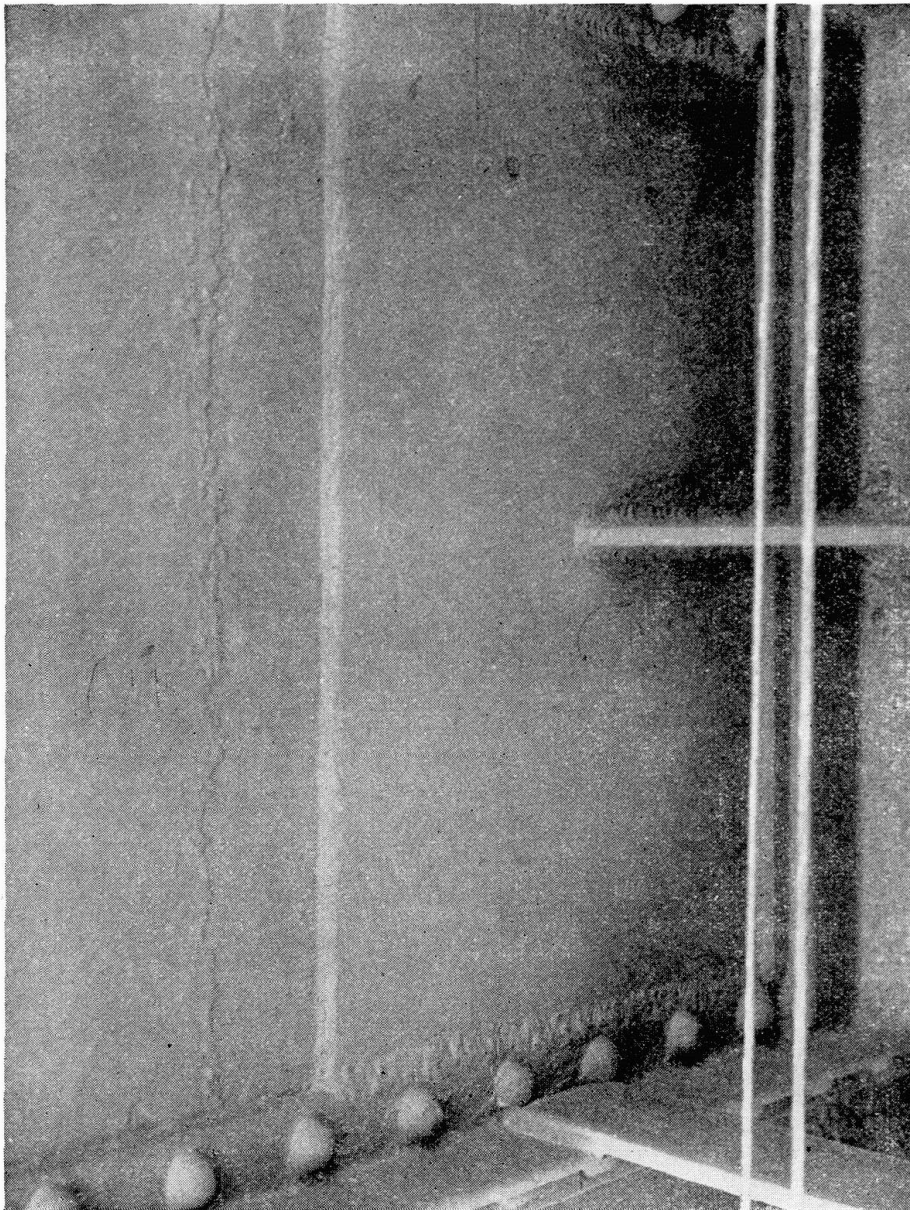
Fig. 4.

In another instance where the webs of the main girders had been holed through corrosion and the webs required to be repaired, fractures took place along the welded seams which were probably due to the contraction of the heated parts of the girder. The failures which were fairly numerous were all identical, being fractures of the vertical butt welds between the new web streng-

thening plate and the toes of the "T" and angle stiffeners. Fig. 4 shows details of construction.

As will be seen from the section it was intended that the welds should not only unite the strengthening plates and the toes of the "T" or angle stiffeners, but also the old web itself. On cutting out the fractured welds, as shown in Fig. 5, it was found, that good penetration had been obtained between the strengthening plate and the "T" but that there was no penetration in the case of the web, as will be seen from the photograph of a part of the "T", strengthening plate and web which were cut out in order that the cause of the fracturing might be ascertained.

Einzelheiten von Stegblechreparaturen. (Brücke No. 2, Monkwearmouth Güter-Linie).  
 Détails de réparations de l'âme. (Pont n° 2, ligne Monkwearmouth — trains de marchandises).  
 Details of repairs to web. (Bridge N° 2, Monkwearmouth Goods Branch).

been in full contact with the web plate. Out of 48 welds 17 were found to be fractured, these were all cut out and in not a single instance had penetration with the web been secured. The practice is now to make the gap  $1/16''$  min. the face of the chamfer the same, using a No. 10 electrode with a slightly higher

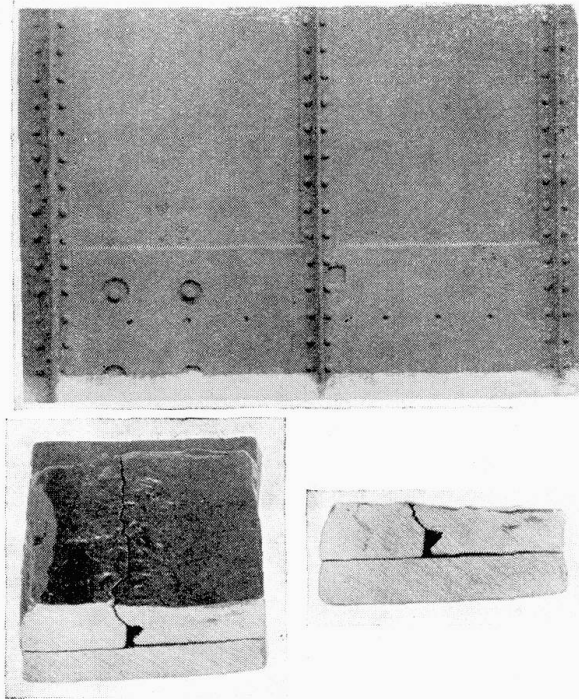
Fig. 5.

The gap between the strengthening plate and the "T" had been prescribed to be  $1/16$ ", but apparently this had not been worked to in all cases, the weld cut out was barely  $1/16$ " and it appeared that the strengthening plate had not

Schnitt durch die gerissene Schweißung.  
Coupe à travers la soudure rompue.  
Section of fractured weld.
