Rehabilitation of Yamuna Bridge at Kairana (India)

Heft C-46: Repair and rehabilitation of bridges: case studies I

10. Rehabilitation of Yamuna Bridge at Kairana (India)

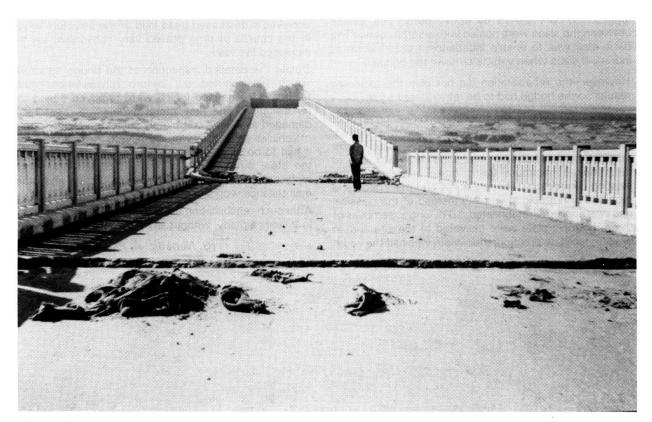
Fig. 1 Top view

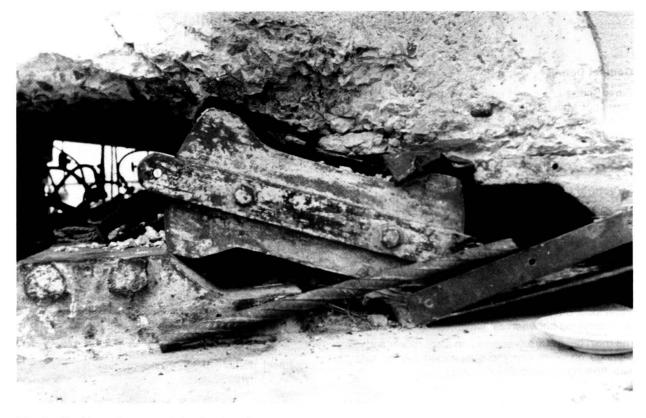
Fig. 2 Position of segmental roller bearings

Tapered steel shims were used to cater for change in inclination of span over supports, during lifting operation. After bringing the span to the level position, the suspended spans were shifted longitudinally to their original position by use of Freyssinet flat jacks at the expansion joint positions.
