# Repair of scoured substructure (Japan)

Zeitschrift: **IABSE structures = Constructions AIPC = IVBH Bauwerke**

Heft C-47: **Repair and rehabilitation of bridges: case studies II**

## Case 2 Repair by reinforced concrete lining; Natori Bridge, Miyagi

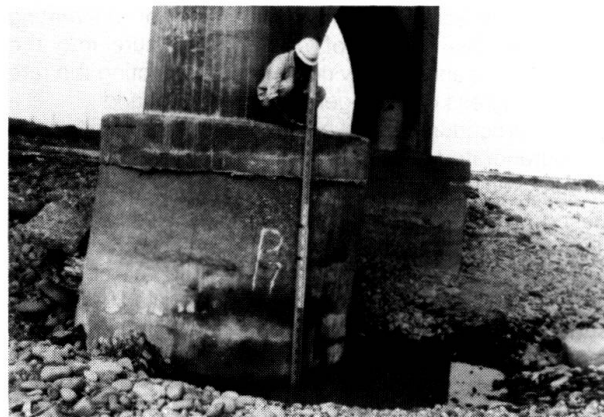
Fig. 6 Before repair (Natori Bridge)

The substructure on this bridge was repaired due to the following problems:

- 1) Exposed steel reinforcements at top of the caisson.
- 2) Bridge pier endangered of toppling due to scouring at the caisson causing differential settlement and loss of strength in the surrounding foundation.
- 3) The connection between caisson and pier has been deteriorated from shear force.
- 4) Furthermore, due to its old design, its ability to resist today's load has been questioned.
