# Ohara Bridge fatigue crack repair (Japan)

### 6. Ohara Bridge Fatigue Crack Repair (Japan)

Owner: Toyama Prefecture  
 Engineer & Contractor: Kawada Industries  
 Work's duration: 6 months  
 Date of repair: 1984 – 1985

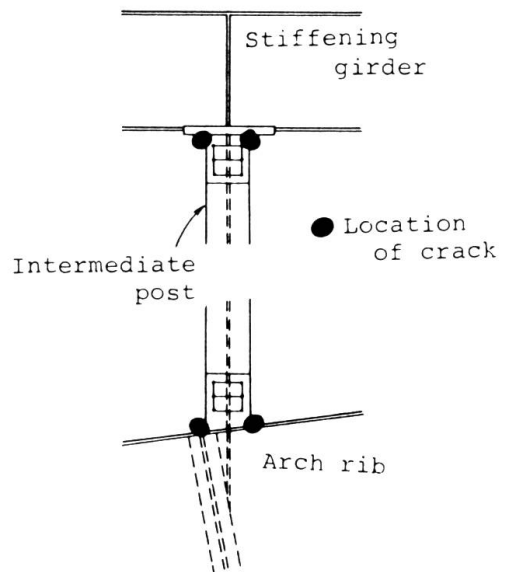
Fig. 2 Location of crack

The fatigue cracks occurred at the connecting gusset plates to each panel of intermediate post, which connects the stiffening girder to arch rib (Fig. 2, 3), and also at the web of stiffening girder above end post, which is the joint between center span and side span (Fig. 4, 5). These cracks were found by visual inspection during patrol in 1982.

According to the results of liquid penetrant tests conducted immediately after finding them, the maximum length of the cracks was 65 mm at the gusset plate of intermediate post, respectively 185 mm at the web of stiffening girder.

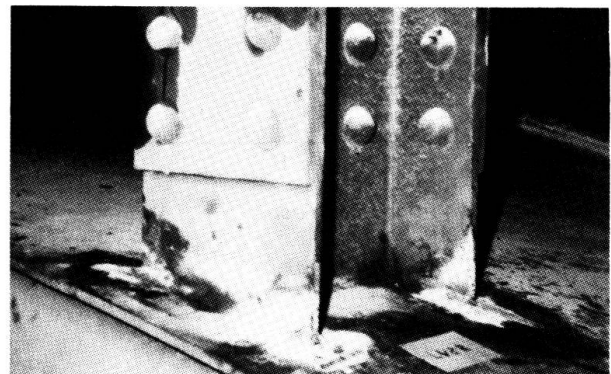
Fig. 3 Crack at gusset

The fatigue cracks in the gusset plates of intermediate posts were mainly caused by excessive stress concentration at the corner section. This stress concentration was caused by a relatively large longitudinal displacement between stiffening girder and arch rib, which was created by the movability of both end supports. This was confirmed from displacement obtained in a loading test on the actual bridge, results from stress measurements, and the results of 3-dimensional finite element method analysis (Fig. 6). Therefore, as repairing method, new damper bearings were installed on the top of both abutments for reducing the relative longitudinal displacement (Fig. 7). This damper bearing comprised a rubber bearing, return spring and special hydraulic damping system. The supporting condition provides movability at both support bearings for static movement such as temperature effect and resists only to vertical movement caused by live load, giving elastic restraint toward longitudinal movements. Moreover, improvement schemes by making rigid joints or by providing hinges at the gusset plates of intermediate posts were reviewed, but the former indicated an adverse influence upon arch rib and the latter was found to be uneasy to work with. In addition, the compression stress was found to be primary, and the relief of residual stress by the outbreak of cracks was found to be expectable, so both improvement schemes were not adopted this time.

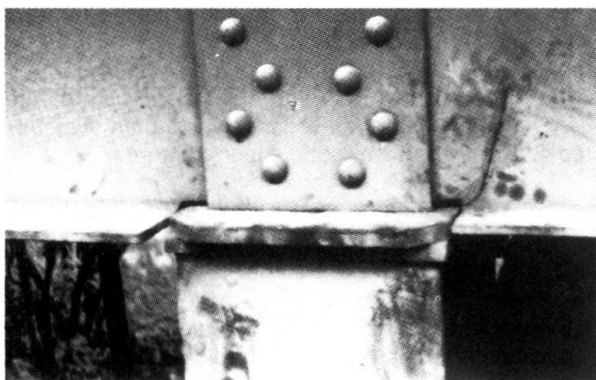
Fig. 5 Crack at stiffening girder web

With respect to the fatigue cracks in the web of stiffening girder above the end post, the stress concentration by secondary bending stress at the notches, which also resulted from out-of-plane displacement, was found to

Among these cracks, a temporary repair was made for the cracks in the web of stiffening girder immediately after finding them in order to prevent a rapid breakdown as explained below. That is, stop holes were drilled at the end of all cracks in the web. Moreover, steel brackets were installed on all end posts and were used as temporary supports for stiffening girders in side span and center span.

be the main cause of the fatigue cracks. This was also confirmed by the loading test on the actual bridge. In the repairing method adopted, it was first necessary to reduce the out-of-plane displacement of web and thus lateral bracings were added near the location of web. As repairing measures against the cracks in web, three schemes were reviewed: making rigid connections or hinged connections at the joints, or repairing cracked portion by double plates. In consequence, the scheme of repairing the cracked portion by double plates was adopted from the viewpoint of easier work and appearance (Fig. 8). It was decided to leave the steel brackets, installed during temporary repair, as they were.
