Strengthening of bridge slab at Kami-Imasu Bridge (Japan)

8. Strengthening of Bridge Slab at Kami-Imasu Bridge (Japan)

Owner: Japan Highway Public Corporation
Engineer: Japan Highway Public Corporation
Date of Construction: 1964
Date of Repair: 1976

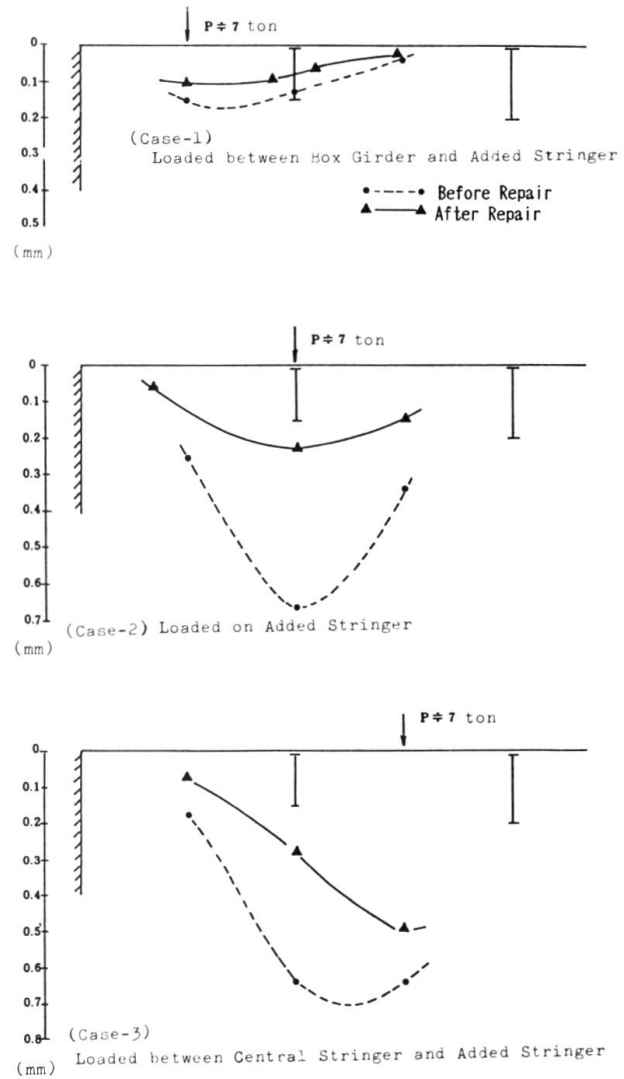
Fig. 2 Effect of Repair

A loading test was conducted, using a truck with a 7-ton rear wheel load in order to measure the difference of deflections before and after the strengthening. The result is shown in Fig. 2.

In cases where the wheel was located between the main box girder and the added stringer (Case-1), on the added stringer (Case-2) and between the original stringer and the added stringer (Case-3), the deflections at the loading points after repair were decreased to 60%, 66% and 78%, respectively. The repair work is, thus, estimated as successful.

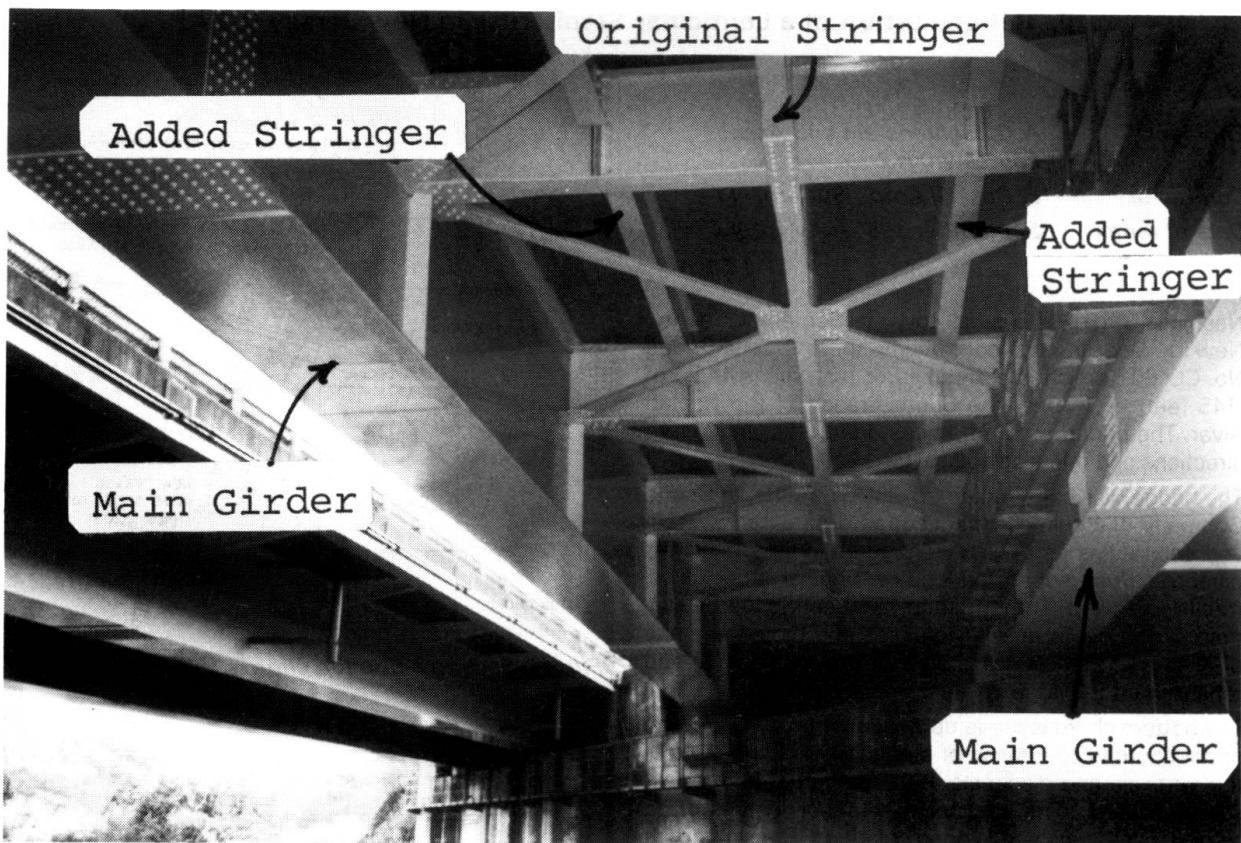
Photo 1 General View of Strengthening

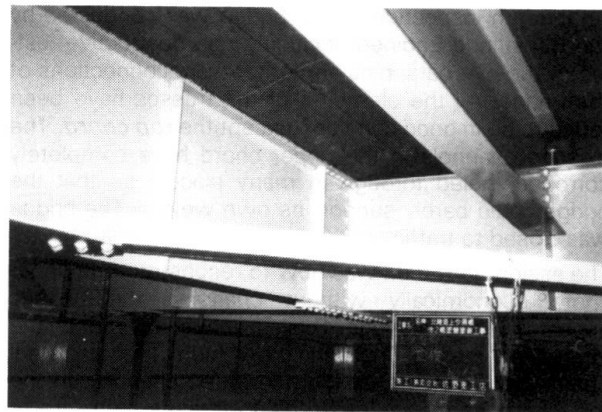
Photo 2 Detail of Added Stringer
