SURFACING ON FORTH ROAD BRIDGE

W. HENDERSON
Scotland

The contributor describes the nature and conditions of the mastic asphalt surface on the orthotropic steel deck of Forth Road Bridge. Specifications are given together with details of minor defects which have arisen in four years of use and the remedial measures taken.

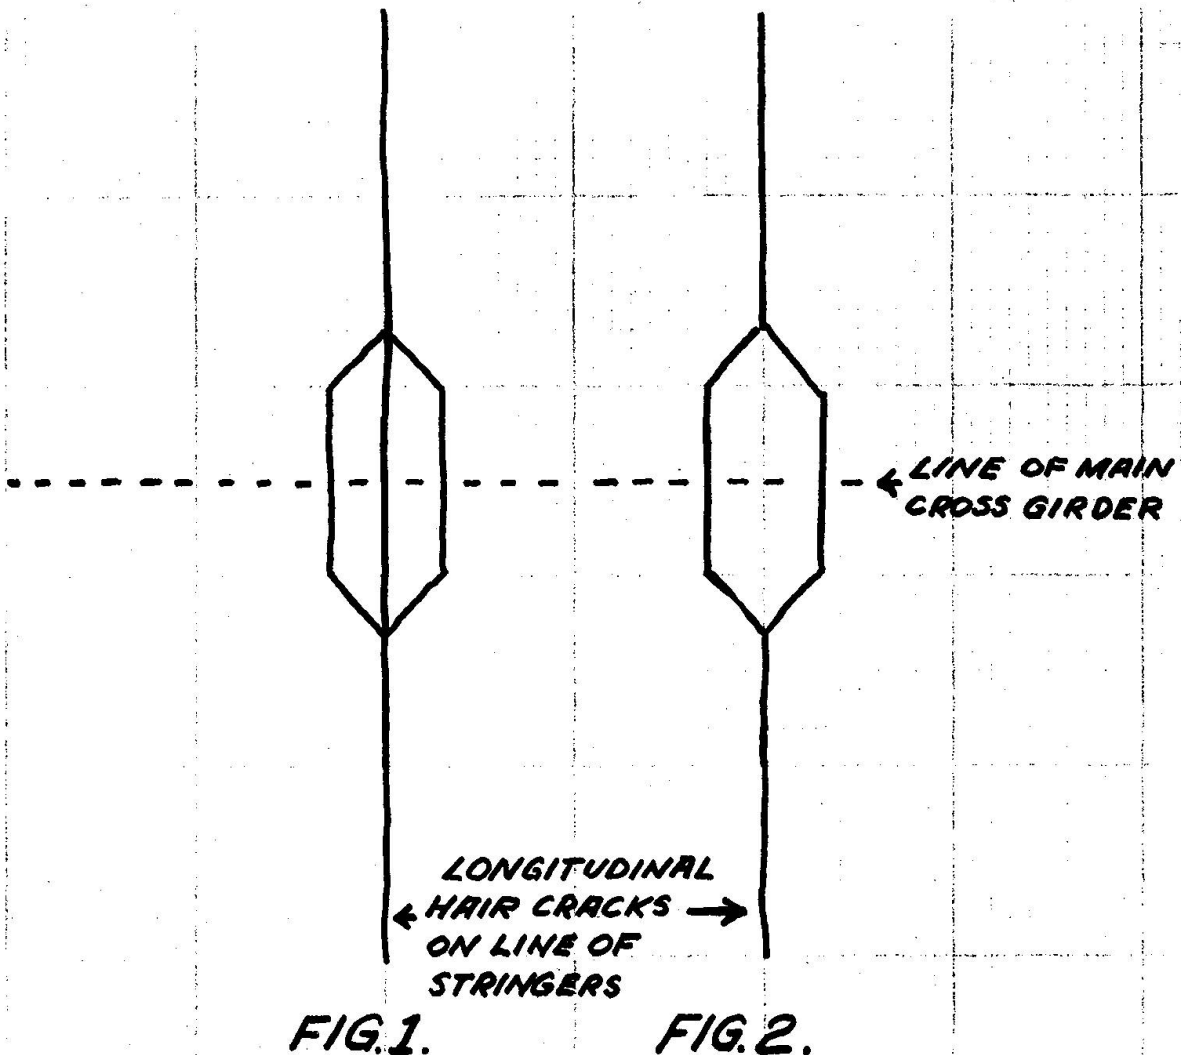
About eight months after the bridge was opened to traffic it was observed that five longitudinal cracks were beginning to appear in the slow lane, some 8 ft (2.4m) from the outer kerb. These fine cracks extended rapidly to form a more or less continuous line along the full length of the main span decked with orthotropic plates. The location of this crack coincided with the position of high negative bending at a stringer. Further fine longitudinal cracks appeared close to the kerb of the slow lane at points where the corresponding stringer passed over the main cross girder. These cracks were generally some 9" (23cm) to 18" (46cm) long. At these points the stringer webs are stiffened with bearing stiffeners and so stiffer than elsewhere.

In the case of each of the main longitudinal cracks, the tracks of vehicles straddle the stringers almost symmetrically and the location of these members is such that actual traffic takes up the position of causing maximum negative movement over this support. On these cracks, too, there was a tendency, where the stringer passes over the main cross girder and is reinforced with bearing stiffeners, for two short cracks to form on either side of the main longitudinal crack for a distance of 9" (23cm) to 18" (46cm) and then to return into it at an angle (Fig.1). In other cases the central crack terminated between the apices of these hexagons (Fig.2).

Careful examination showed that the bond between the asphalt, and the steel was not impaired. An area of asphalt was removed for inspection and it may be of some interest to note that over small patches the zinc spray applied to the steel surface pulled off with the asphalt.

Remedial measures were put in hand quickly; these consisted of making a "saw" cut ~~1/2~~ 1" (1.25cm) wide along the line of each crack to a depth of 1" (2.5cms). This cut was freed from dust by blowing out with compressed air and then filled by pouring in a sealant conforming with the current British Standard 2499(55), and with the American Federal Specification SS/S 164. The actual material used is a proprietary known as Expandite Pliastic 55.
