POST EARTHQUAKE CONSTRUCTION OF GEDİZ

Aybars Gürpınar

Associate Professor of Engineering Sciences
Earthquake Engineering Research Institute
Middle East Technical University, Ankara Turkey

SUMMARY

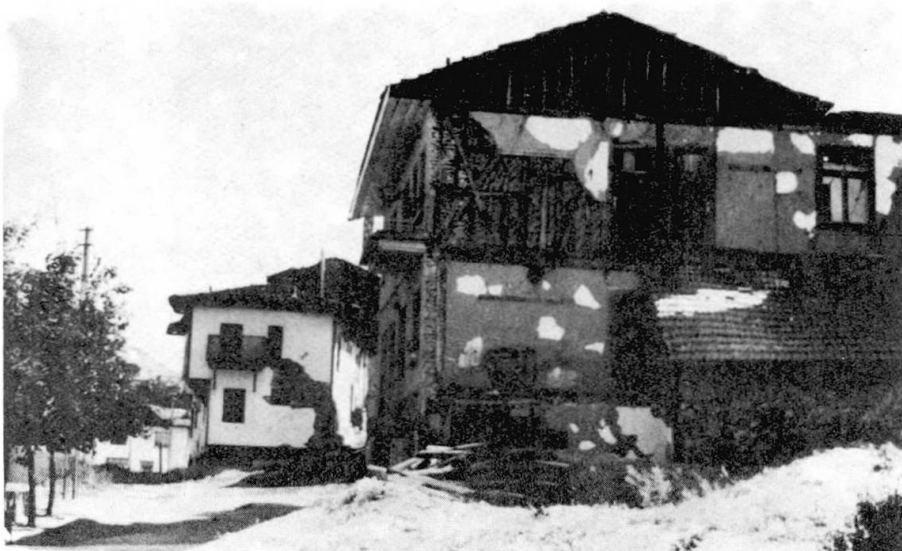
By far the most common residential type of construction in Gediz is wood frame. A typical Gediz house of this type (**Hımsı**) may be seen in Figure 4. The major deficiency of this type of construction during an earthquake is the danger of loose infill, improper diagonal bracing and poor masonry foundation. A more refined version of this type of construction may be seen in

Figure 4. Typical Wood Frame Structure (Hımsı)

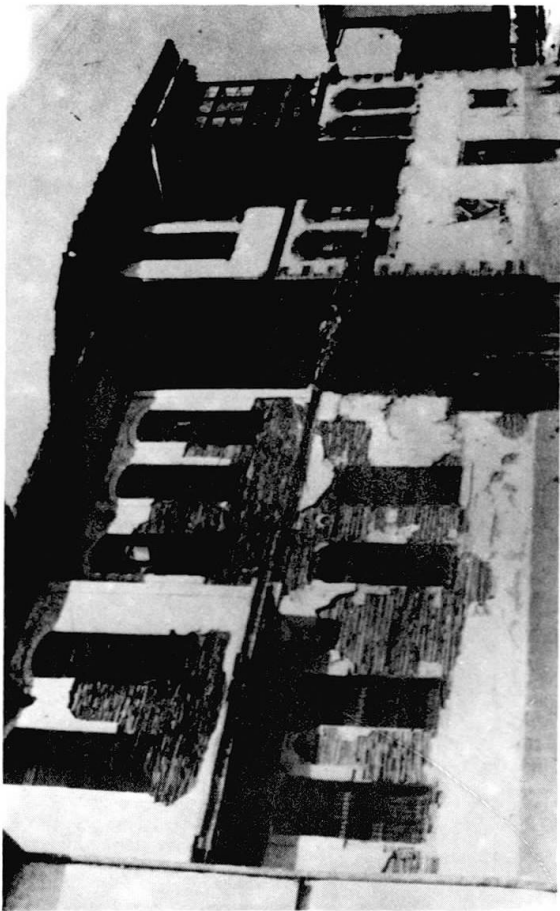
Figure 5. The first two points of deficiency are generally taken care of in this type (balıdadi) of construction.

Figure 5. Typical Wood Frame Structure (Bagdad)

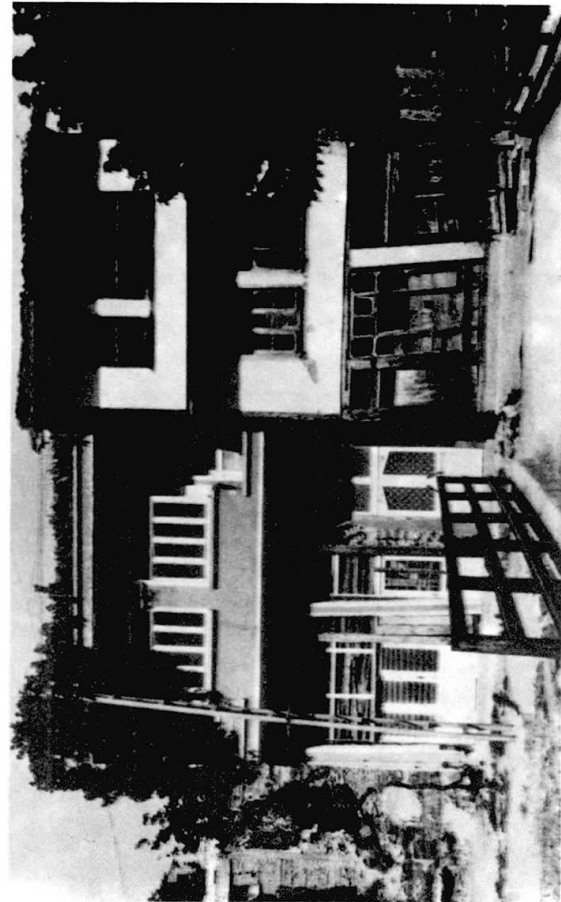
The major causes of failure for wood frame structures were spilling of loose infill material, inadequate cross bracing and poor foundation. Sidesway of one such building due to inadequate cross bracing may be seen in Figure 6. On the whole, however, wood frame structures behaved exceptionally well during the earthquake.

Figure 6. Sidesway Caused by Inadequate Cross Bracing
