REPAIR OF EARTHQUAKE DAMAGED BUILDINGS

Loring A. Wyllie, Jr.
Structural Engineer
H.J. Degenkolb and Associates
San Francisco, California U.S.A.

SUMMARY

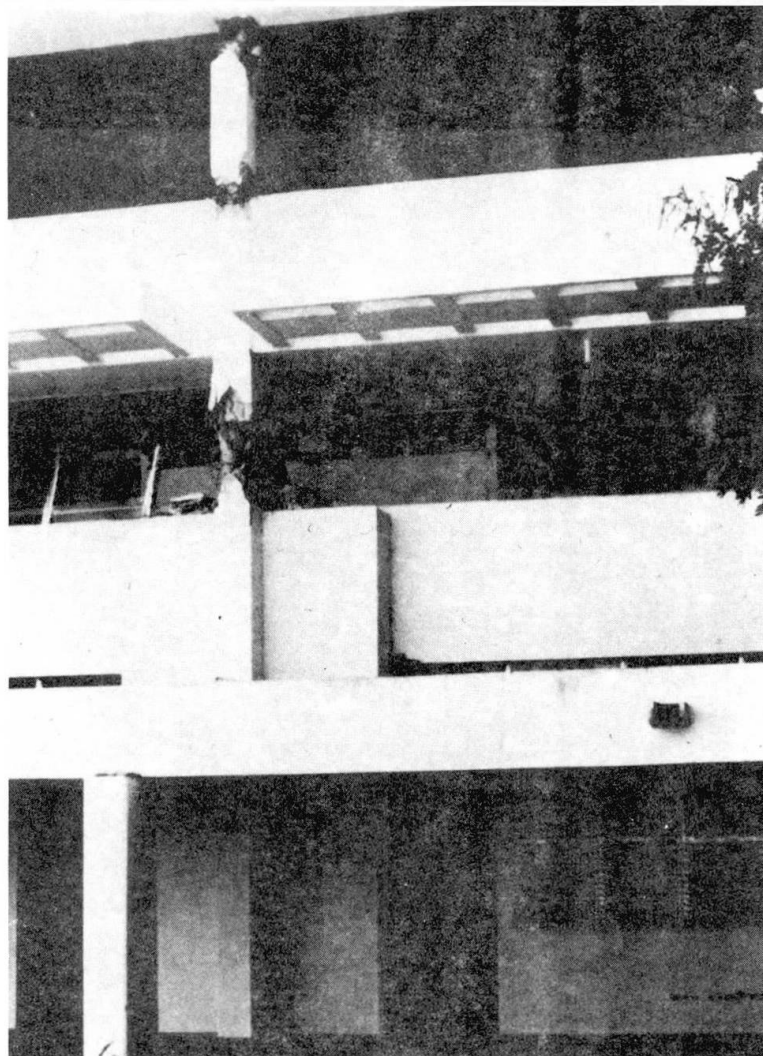
The first example involves the Colegio Teresiano on the outskirts of Managua, Nicaragua. The building is a three story concrete frame school building of a long rectangular plan, similar to schools built throughout the world. A small earthquake of magnitude 4.6 in 1968 was centered quite close to the building and caused cracking and structural distress to the columns in the first story. The building was repaired by adding a stiffened concrete wall element in the first story between classroom doors and extending up to the second floor balcony rail height. This new wall element can be seen in Figure 1.

The destructive Managua earthquake of December 23, 1972, caused considerable damage to this building, but only in the second and third floors, where considerable column damage resulted. Figure 1 was taken after this second earthquake. The new wall elements in the first floor prevented damage in that floor, but permitted the earthquake forces and motion to travel upward, causing the observed damage. The repairs had not considered the effect on the remainder of the structure. Had these or stronger walls extended to the roof, much of this damage might have been prevented.

Figure 1. Colegio Teresiano in Managua, Nicaragua, after 1972 earthquake. First story stiffening wall, which can be seen projecting outward from second floor beam, prevented first story damage but increased upper story damage.

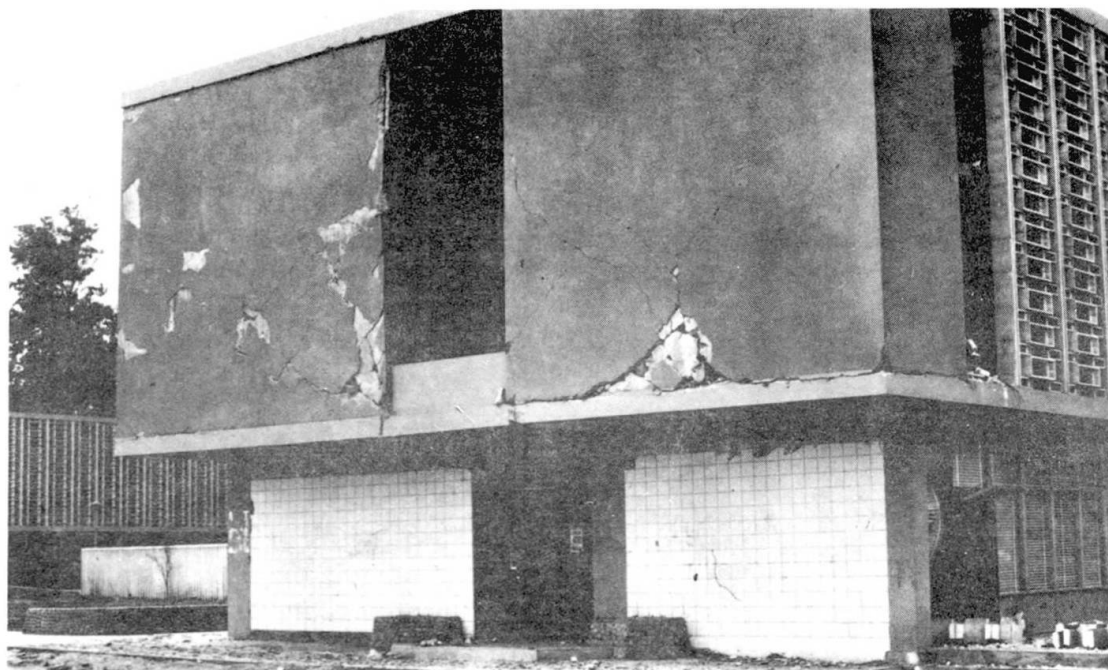
A second example shows a three story classroom building at the Agricultural University in the La Molina area of Lima, Peru. There are four identical buildings of concrete construction. The first story was originally framed without structural walls and only columns for support and bracing. Considerable wall panels and masonry partitions were present in the upper two stories. A magnitude 7.5 earthquake on October 17, 1966, caused significant damage to the first story columns, so concrete shear panels were introduced to stiffen and brace this first story.

A second earthquake of magnitude 7.6 affected these structures on October 3, 1974. Figure 2 shows the end of one of these buildings after that earthquake. There was little damage in the first story due to the previous strengthening, but that increased stiffness caused considerable damage in the upper two floors which had not been strengthened after the 1966 earthquake.

Figure 2. Classroom building at Agricultural University after 1974 earthquake. Stiffened first story had little damage due to added concrete wall panels, but upper stories had increased damage in this earthquake.
